# World Trade Center Building Performance Study:

*Data Collection, Preliminary  
Observations, and  
Recommendations*

**Federal Emergency Management Agency**

FEMA 403 / September 2002

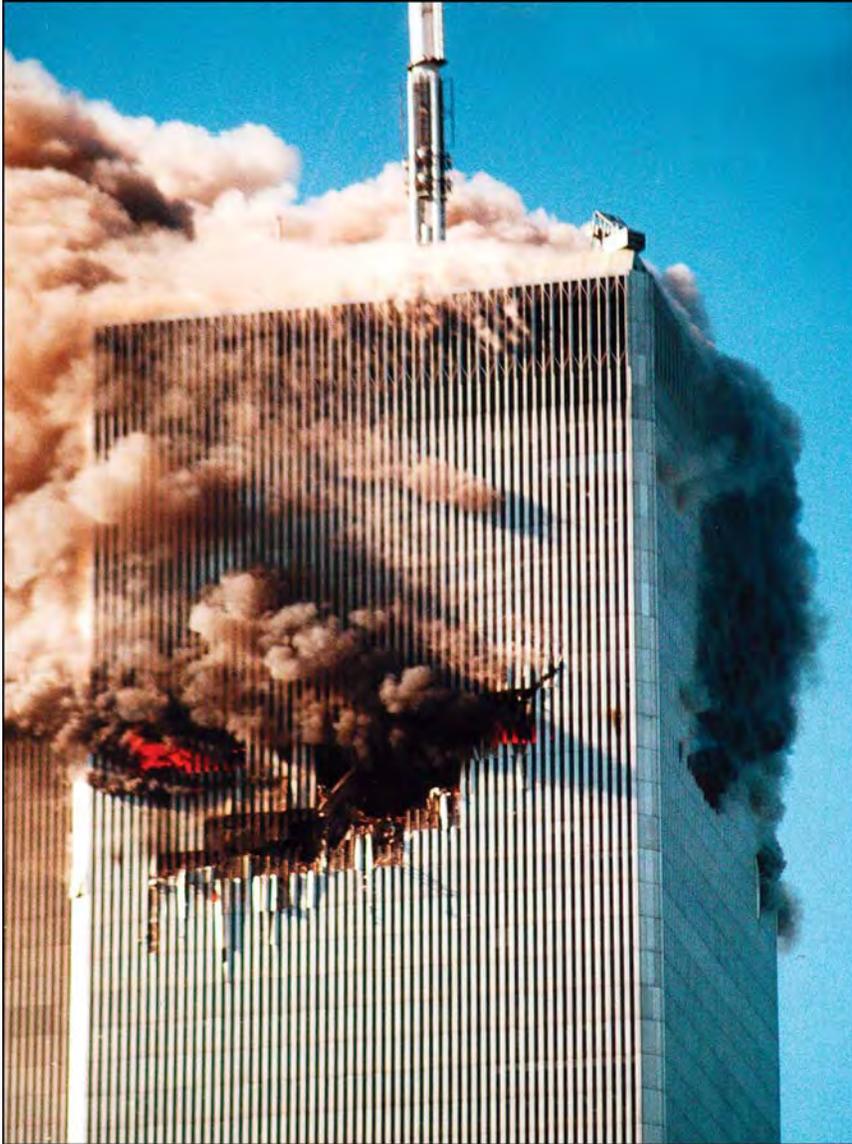
Figure 2-13 Zone of aircraft impact on the north face of WTC 1.

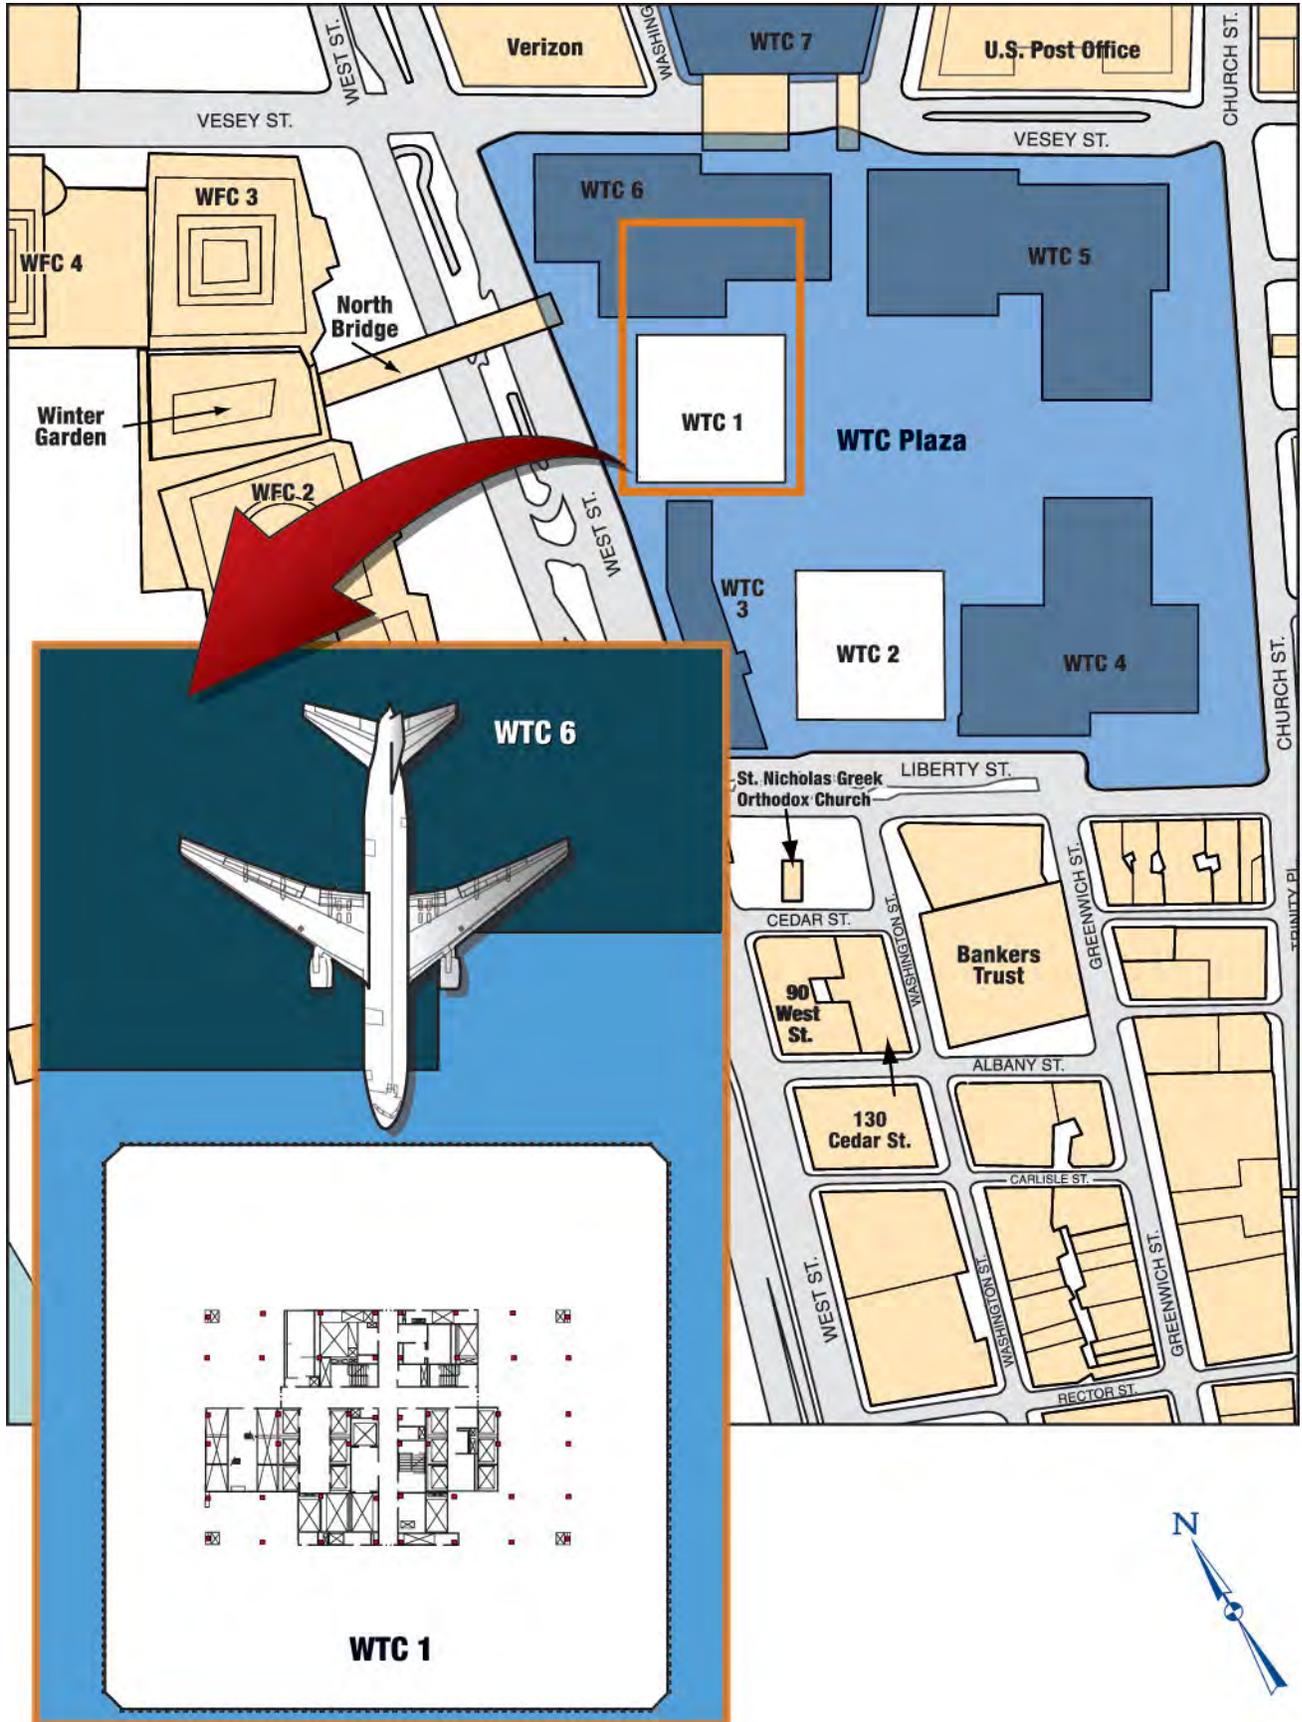
Figure 2-14 Approximate zone of impact of aircraft on the north face of WTC 1.

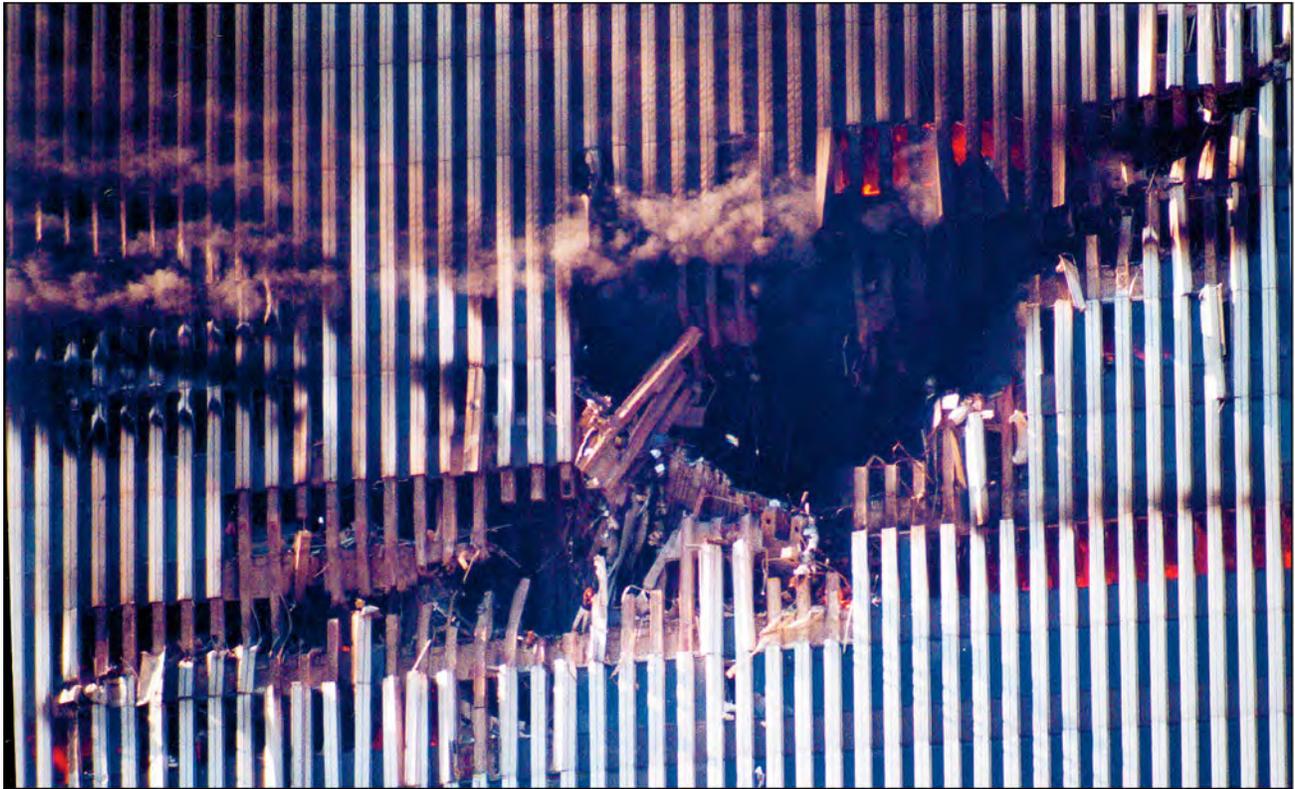
Figure 2-15 Impact damage to the north face of WTC 1.

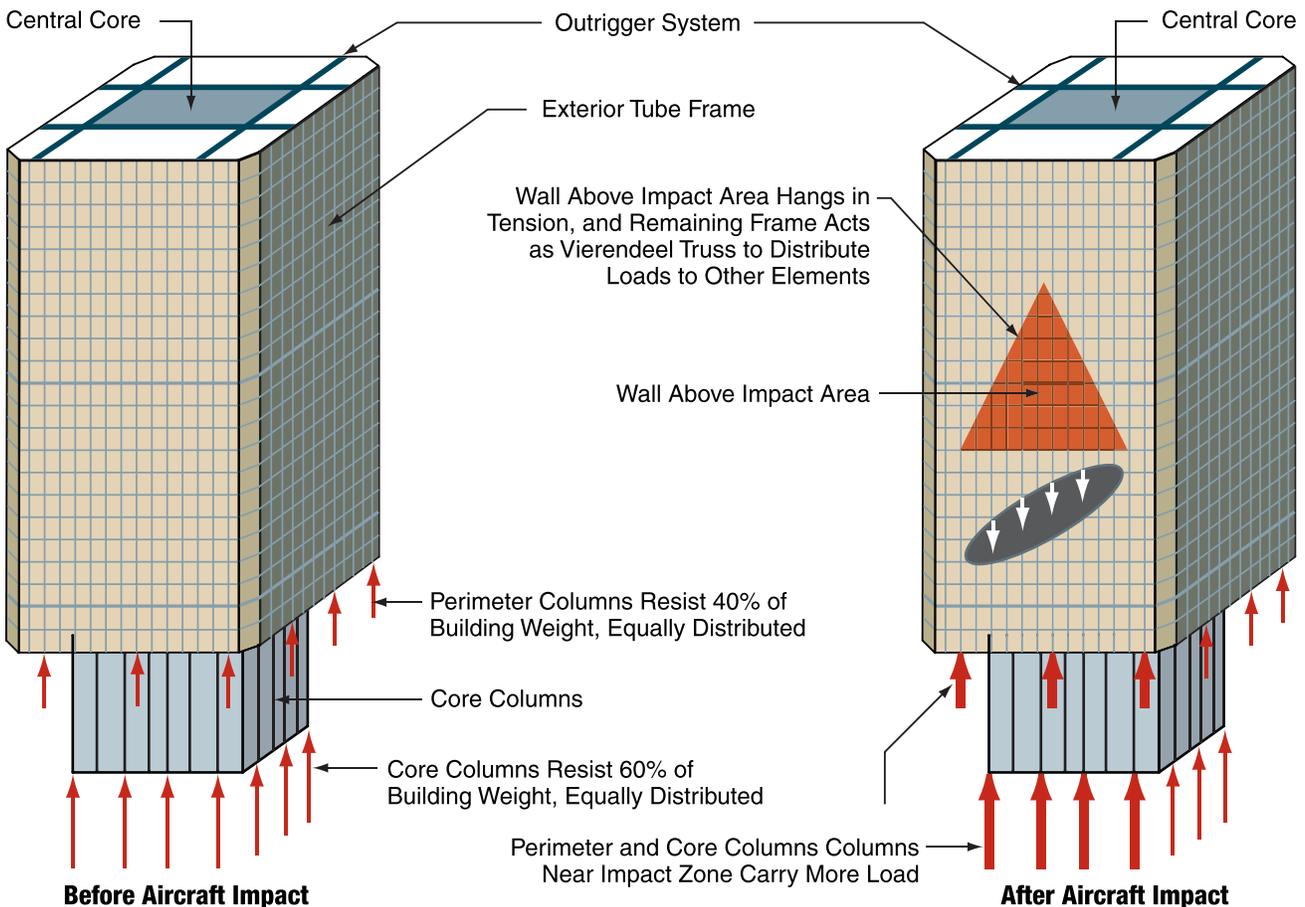
Figure 2-19 Redistribution of load after aircraft impact.

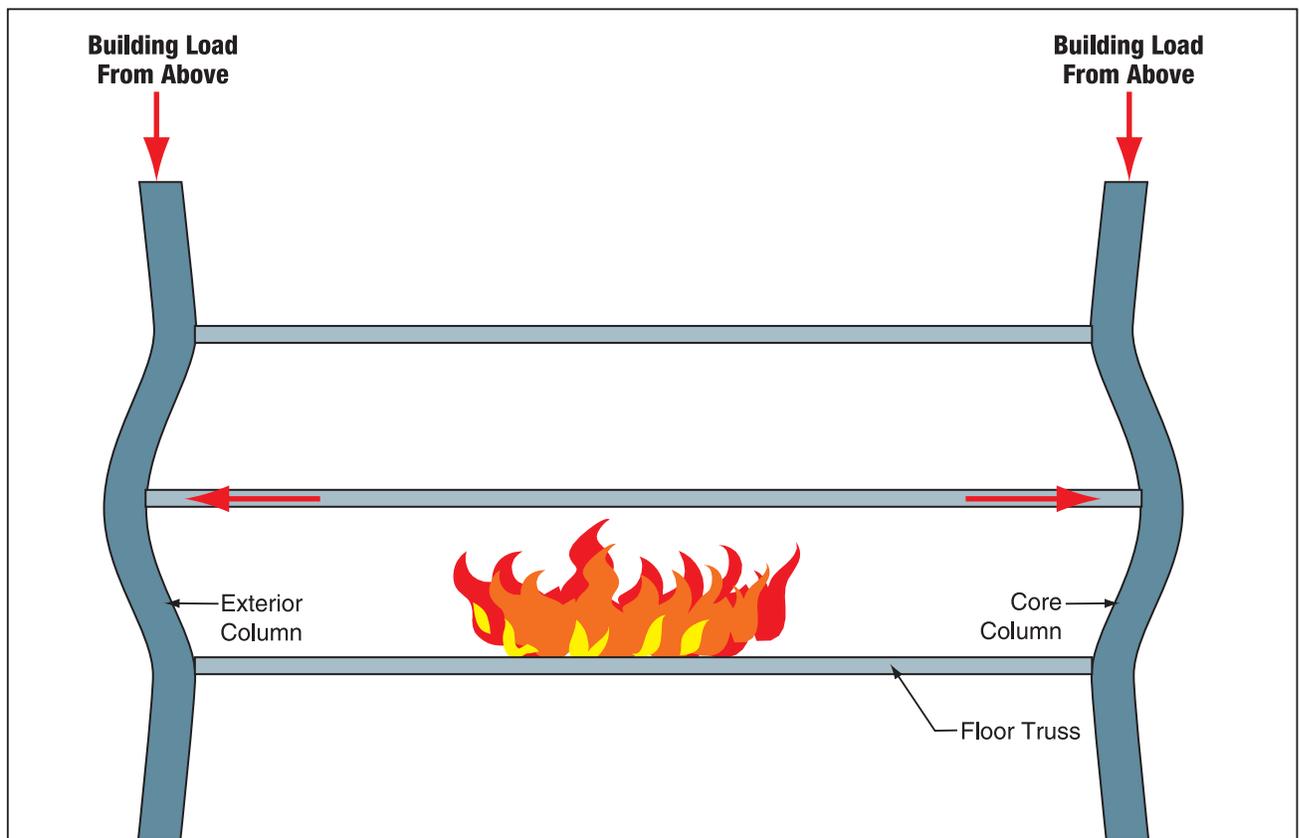
Figure 2-20 Expansion of floor slabs and framing results in outward deflection of columns and potential overload.

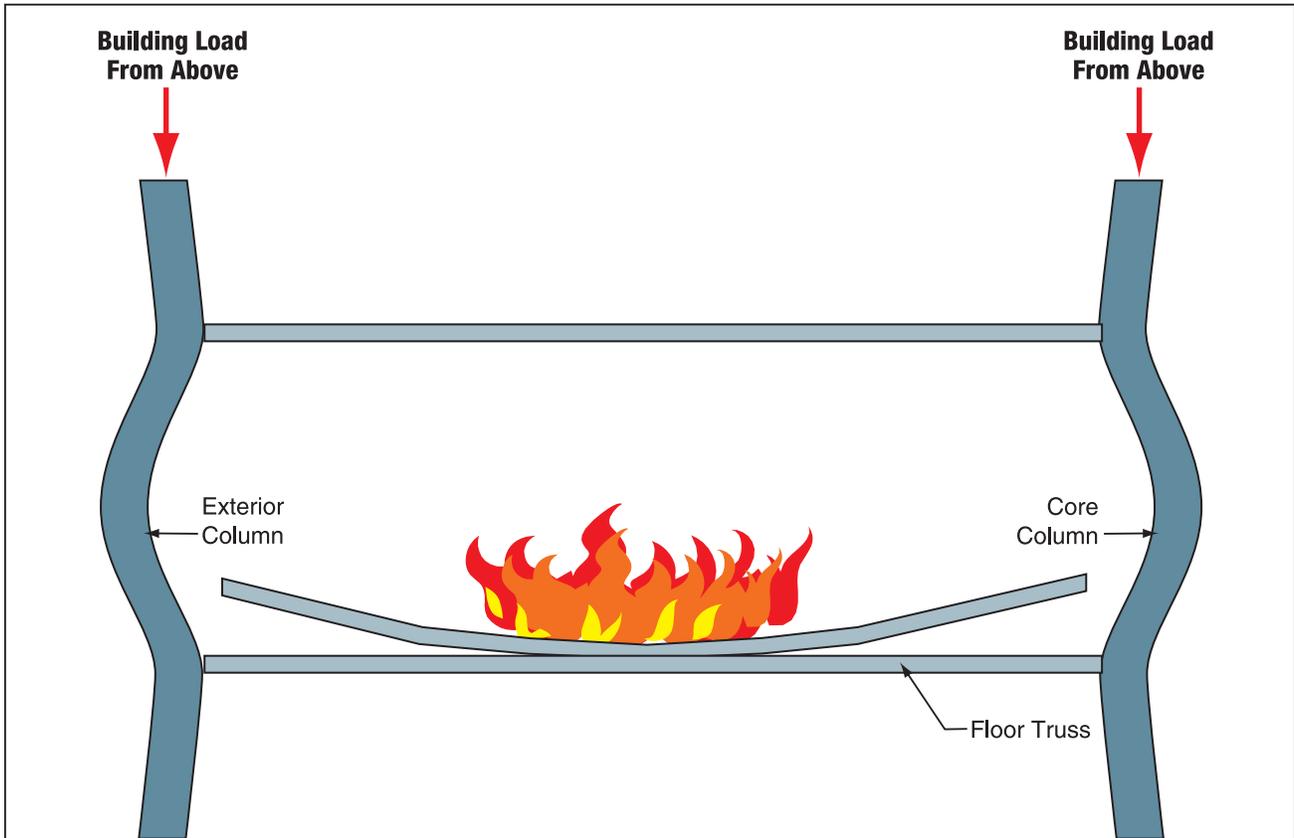
Figure 2-21 Buckling of columns initiated by failure of floor framing and connections.

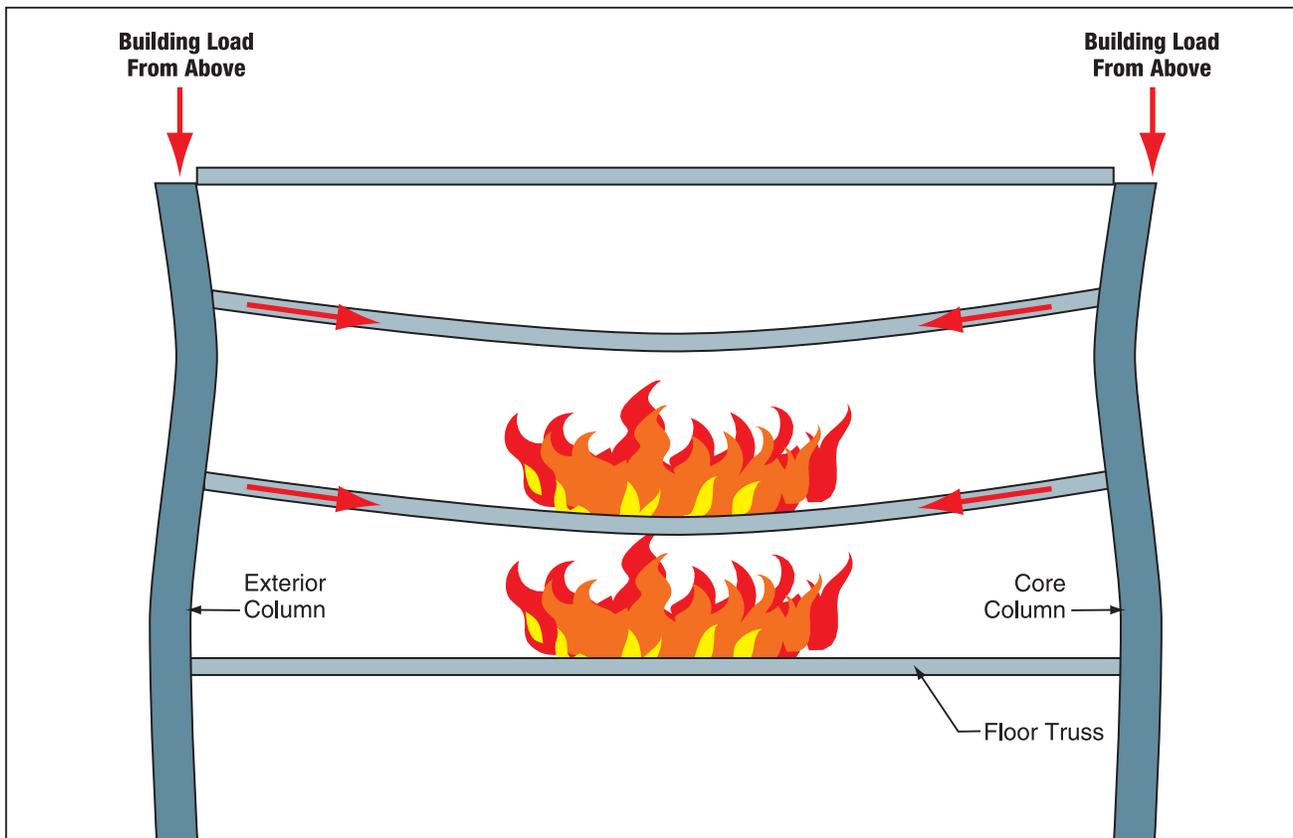
Figure 2-22 Catenary action of floor framing on several floors initiates column buckling failures.

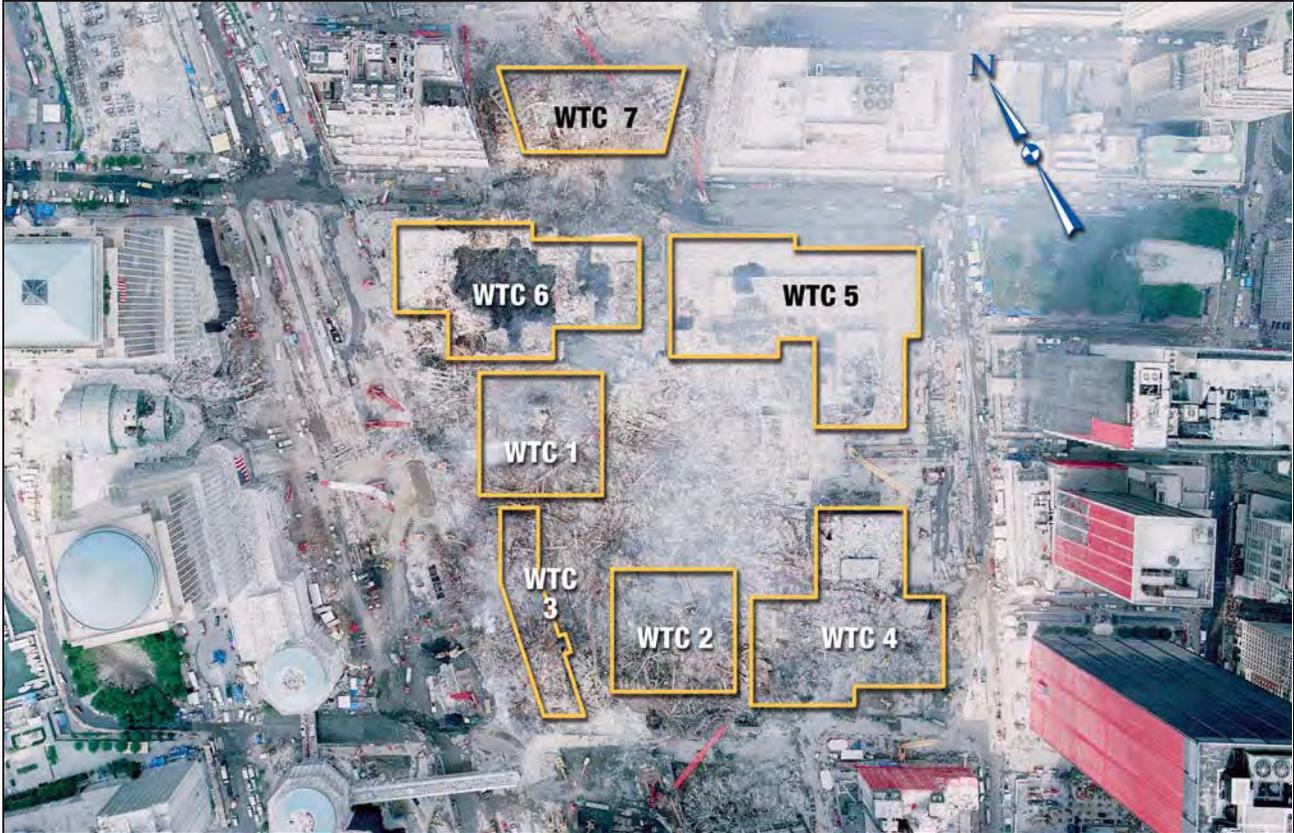
Figure 2-23 Aerial photograph of the WTC site after September 11 attack showing adjacent buildings damaged by debris from the collapse of WTC 1.

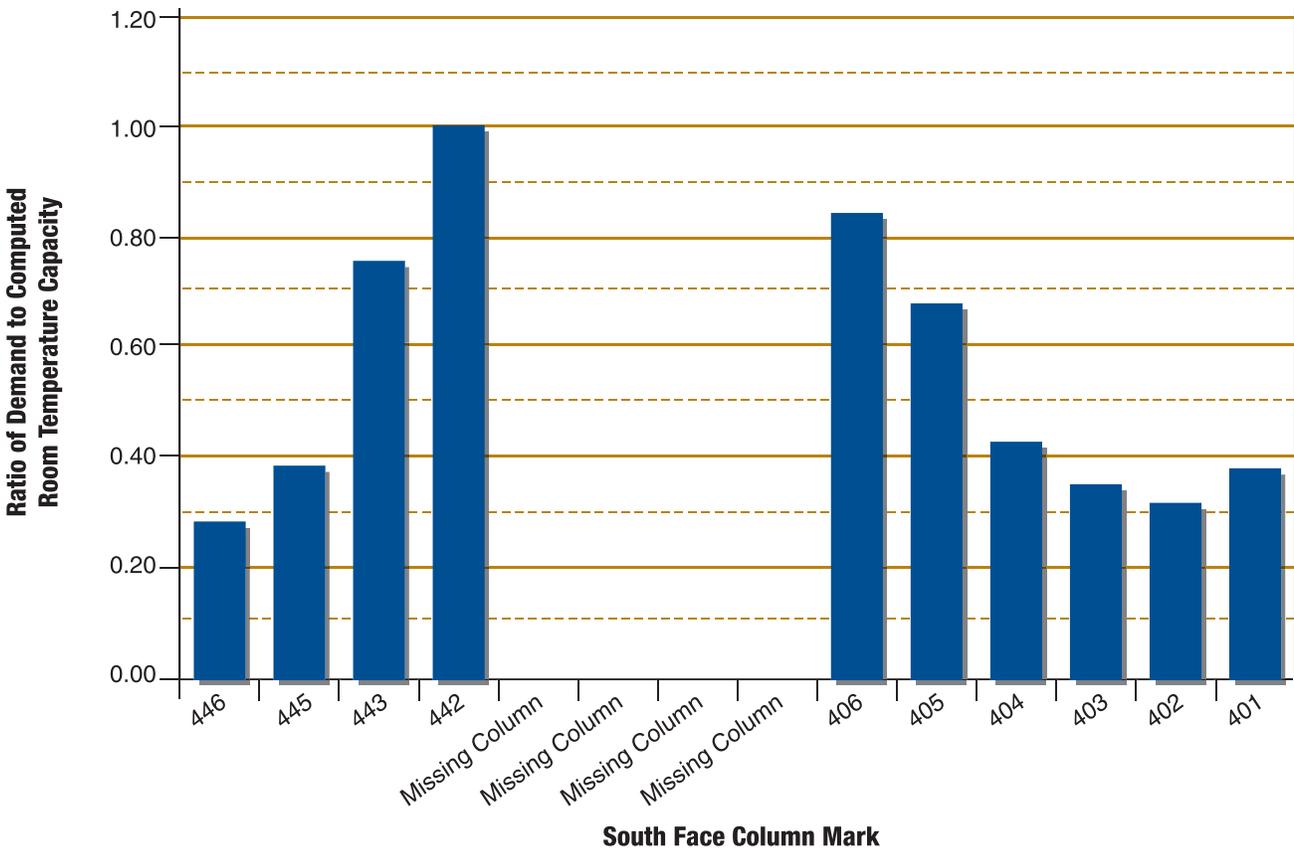
Figure 2-31 Plot of column utilization ratio at the 80th floor of WTC 2, viewed looking outward. (Conservatively assumes columns 407–411 and 440–441 to be missing.)

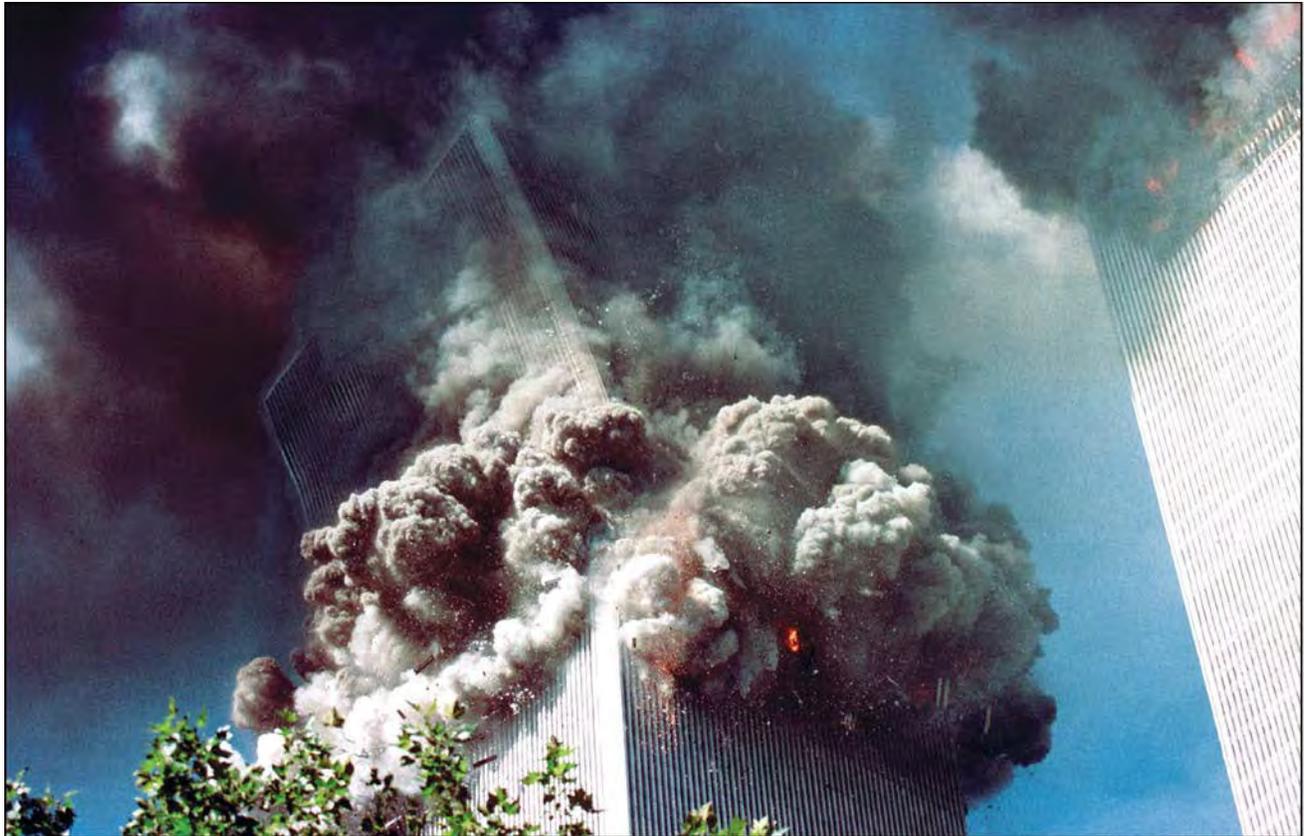
Figure 2-32 The top portion of WTC 2 falls to the east, then south, as viewed from the northeast.

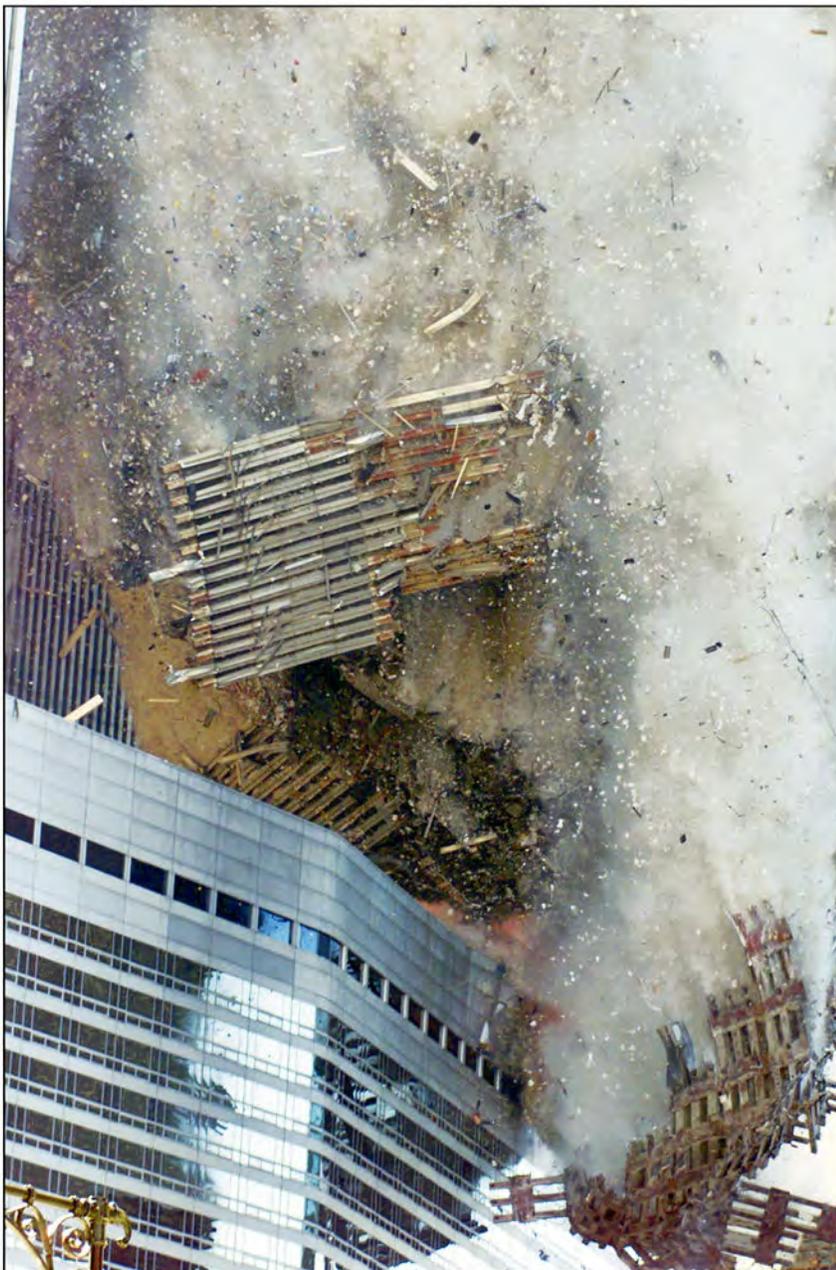
*Figure 3-6  
Exterior columns from the collapse of WTC  
2 falling on the southern part of WTC 3.*

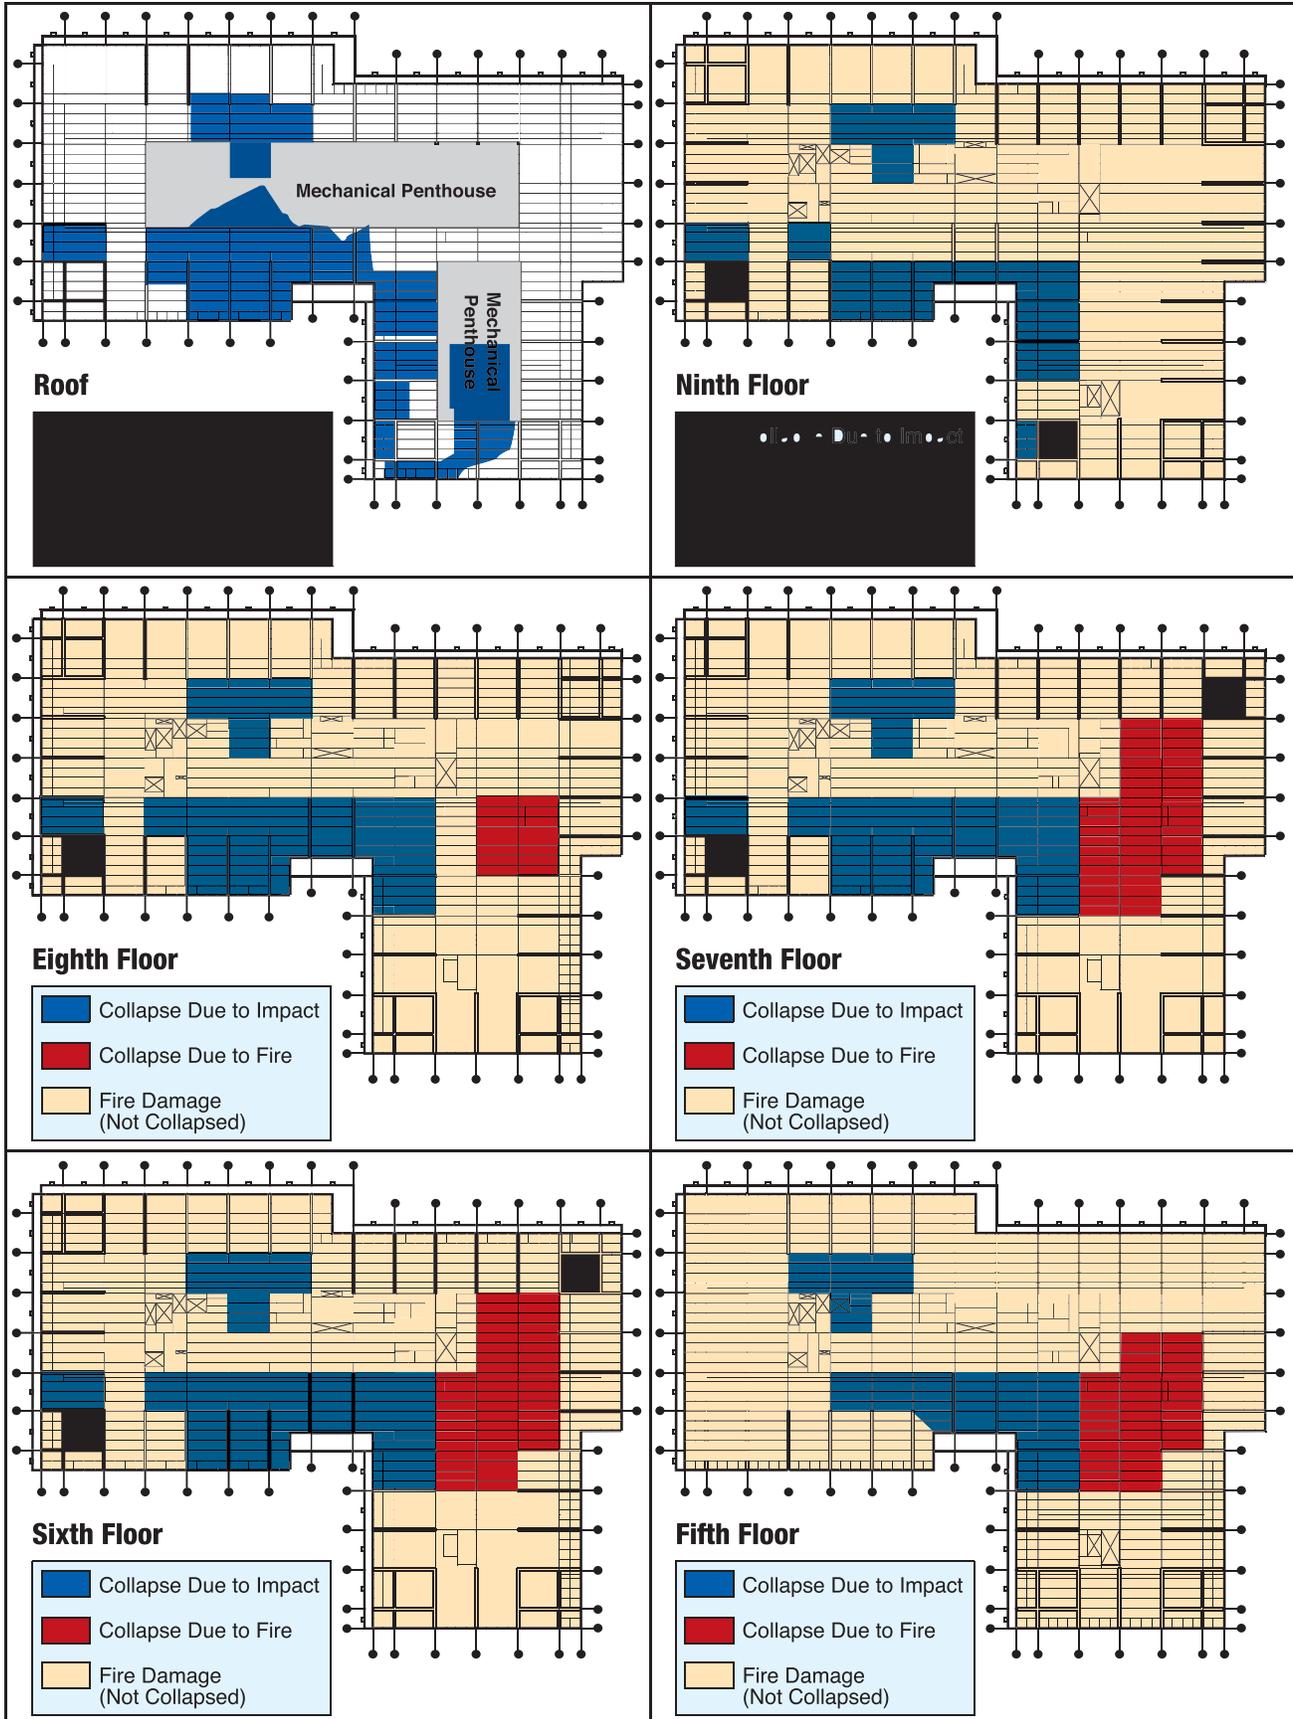
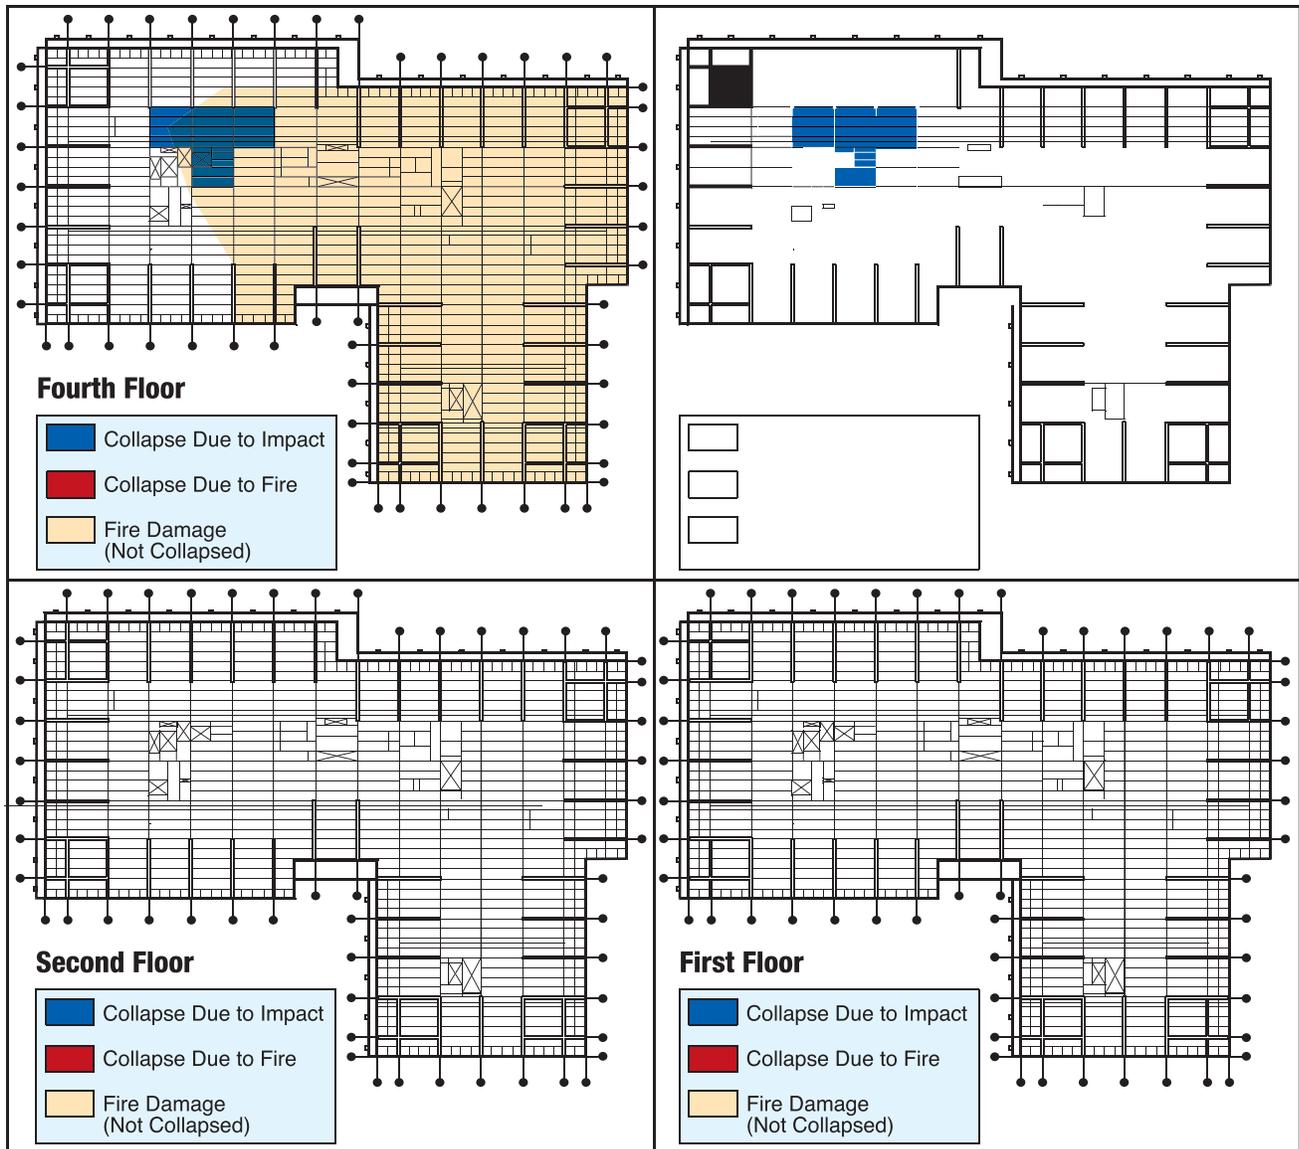
Figure 4-7 Approximate locations of damaged floor areas in WTC 5.

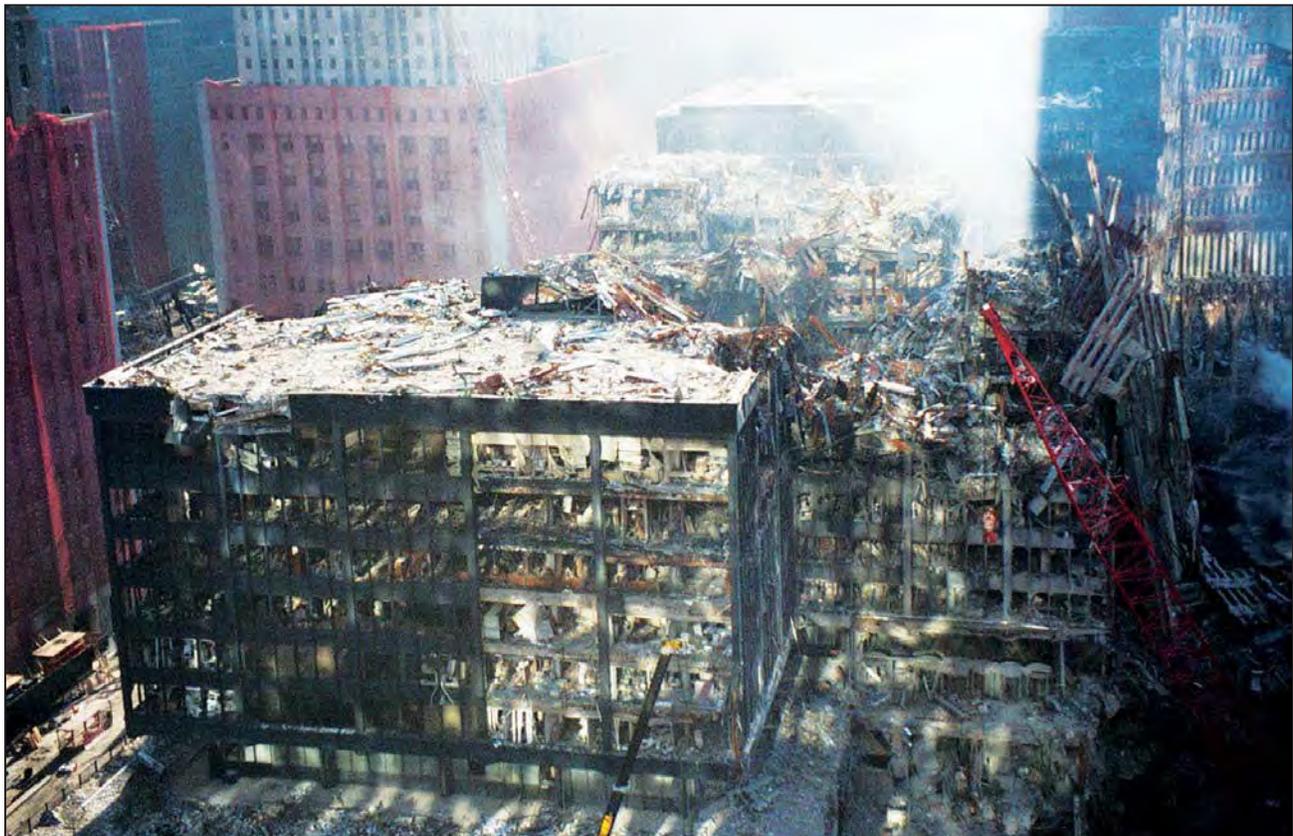
Figure 4-9 Impact damage to WTC 6.

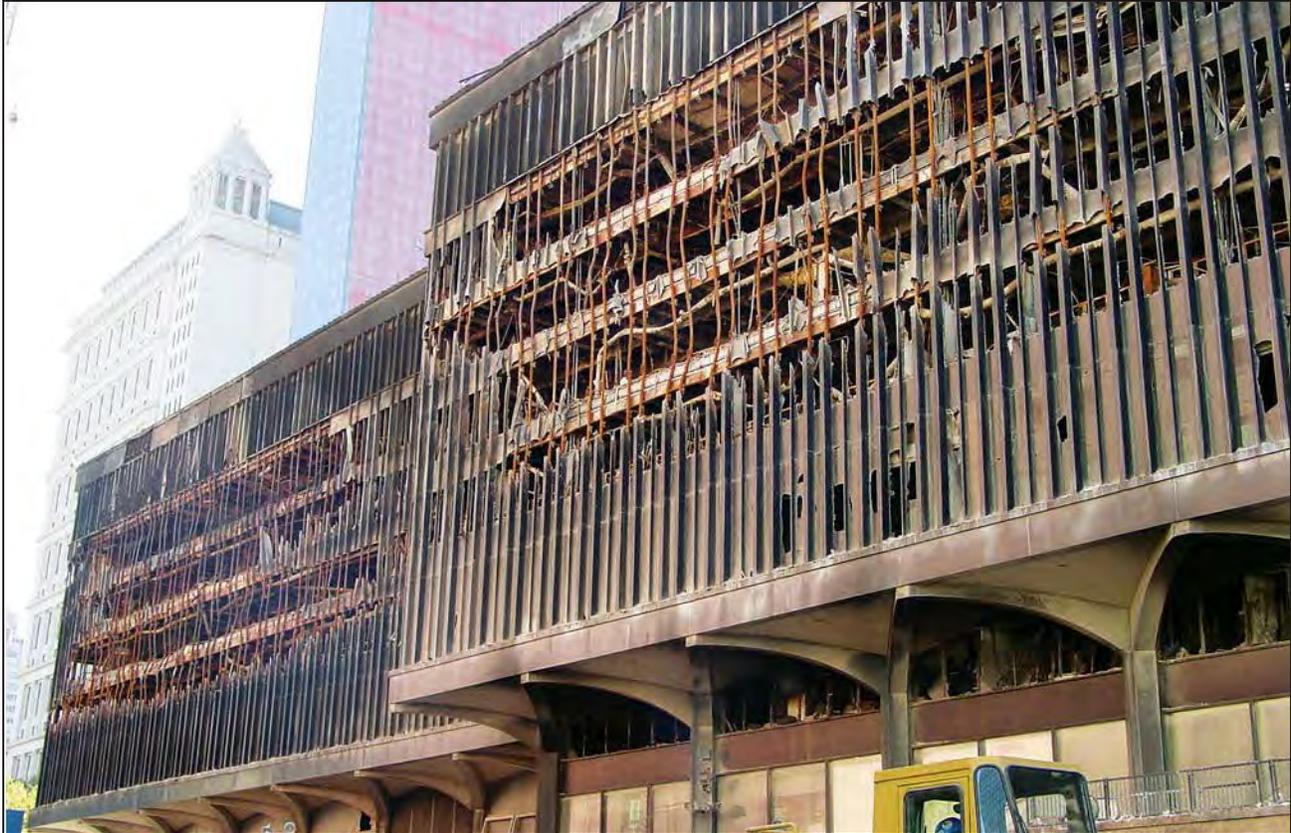
Figure 4-11 WTC 5 façade damage.

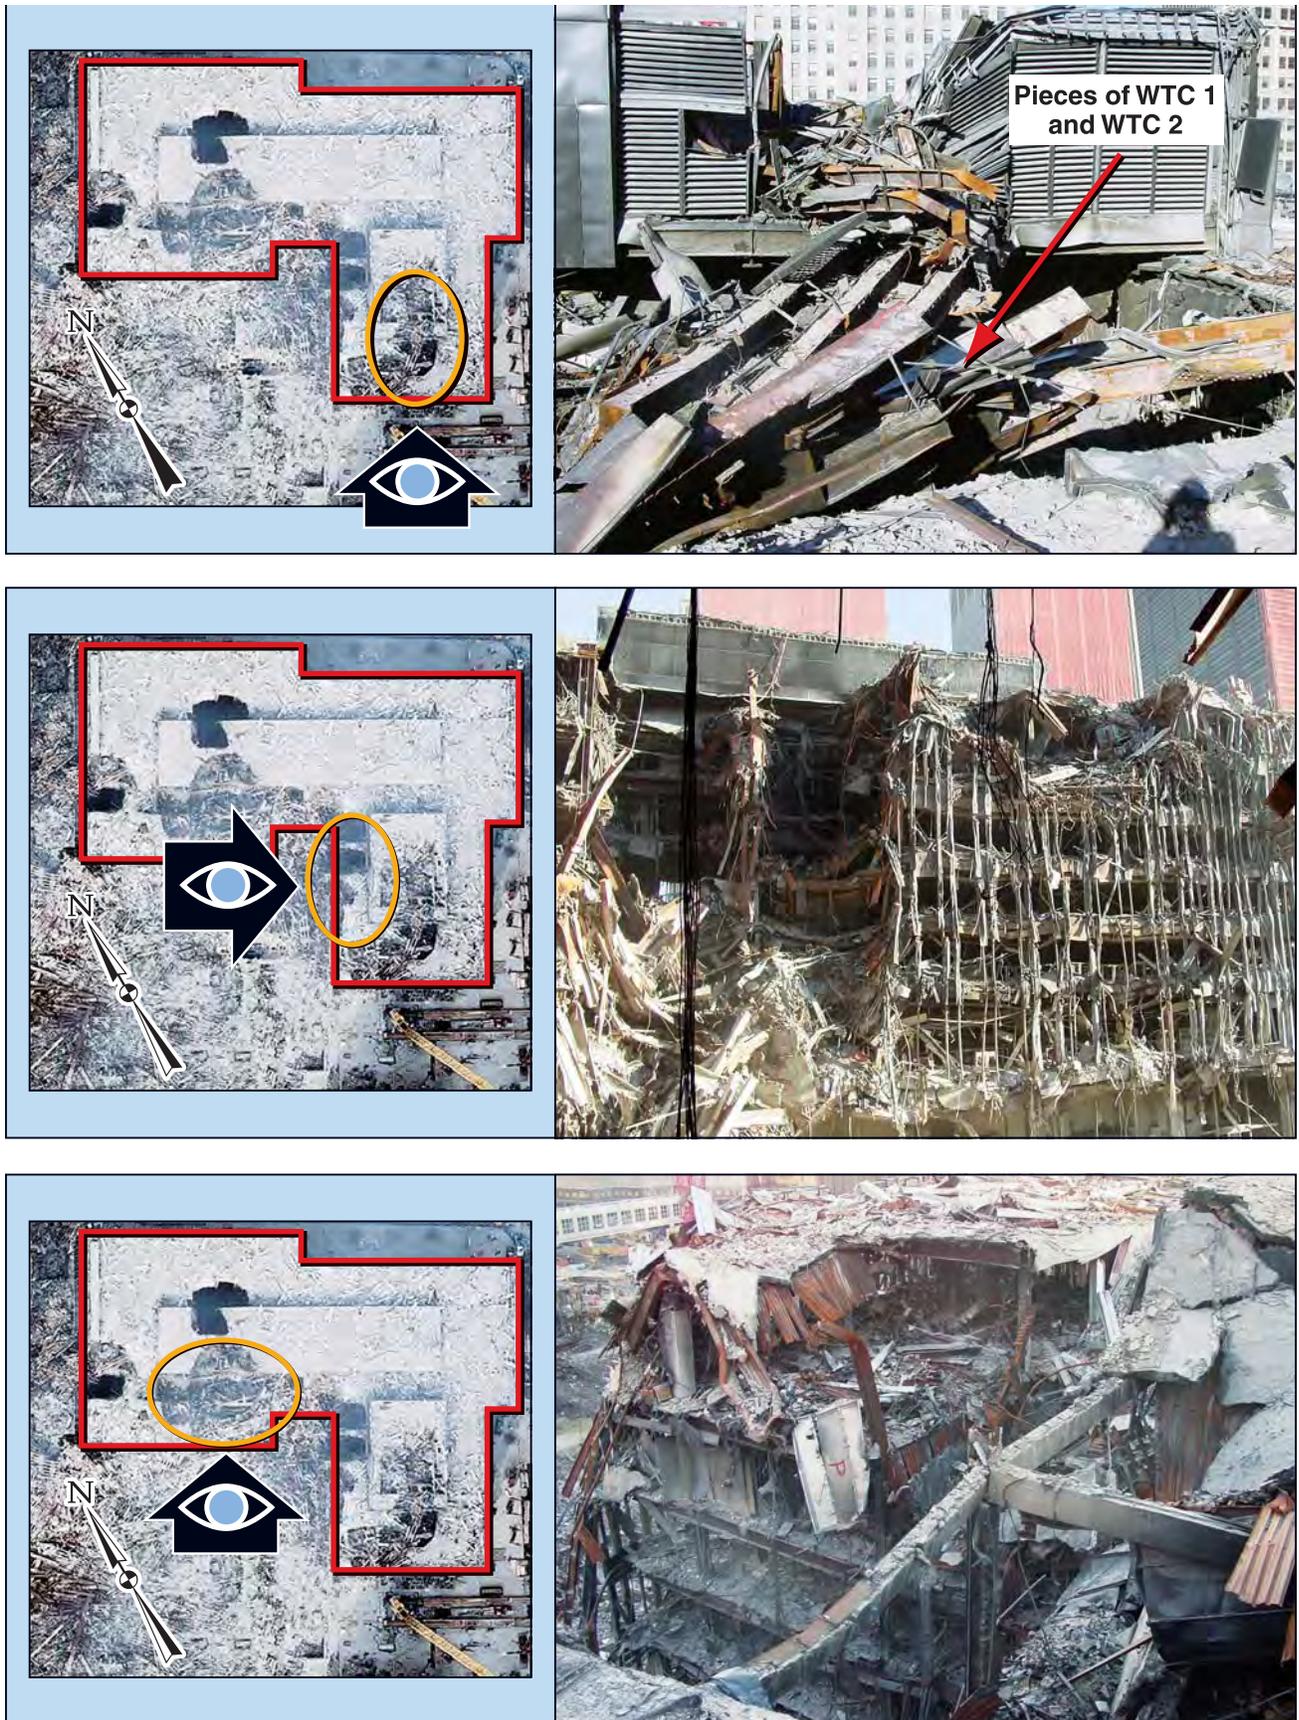
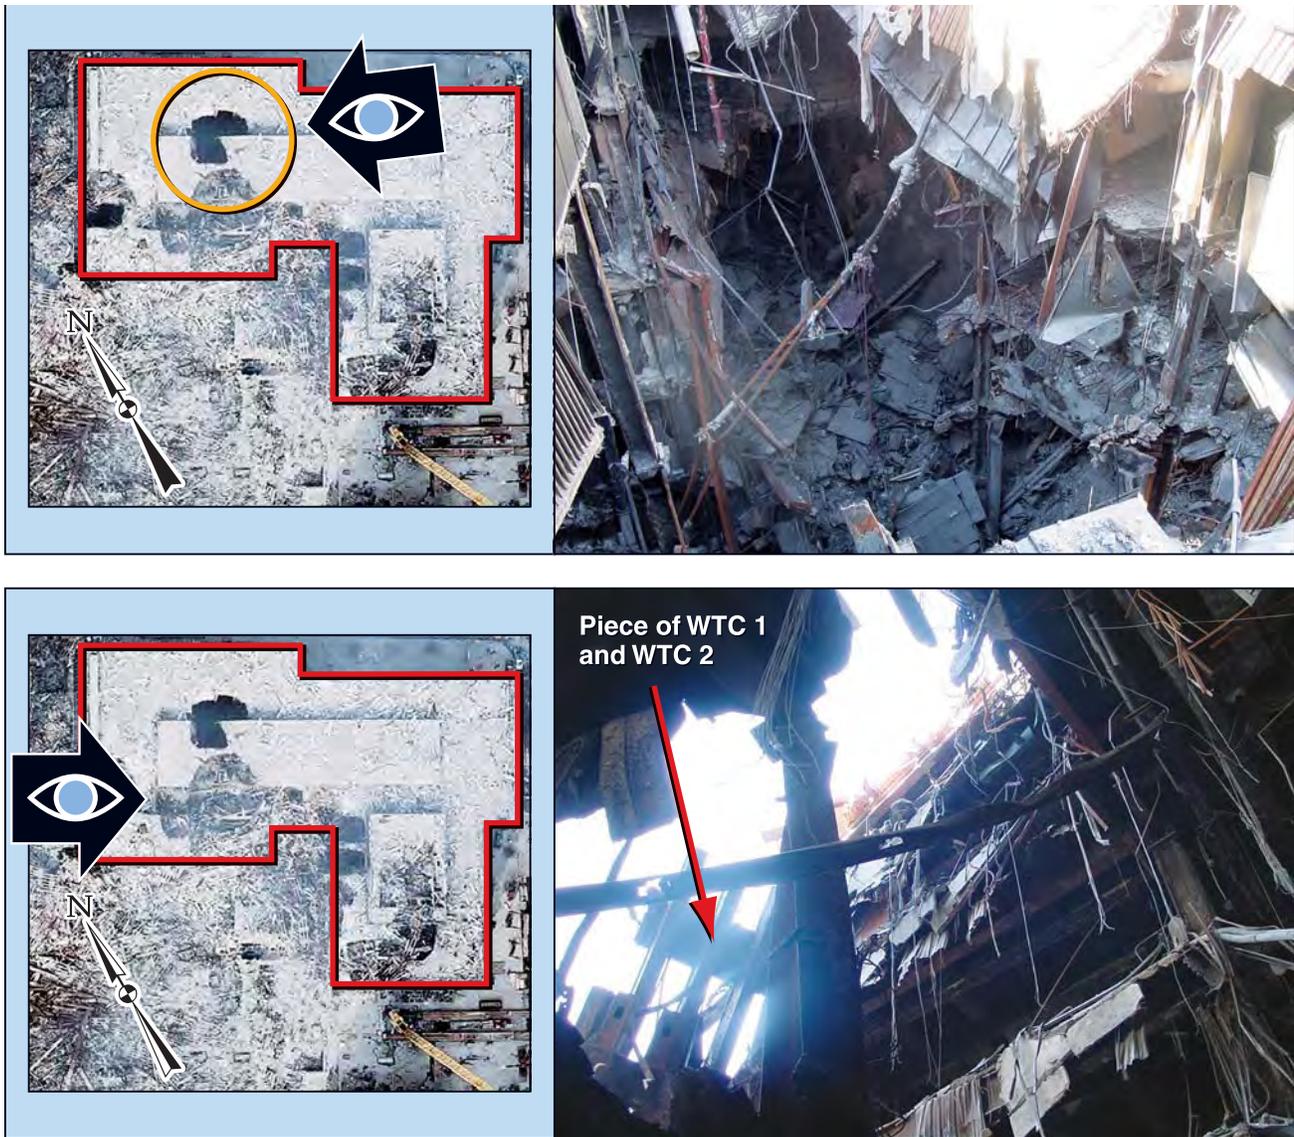
The debris from the towers caused damage to the outside wall steel framing of WTC 5, but this damage did not cause any additional collapse of the floors. In fact, the steel pipe façade supports (mullions) provided structural redundancy to the floor framing and redistributed some portion of the cantilevered floors to other levels.

Figure 4-12 Impact damage to WTC 5.
