# World Trade Center Building Performance Study:

*Data Collection, Preliminary  
Observations, and  
Recommendations*

**Federal Emergency Management Agency**

FEMA 403 / September 2002

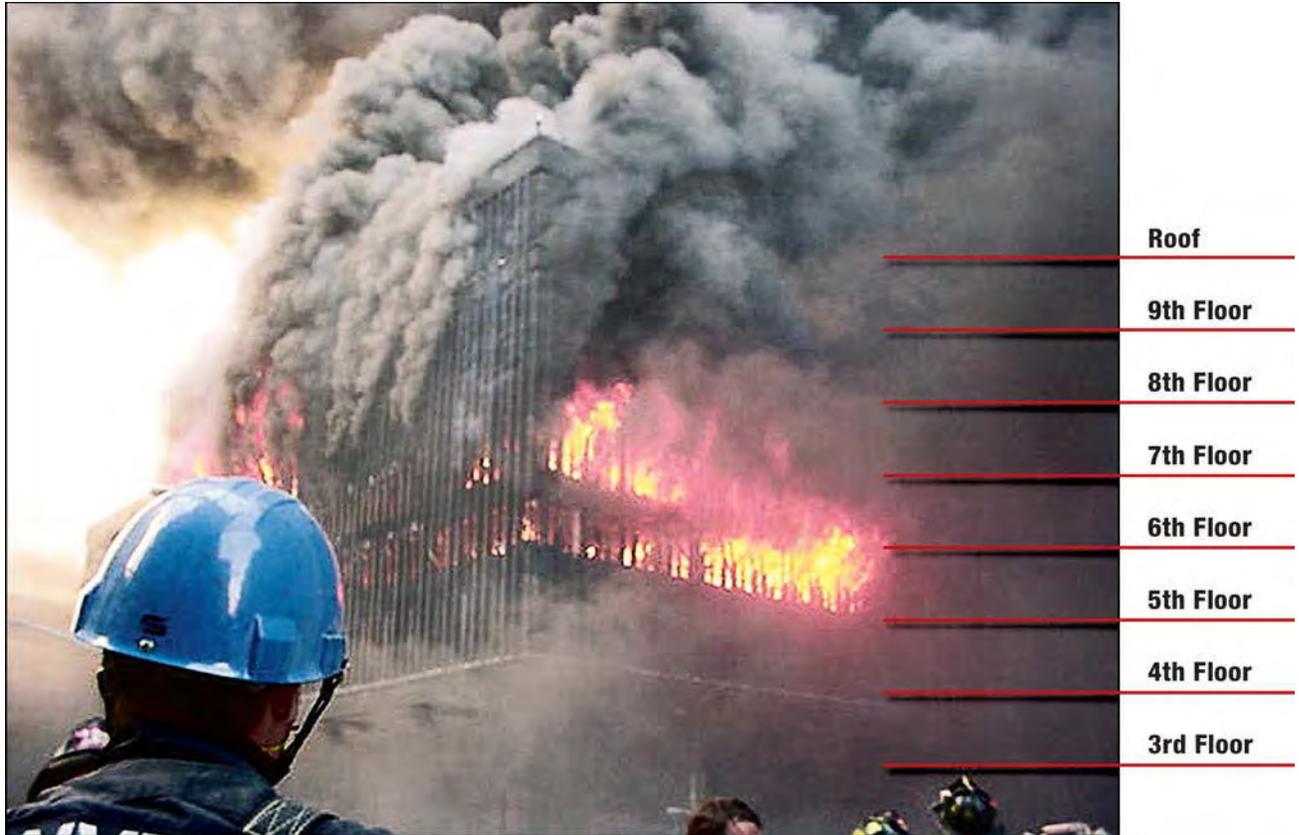
Figure 4-13 WTC 5 on fire.

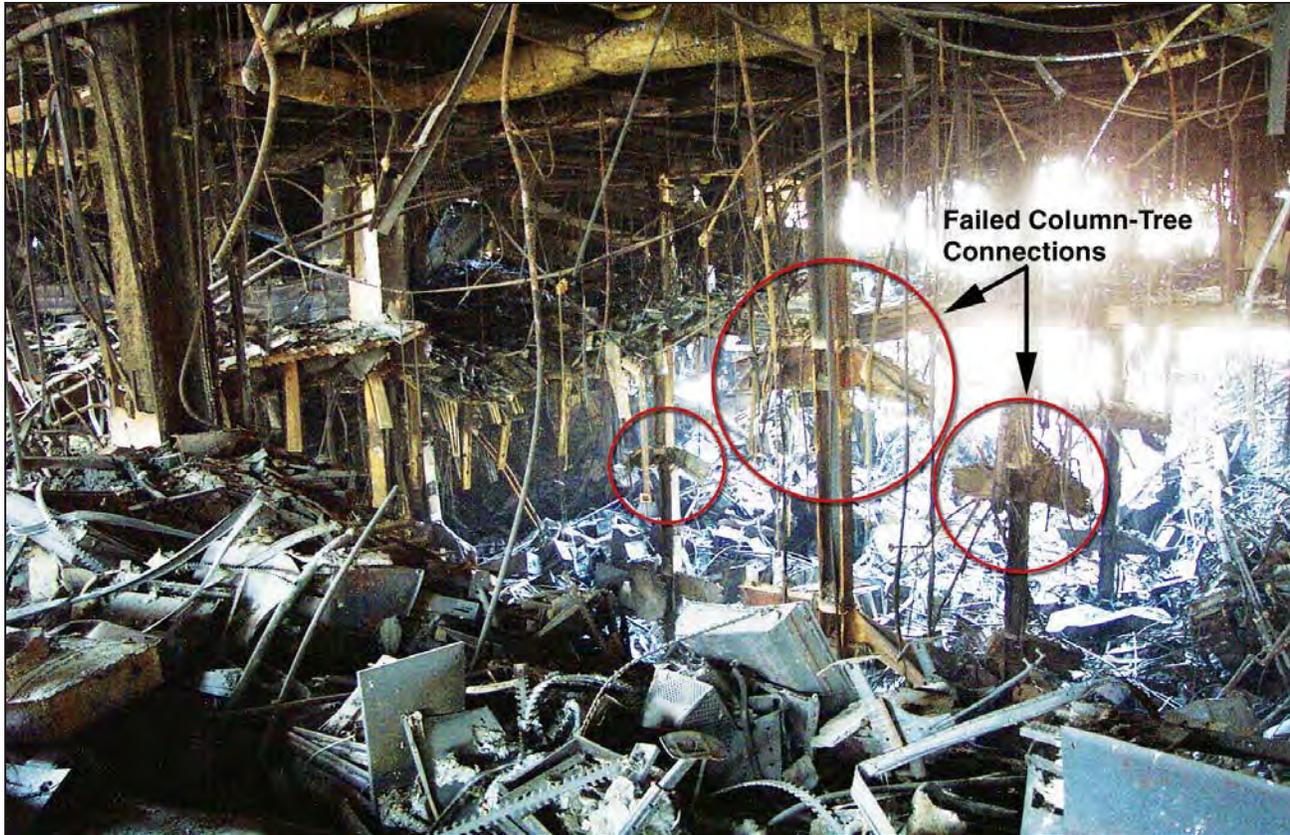
Figure 4-18 Internal collapsed area in WTC 5.

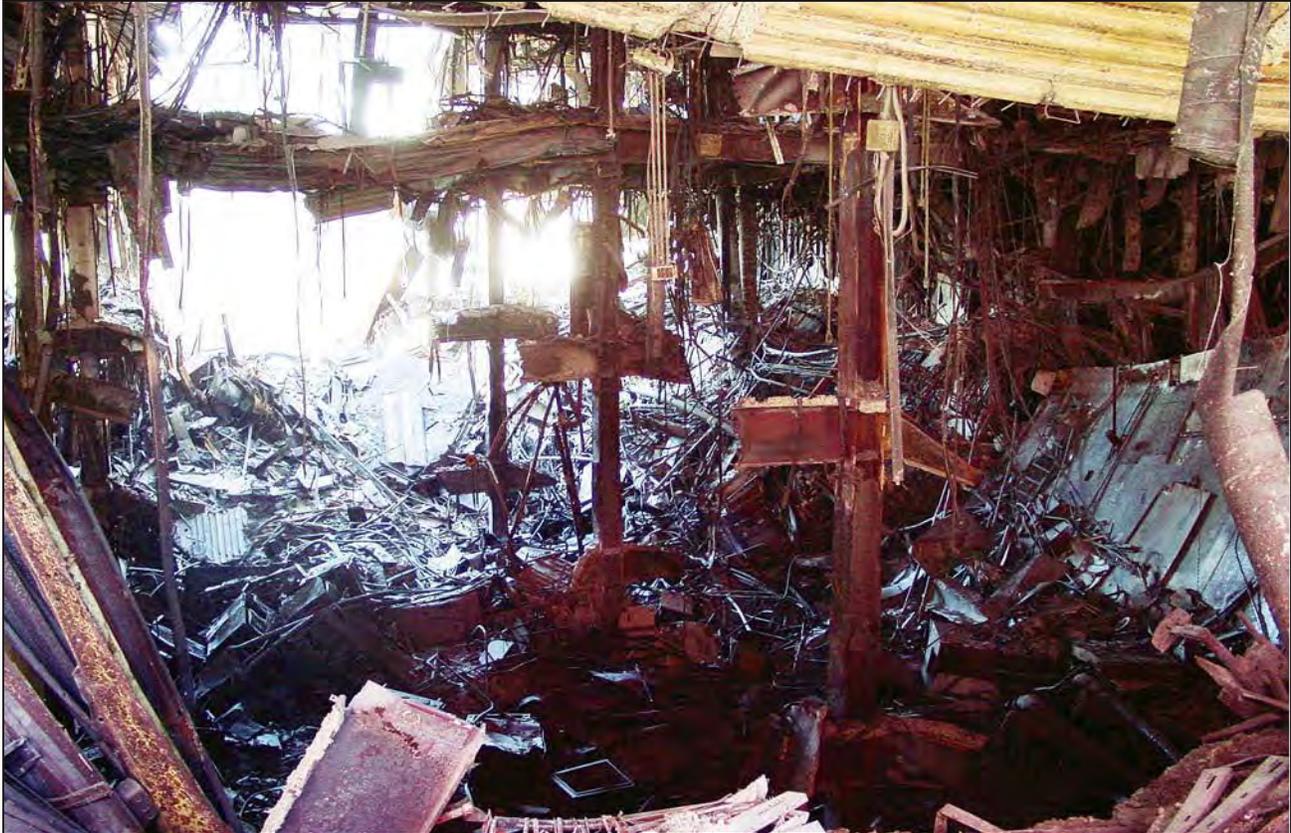
Figure 4-20 Internal collapsed area in WTC 5.

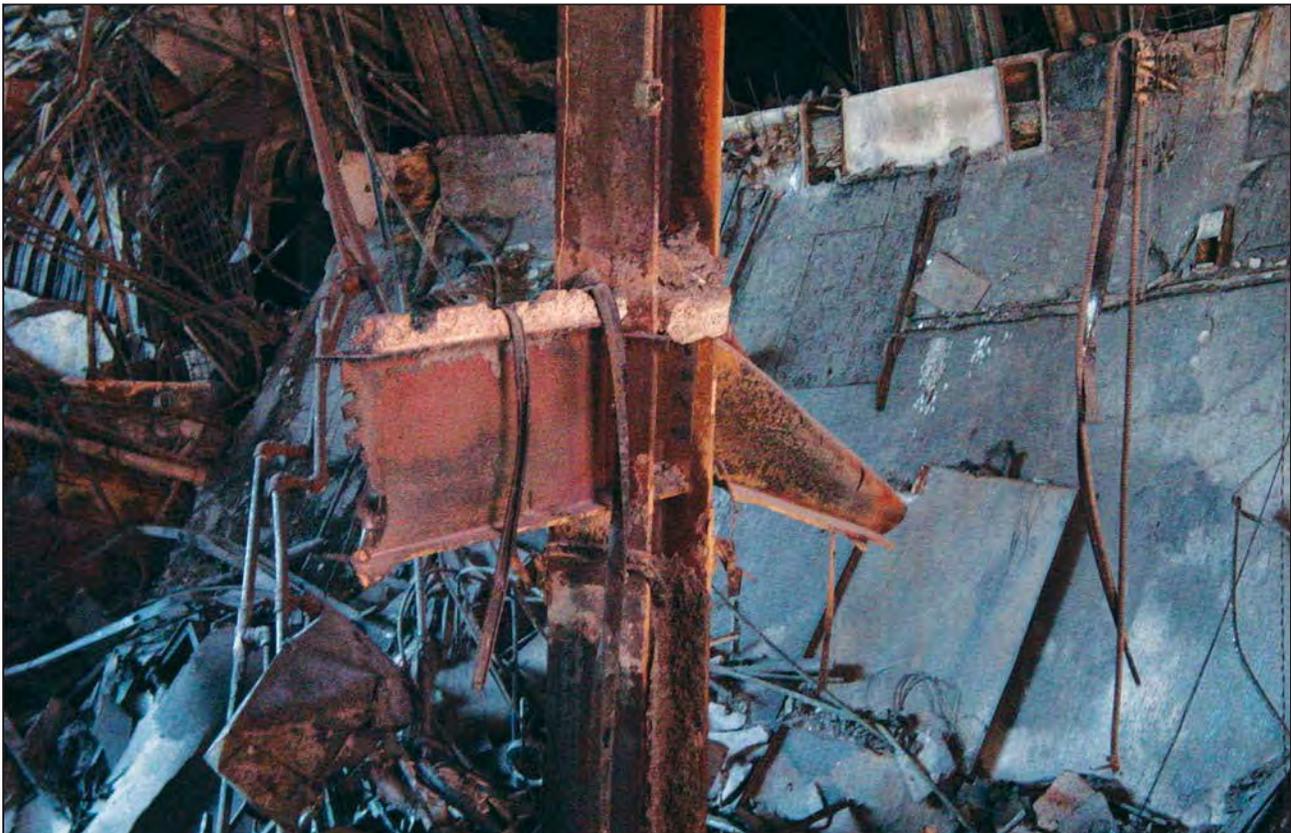
The structural collapse appeared to be due to a combination of excessive shear loads on bolted connections and unanticipated tensile forces resulting from catenary sagging of the beams. The existence of high shear loads, likely due to collapsing floor loads from above, was evident in many of the column-tree

Figure 4-21 Internal collapsed area in WTC 5 with closeup of connection failure at column tree.

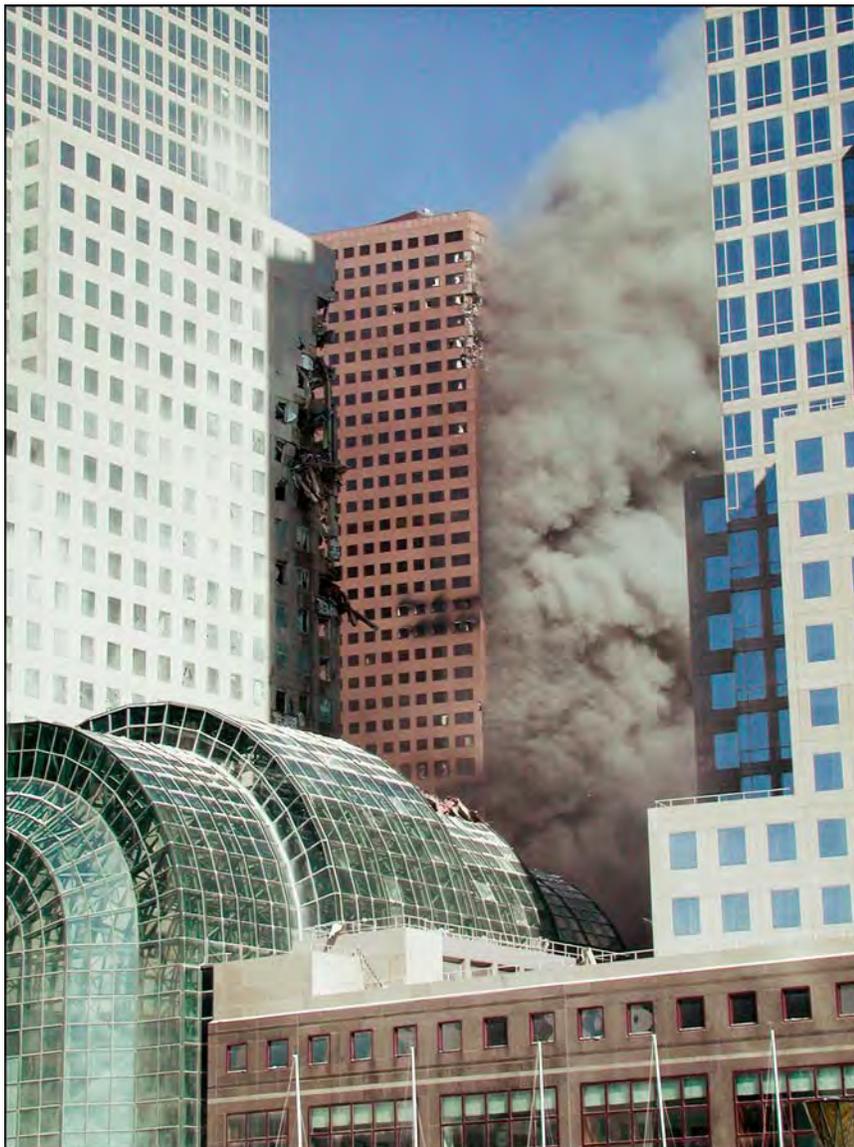
*Figure 5-17  
Building damage to the southwest corner and smoke plume from south face of WTC 7, looking from the World Financial Plaza. Note damage to WFC 3 in the foreground.*

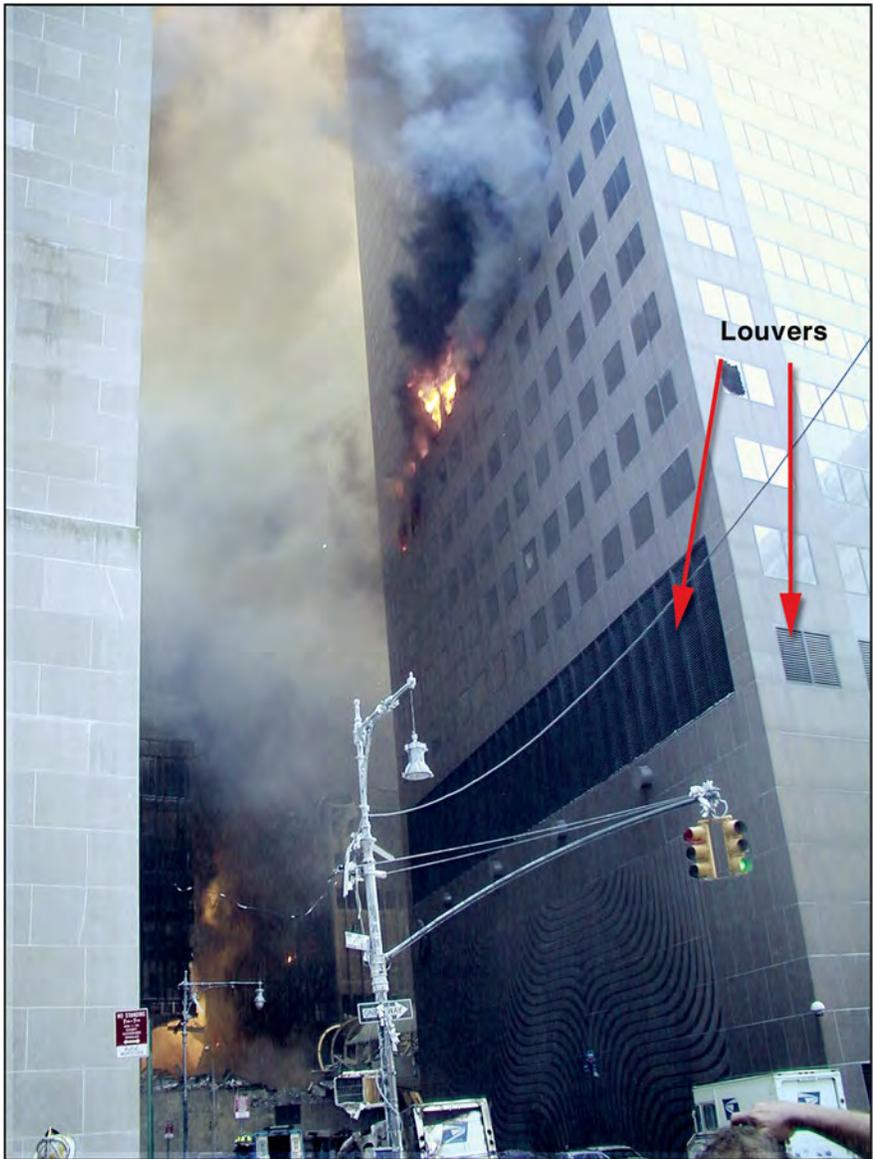
Figure 5-19  
Fires on the 11th and 12th floors of  
the east face of WTC 7.

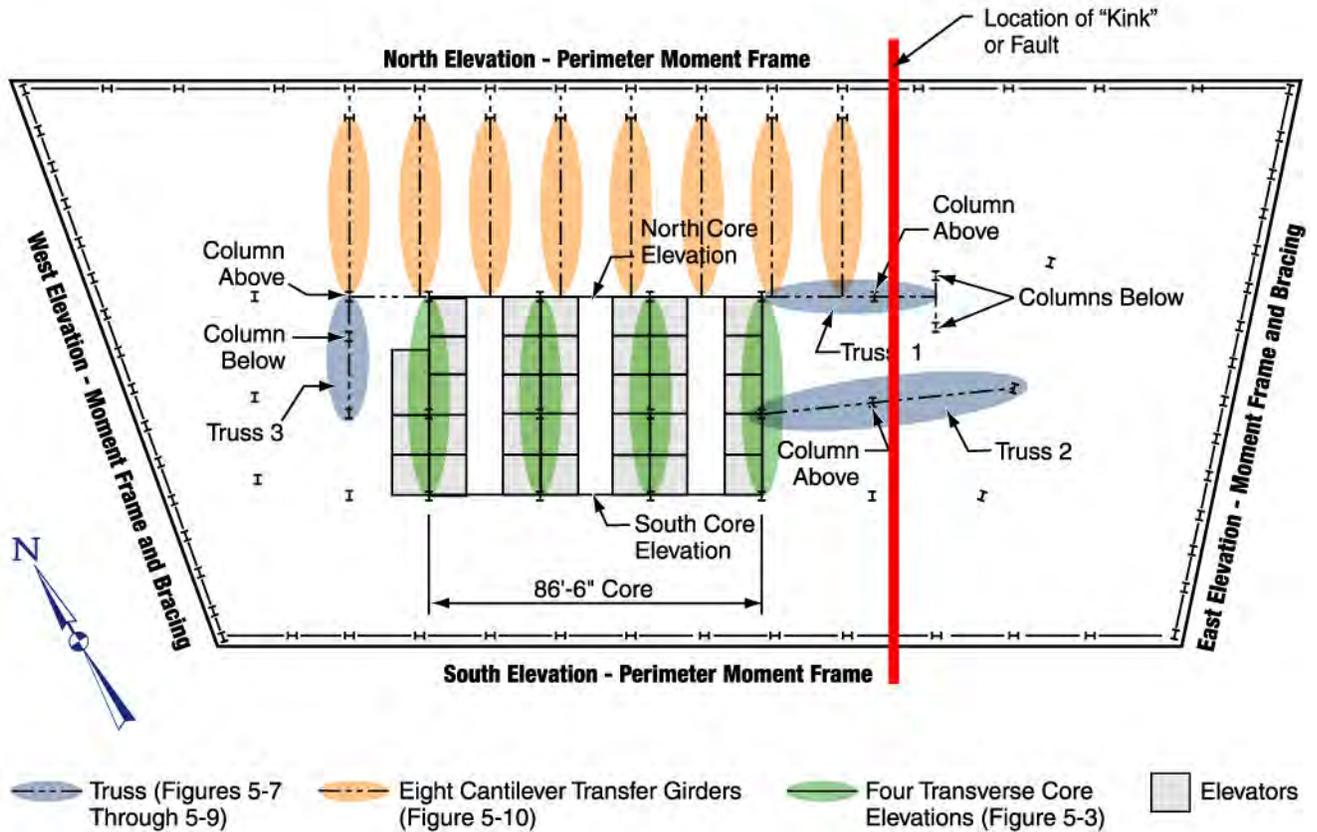
Figure 5-24 Areas of potential transfer truss failure.

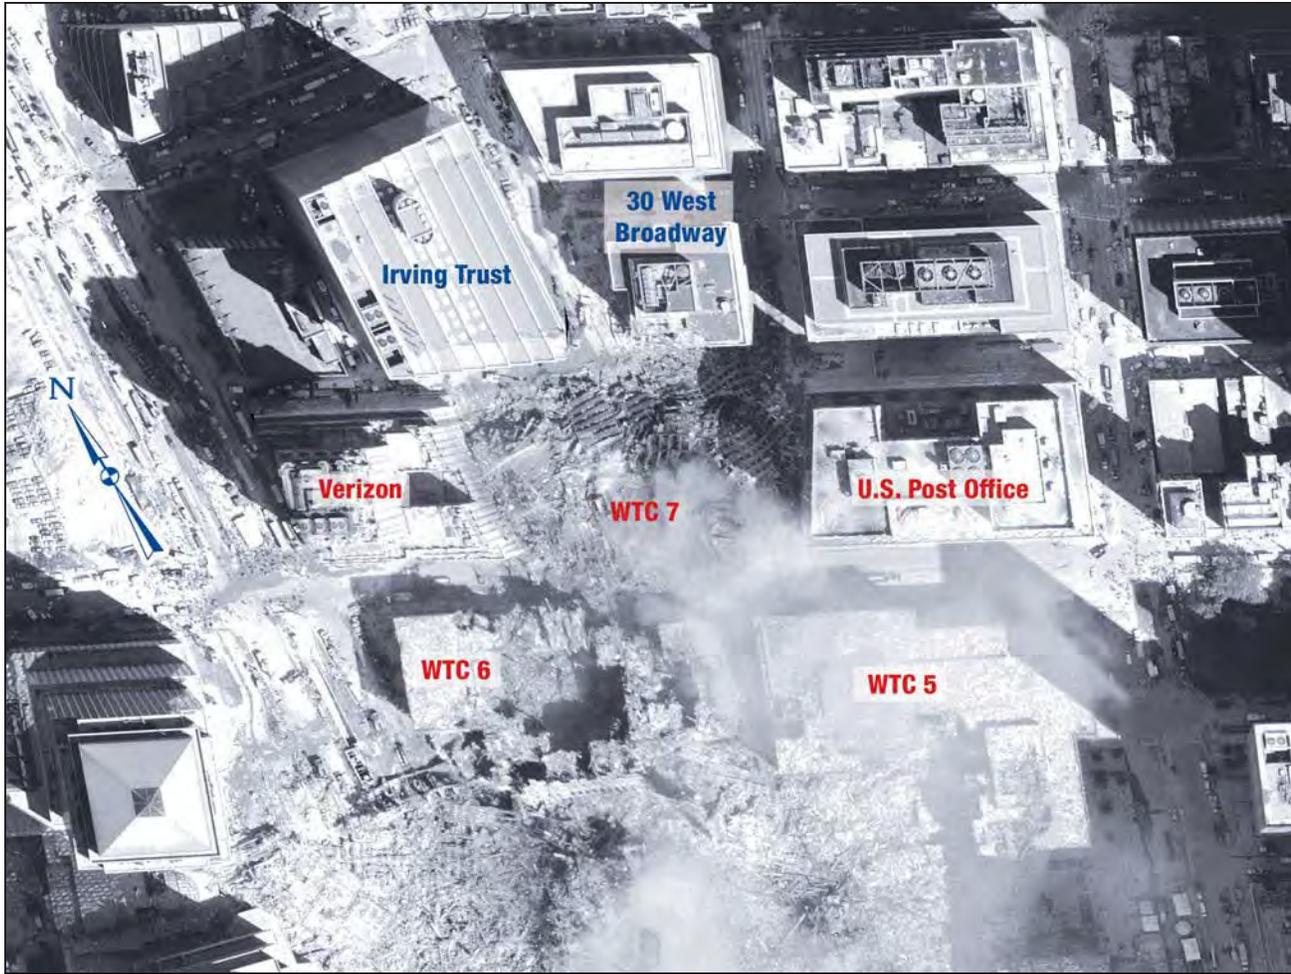
Figure 5-26 Debris generated after collapse of WTC 7.

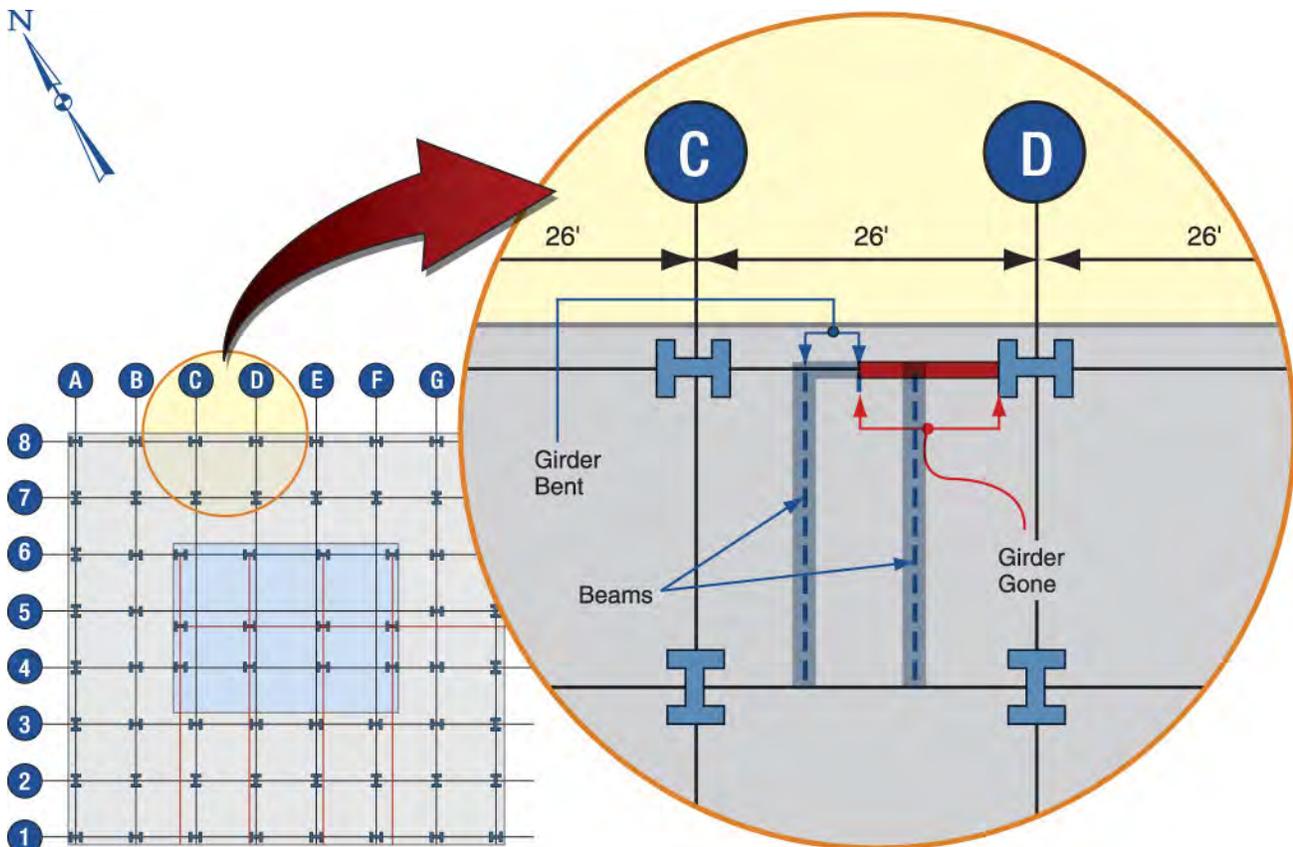
Figure 6-4 Area of initial impact of debris at the 23rd floor.

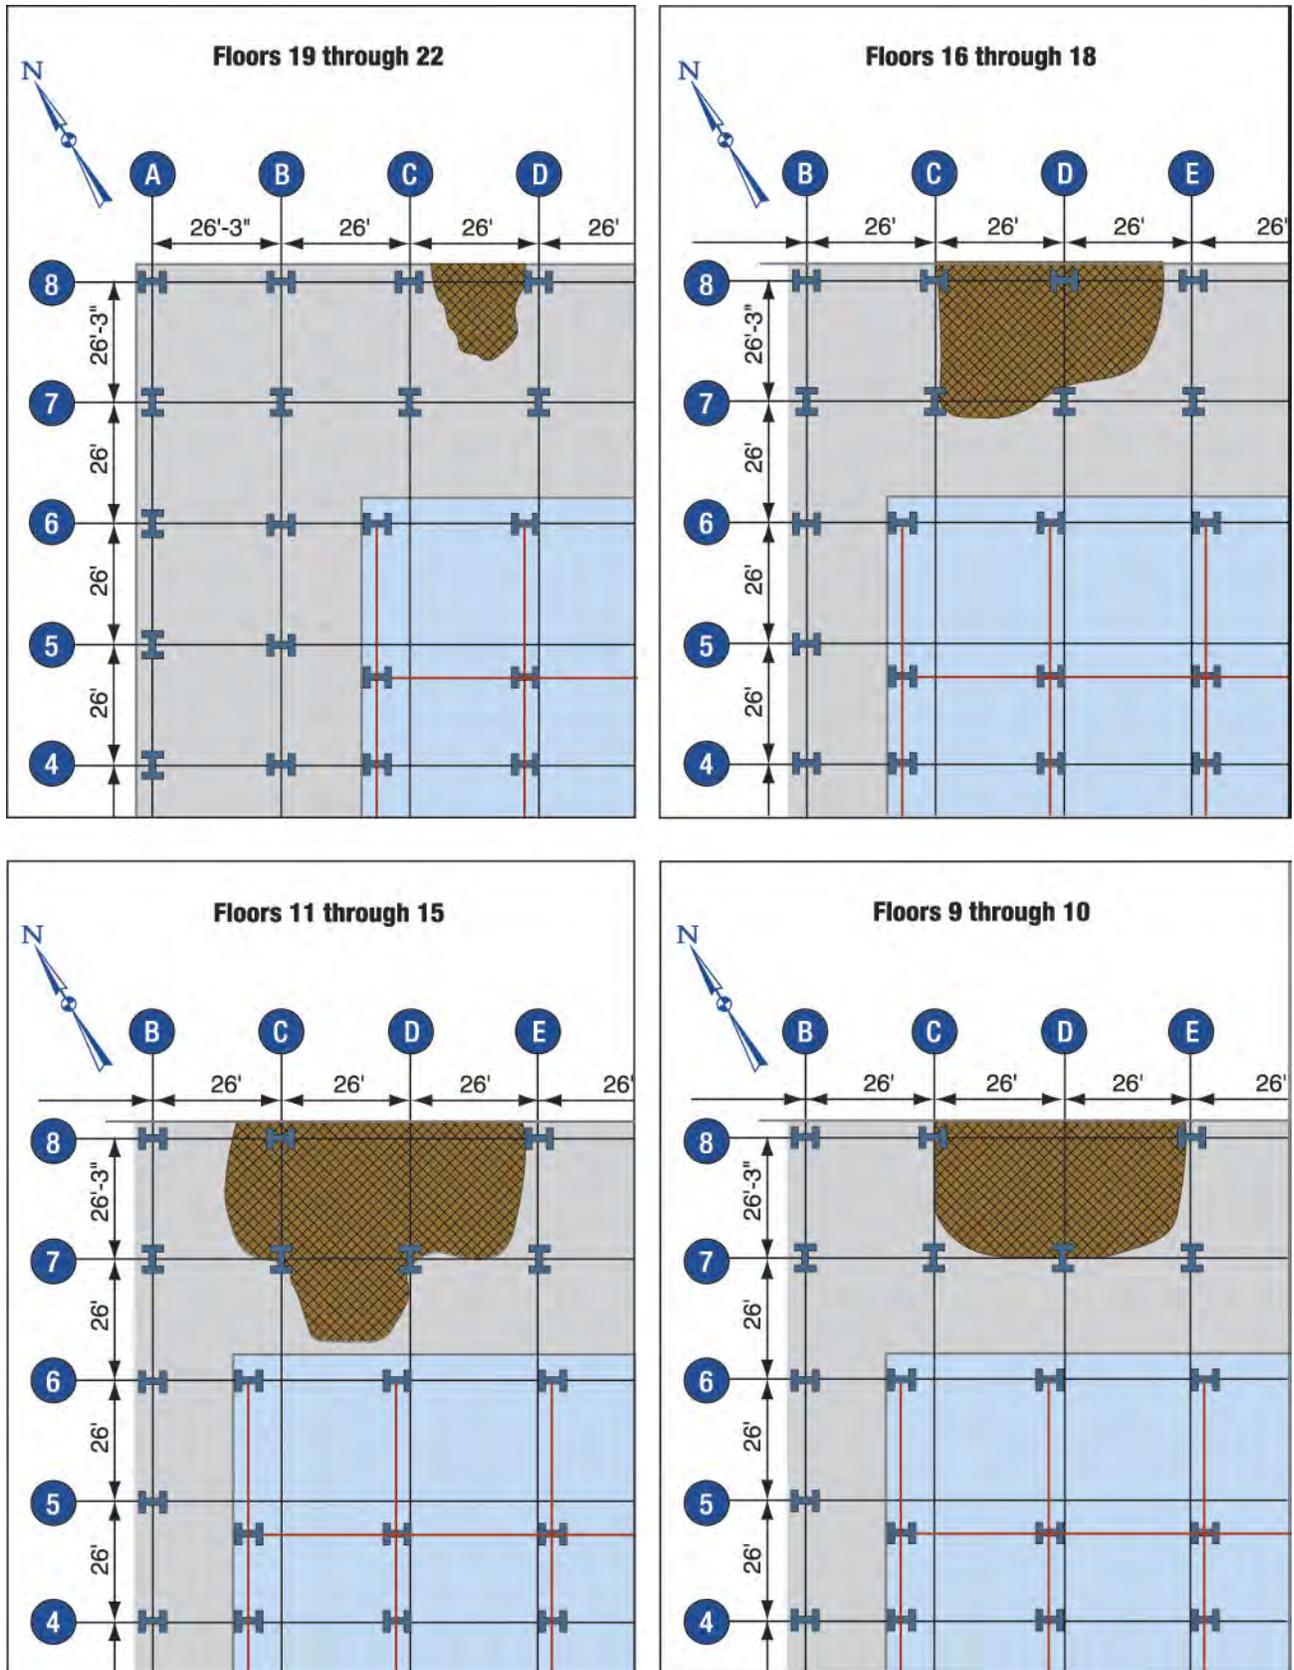
Figure 6-5 Approximate zones of damage – 19th through 22nd floors, 16th through 18th floors, 11th through 15th floors, and 9th through 10th floors.

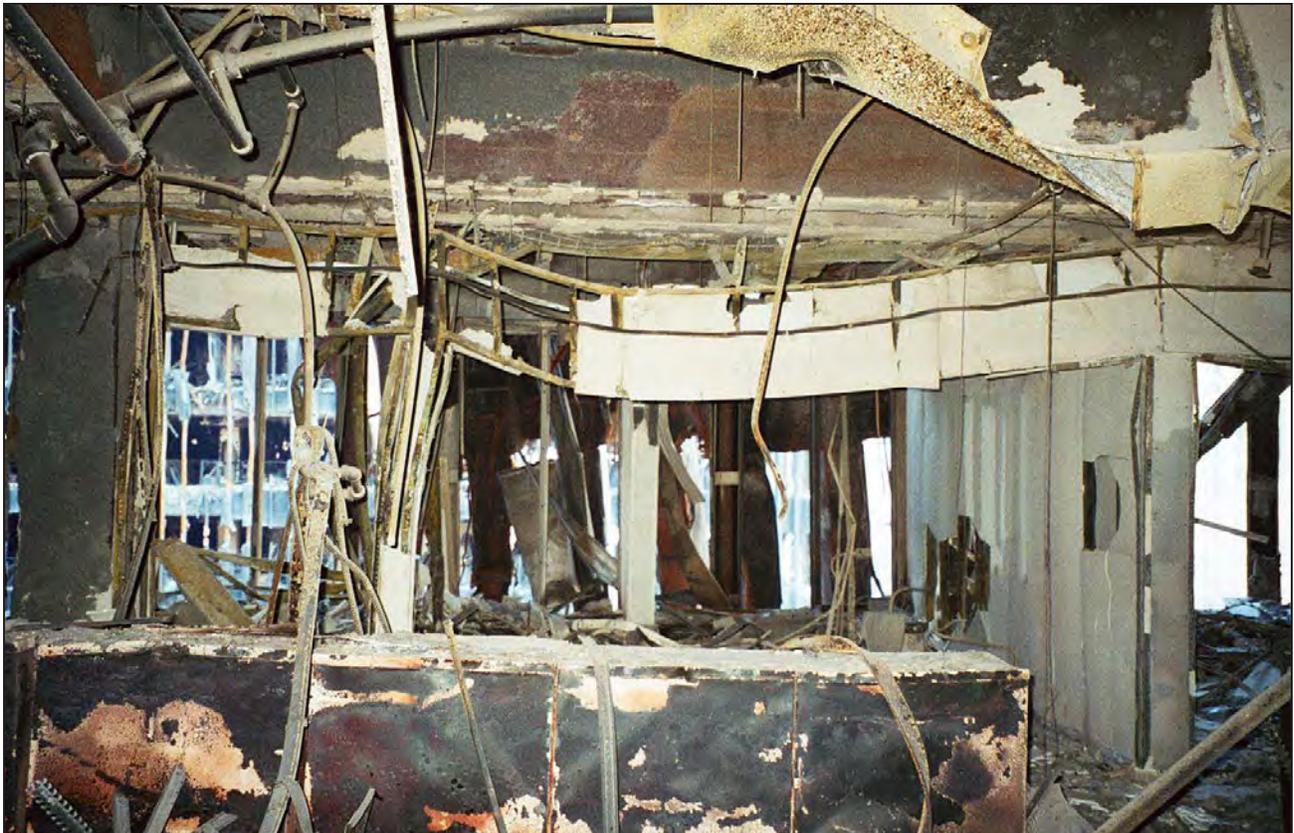
Figure 7-5 Interior damage at floor 20 of WFC 3.

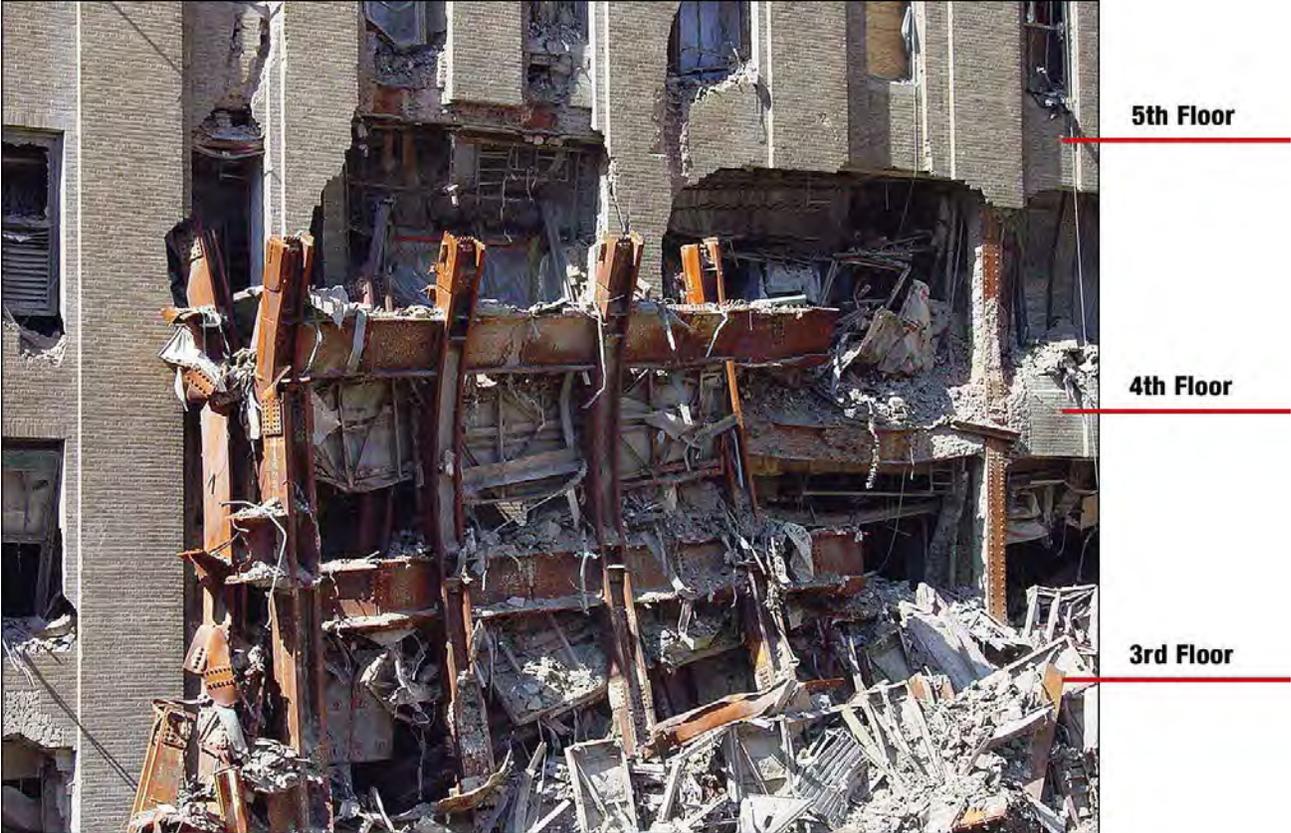
Figure 7-7 Verizon building – damage to east elevation (Washington Street) due to WTC 7 framing leaning against the building.

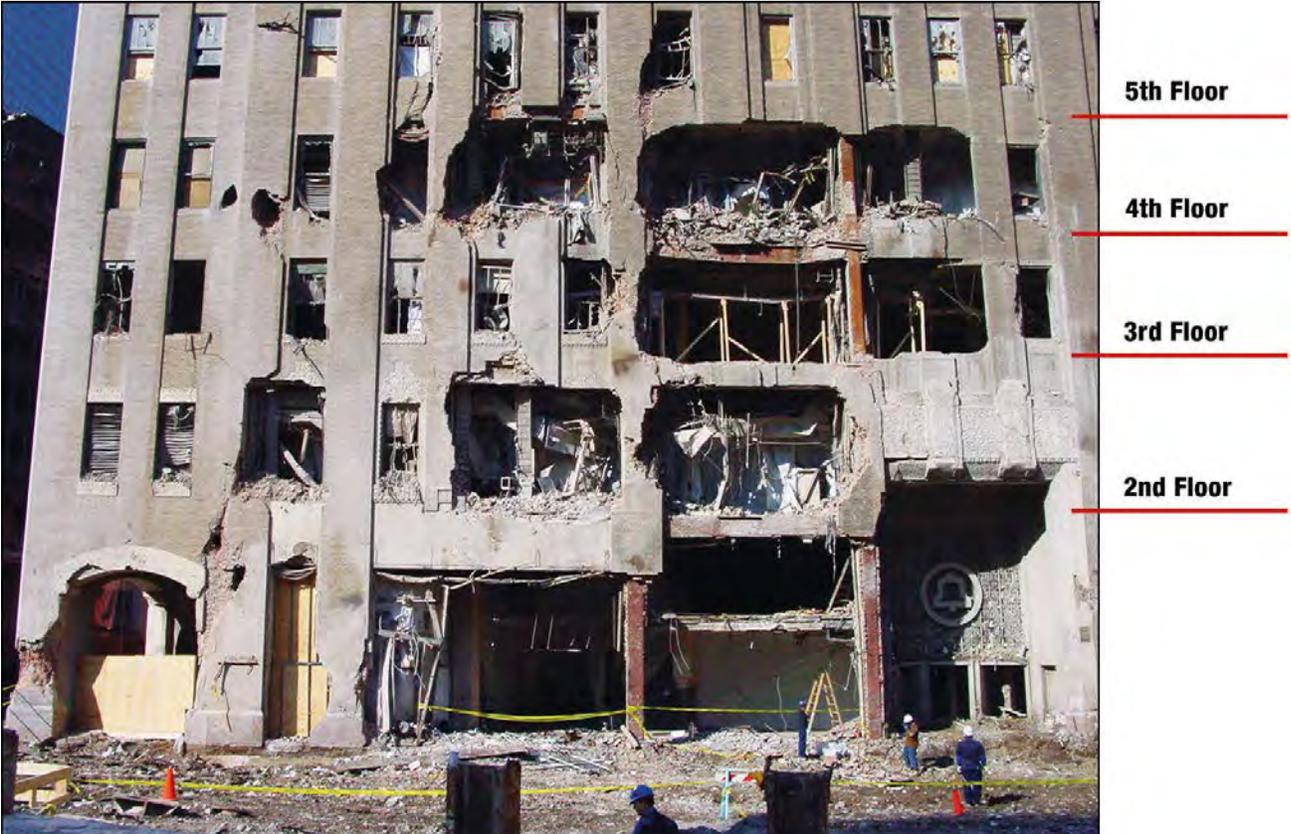
Figure 7-8 Verizon building – damage to east elevation (Washington Street).

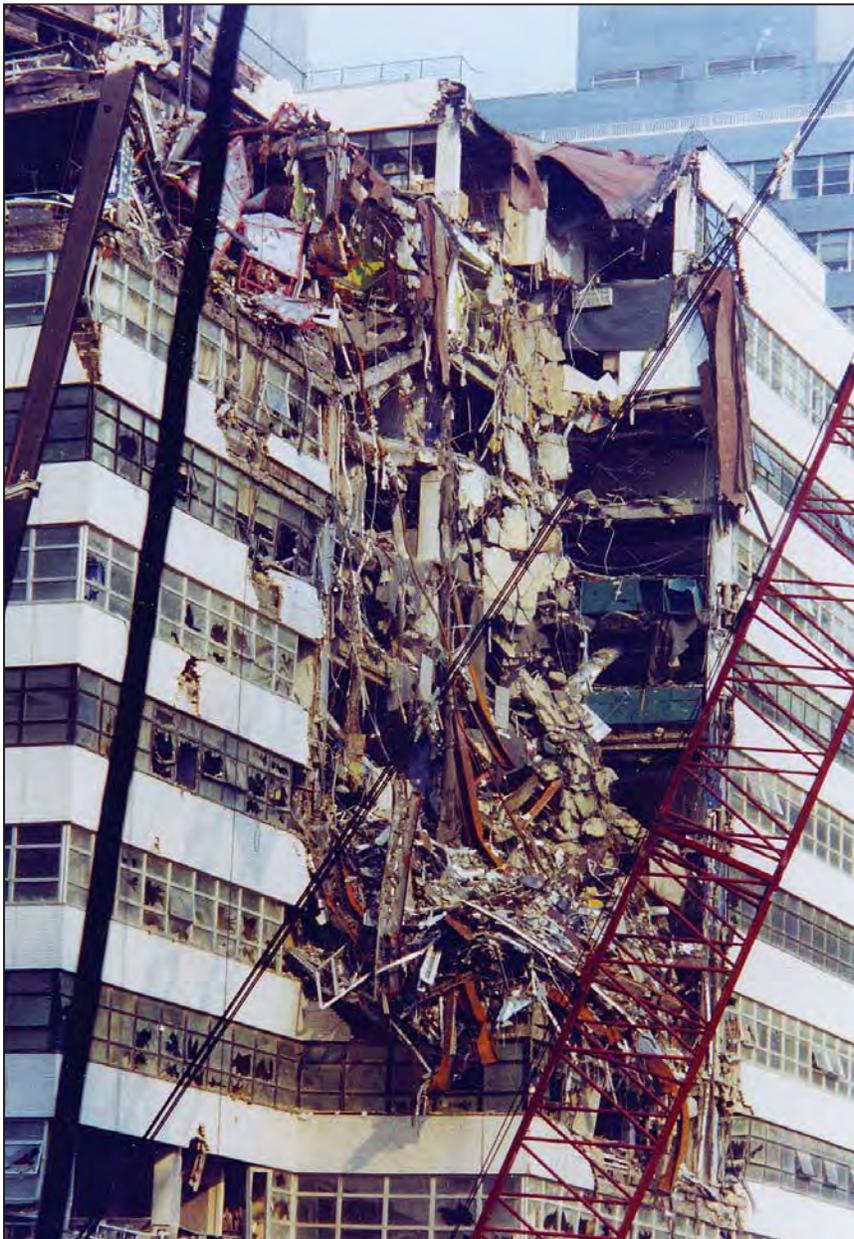
*Figure 7-13*  
30 West Broadway – south façade, 6th floor to roof, looking northeast.

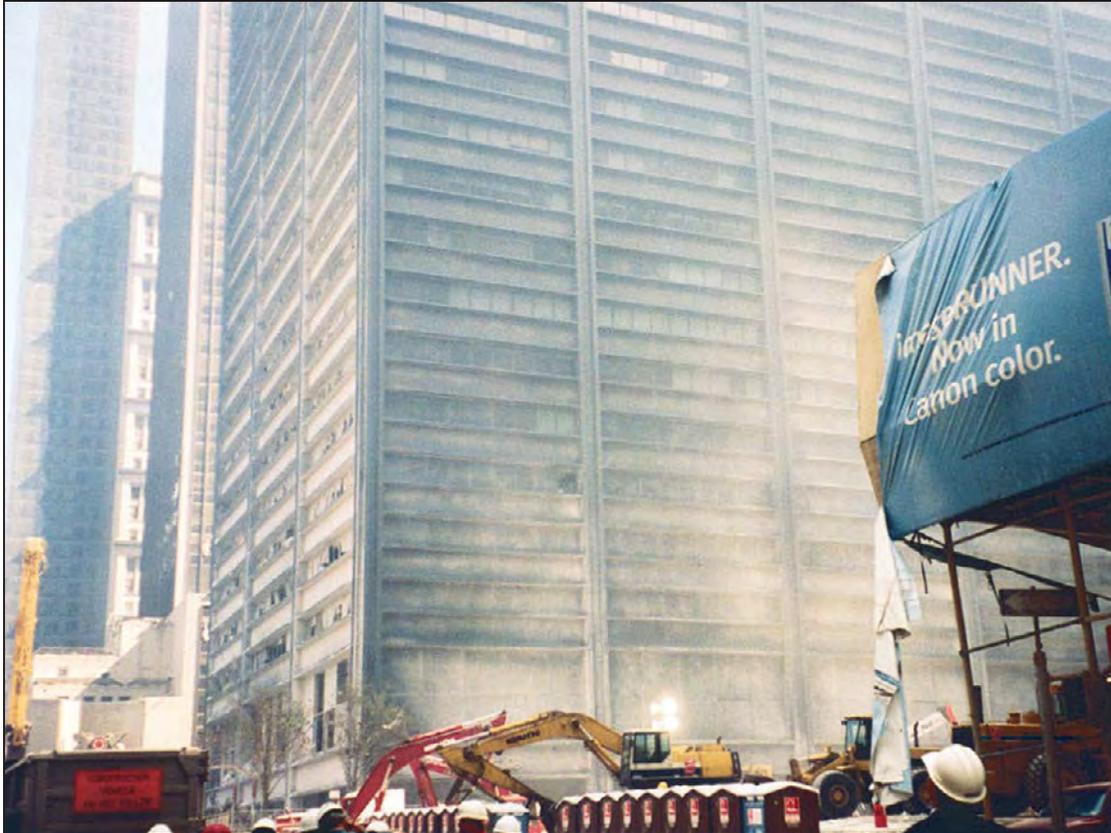
Figure 7-18 One Liberty Plaza – south elevation, lower floors.

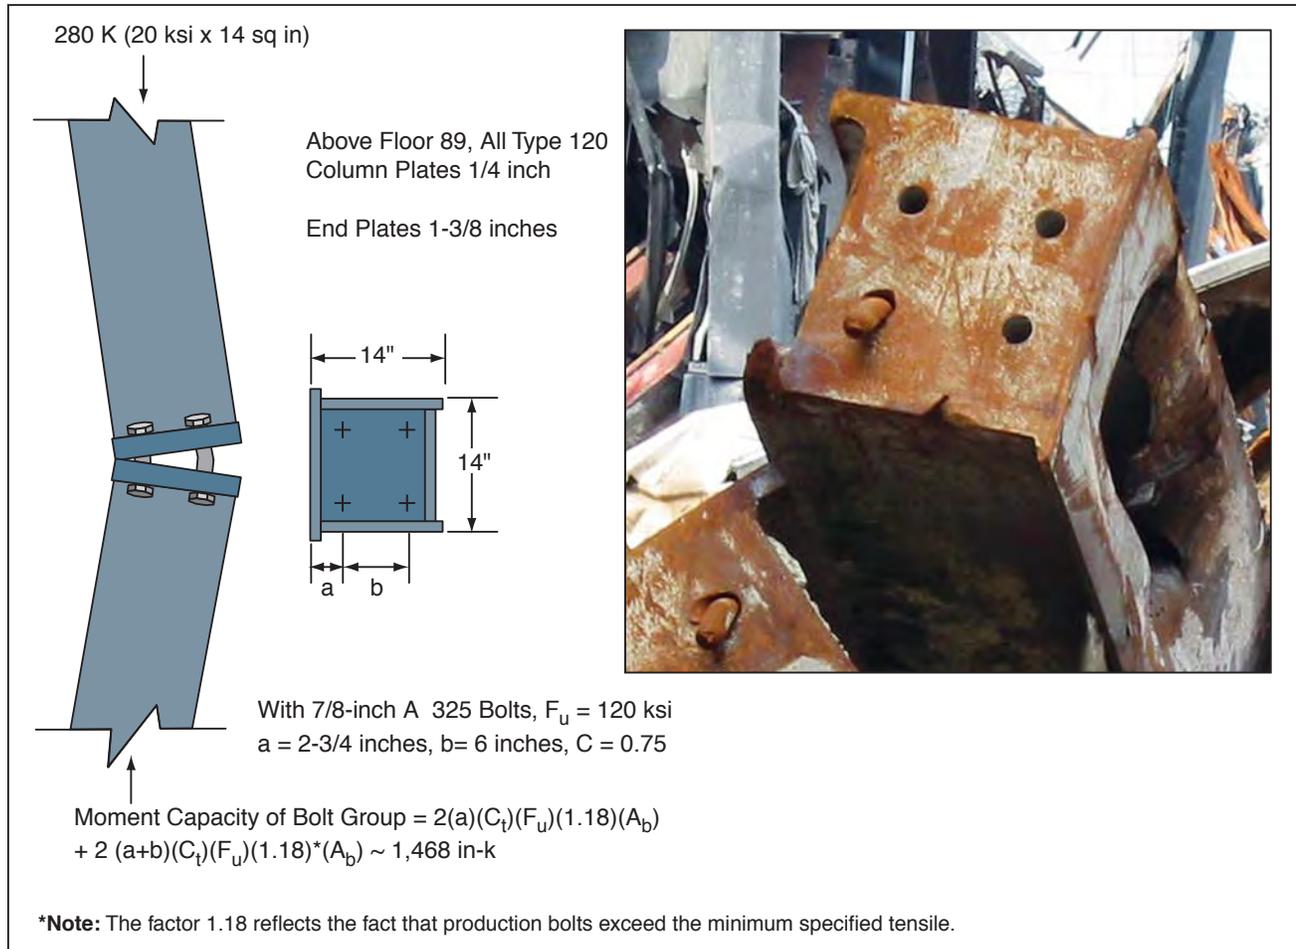
Figure B-7 Bent and fractured bolts at an exterior column four-bolt connection.

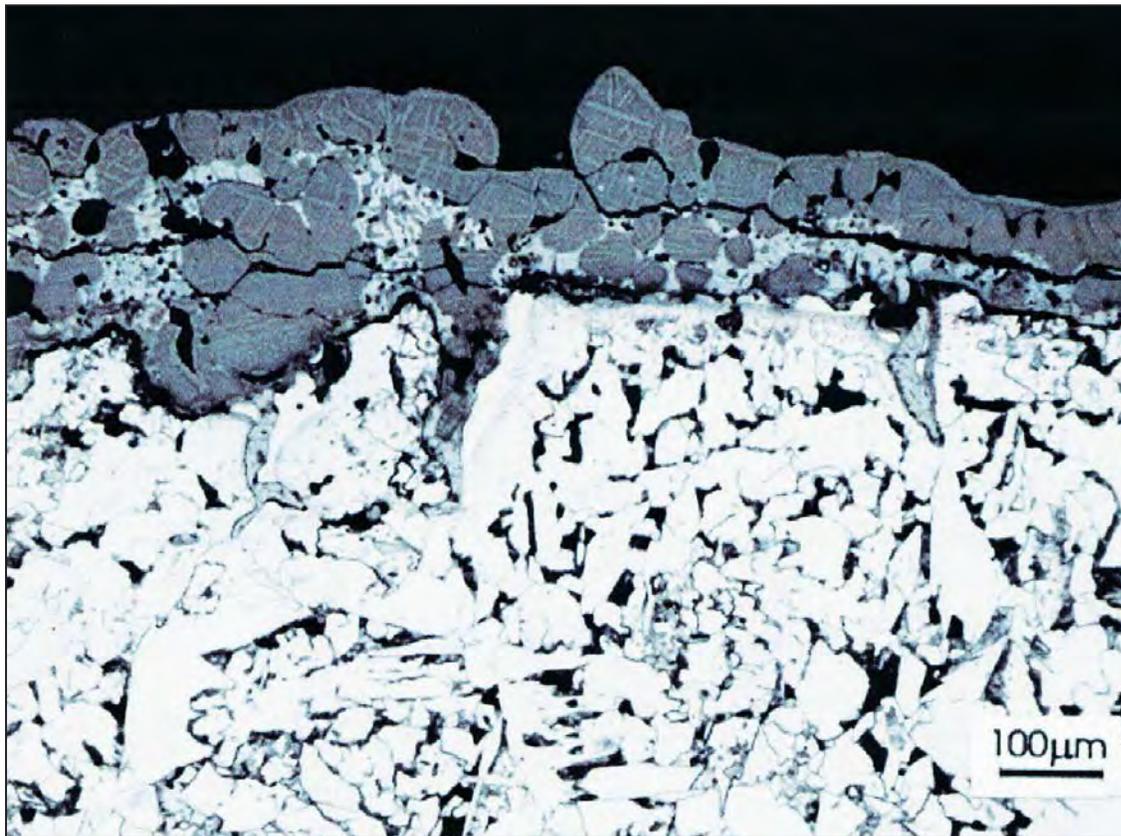
Figure C-5 Another hot corrosion region near the steel surface (etched with 4 percent nital). (Note: (1) Oxide rounding where the FeO-FeS eutectic product is present. (2) Reduction in banding of the steel when re-transformation occurs on cooling from austenite to ferrite and pearlite.)

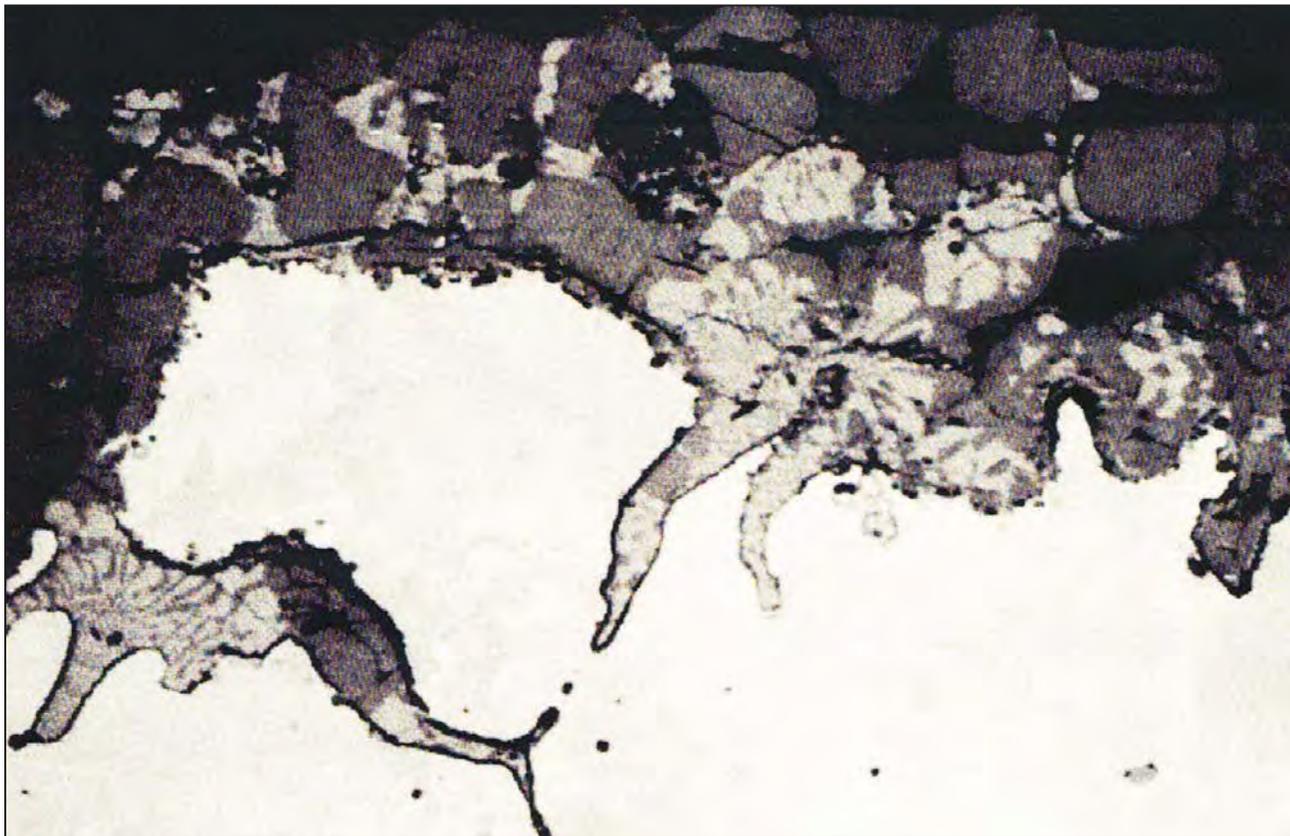
Figure C-7 Deep penetration of liquid into the steel. (Note: Hot corrosion of the steel can produce "islands" of steel surrounded by liquid, which will make erosion of the steel much easier.)

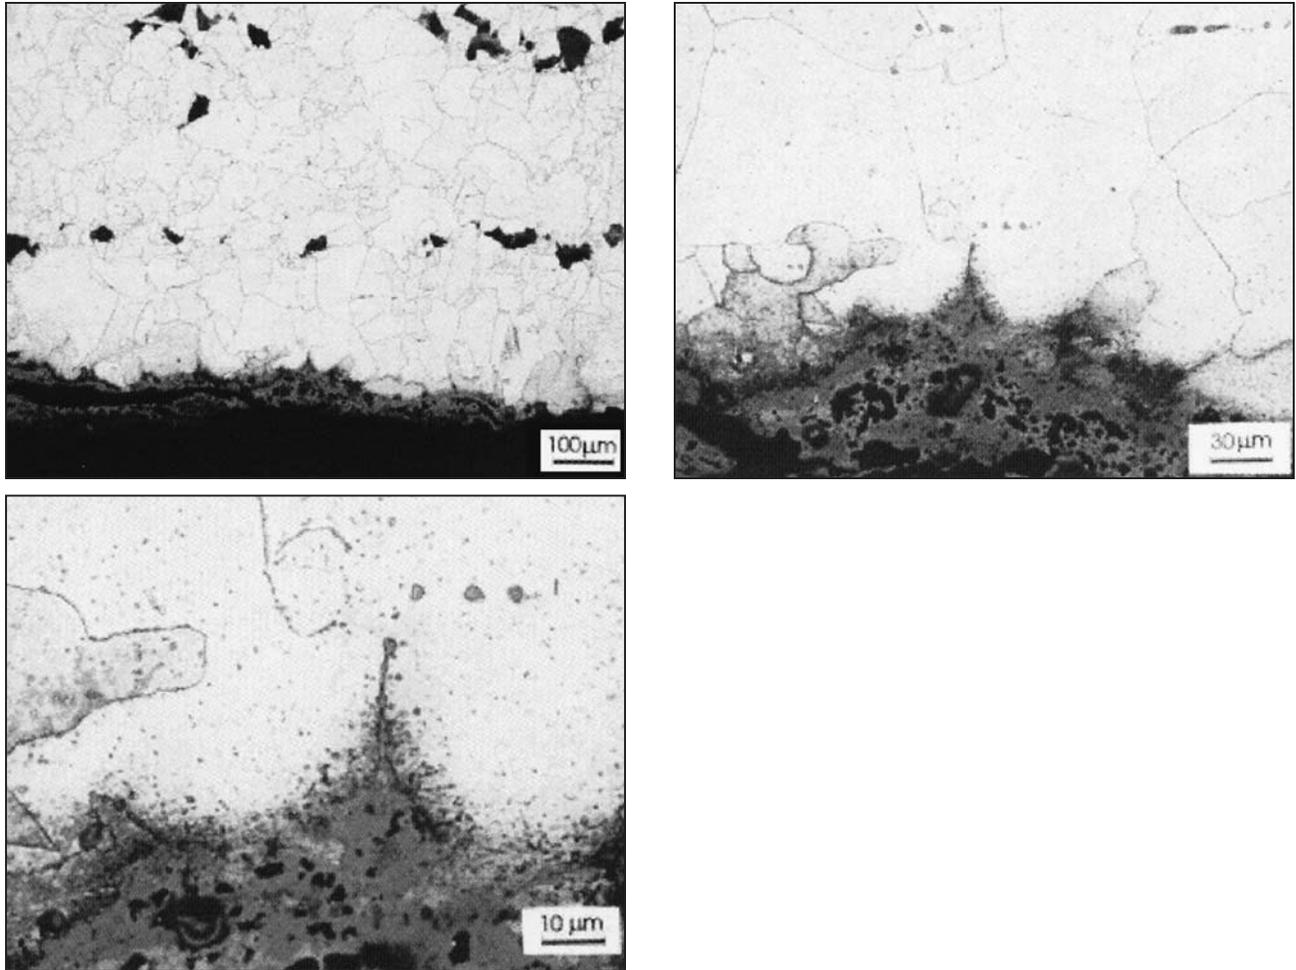
Figure C-11 Microstructure of a typical region showing the surface and grain boundary corrosion attack of Sample 2.

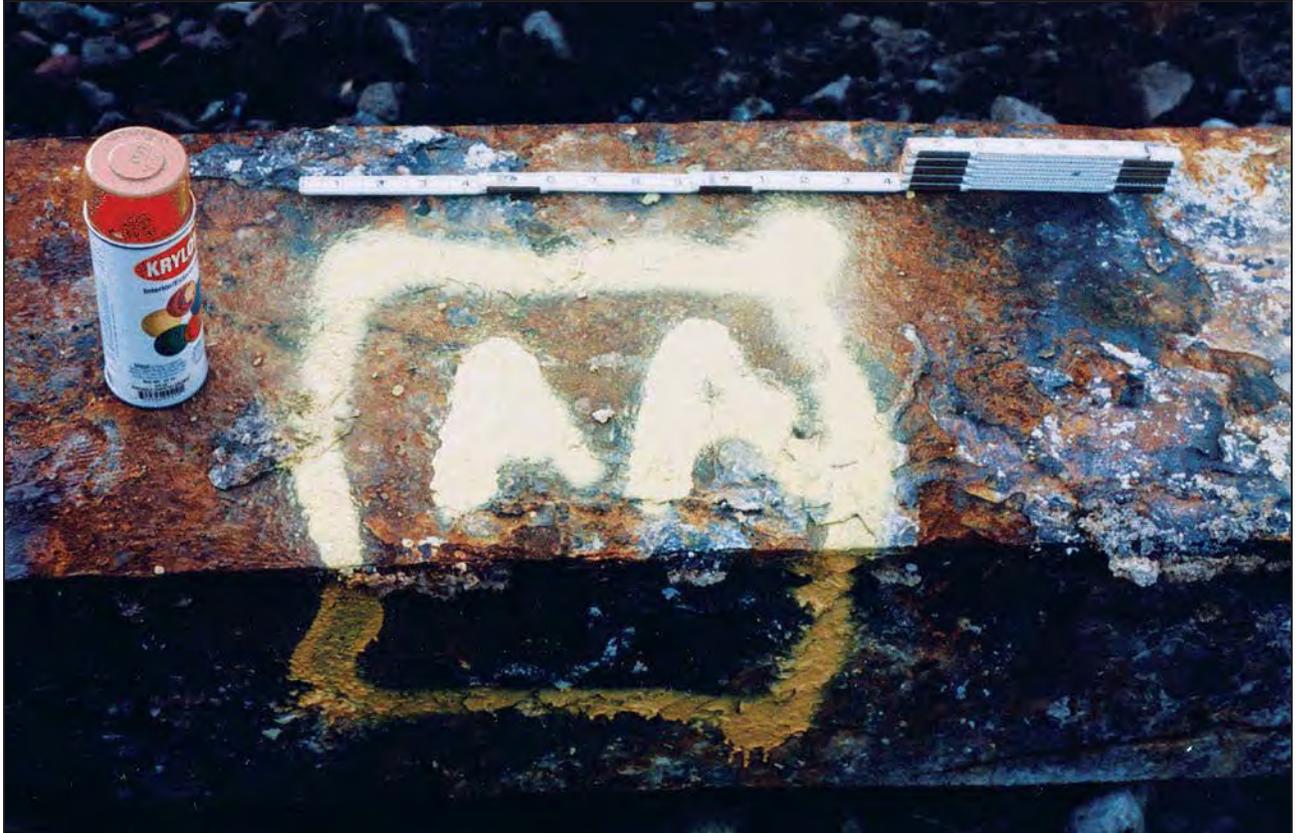
Figure D-11 Burnt steel piece marked for cutting of coupon.
