# World Trade Center Building Performance Study:

*Data Collection, Preliminary  
Observations, and  
Recommendations*

**Federal Emergency Management Agency**

FEMA 403 / September 2002

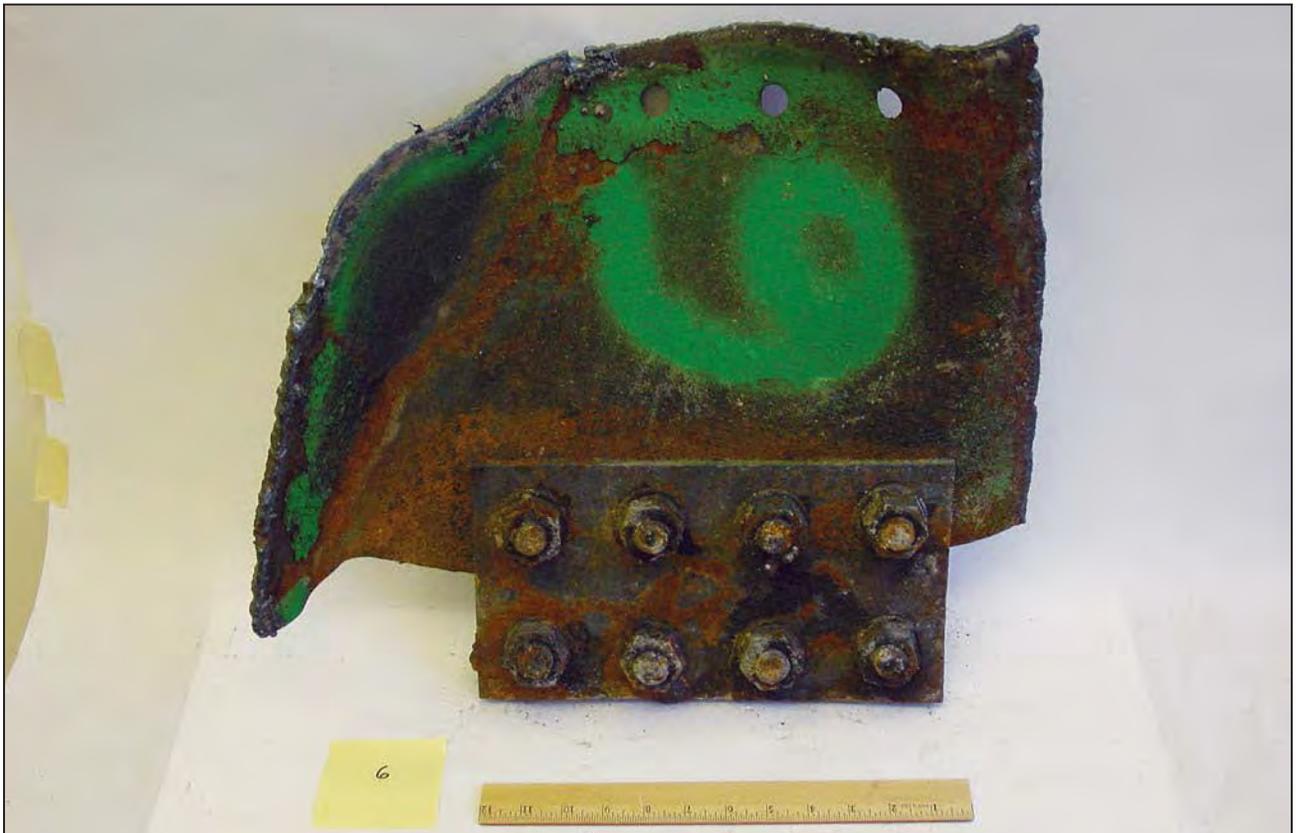
Figure D-12 Coupon cut from WTC 5 showing web tear-out at bolts.

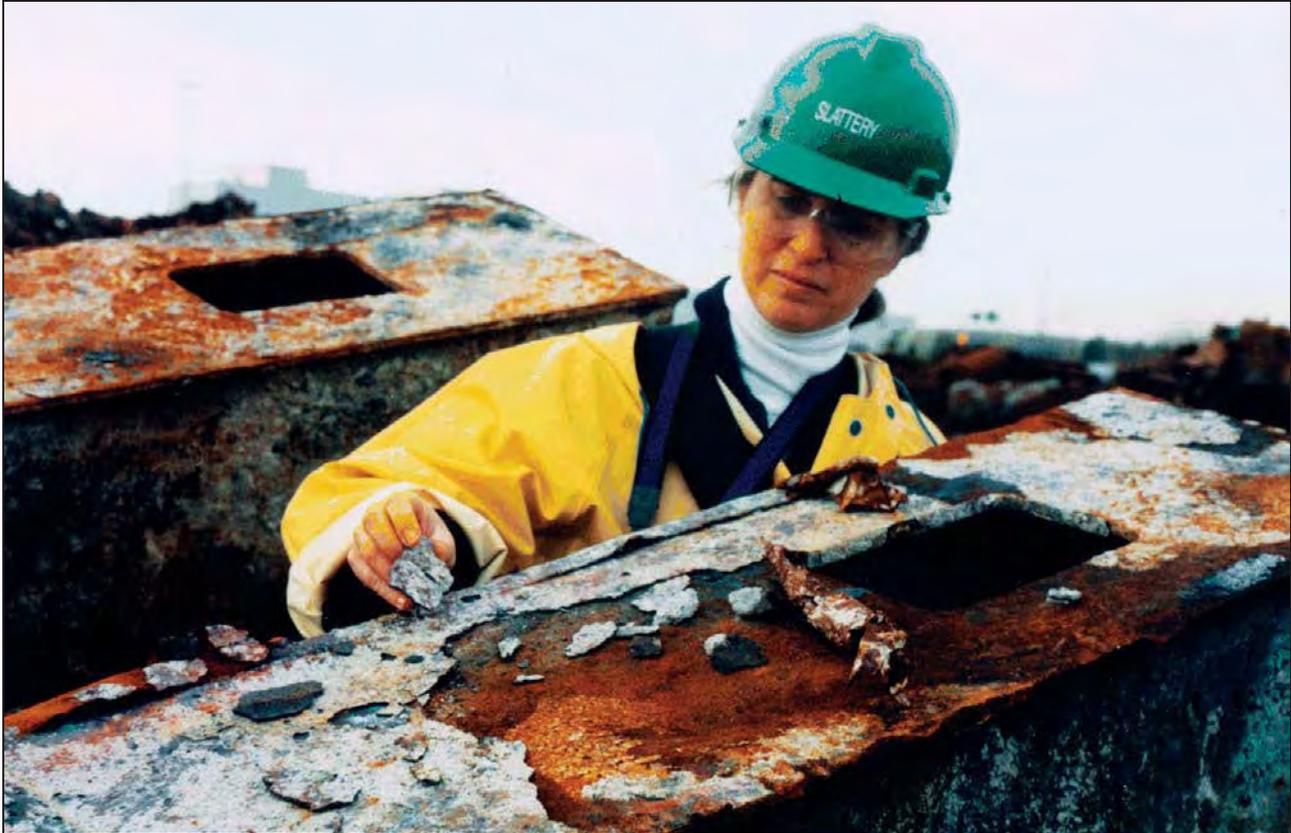
Figure D-16 Engineer inspecting fire damage of perimeter column tree from WTC 1 or WTC 2.
