# World Trade Center Building Performance Study:

*Data Collection, Preliminary  
Observations, and  
Recommendations*

**Federal Emergency Management Agency**

FEMA 403 / September 2002

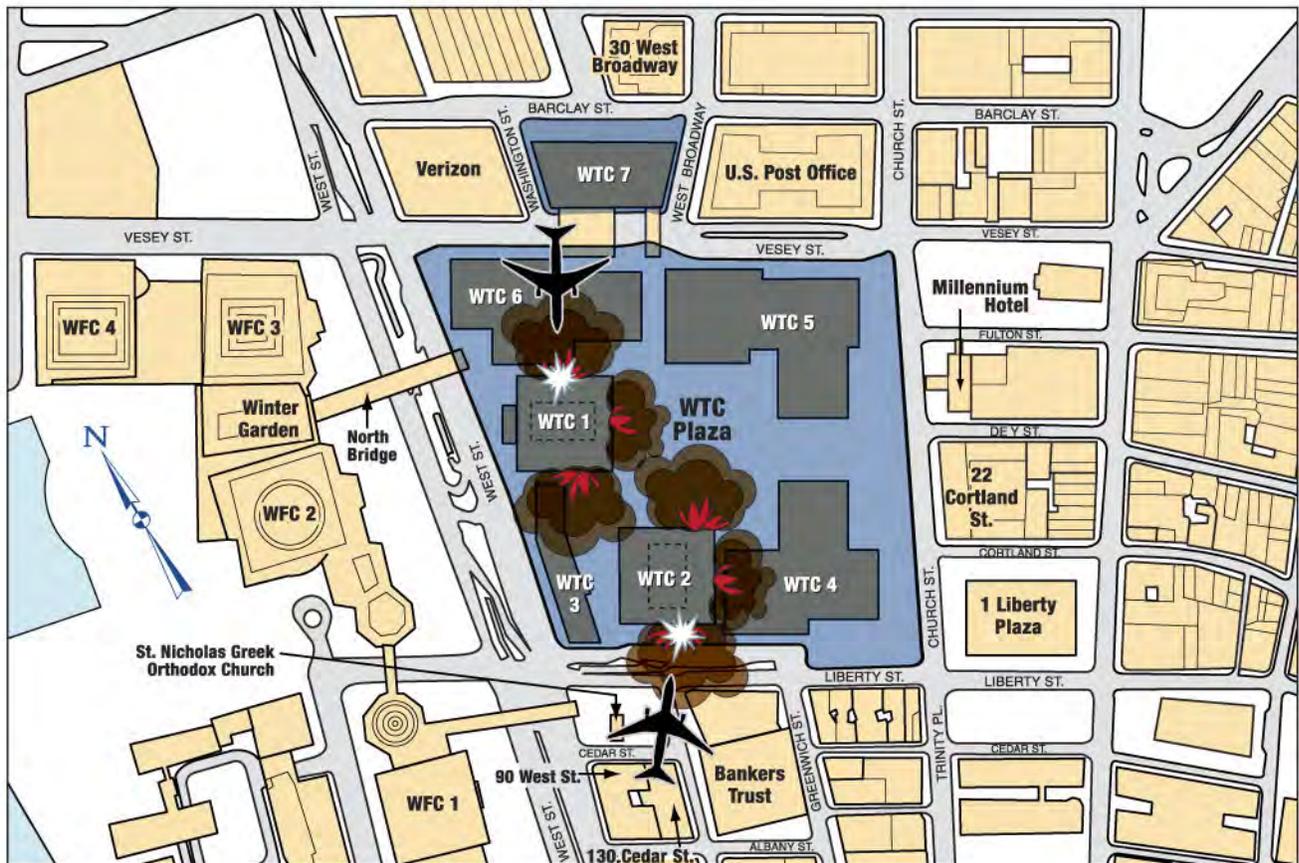
The north tower was struck between floors 94 and 98, with the impact roughly centered on the north face. The south tower was hit between floors 78 and 84 toward the east side of the south face (Figures 1-3 and 1-4). Each plane banked steeply as it was flown into the building, causing damage across multiple floors. According to Government sources, the speed of impact into the north tower was estimated to be 410 knots, or 470 miles per hour (mph), and the speed of impact into the south tower was estimated to be 510 knots, or 590 mph. As the two aircraft impacted the buildings, fireballs erupted (Figure 1-5) and jet fuel spread across the impact floors and down interior shaftways, igniting fires (Figure 1-6). The term fireball is used to describe deflagration, or ignition, of a fuel vapor cloud. As the resulting fires raged throughout the upper floors of the two WTC towers, thousands attempted to evacuate the buildings. It was estimated by the Port Authority that the population of the WTC complex on September 11, 2001, was 58,000 people. This estimate includes the PATH and MTA stations and the Concourse areas. Almost everyone in WTC 1 and WTC 2 who was below the impact areas was able to safely evacuate the buildings, due to the length of time between the impact and collapse of the individual towers.

Figure 1-3 WTC impact locations and resulting fireballs.

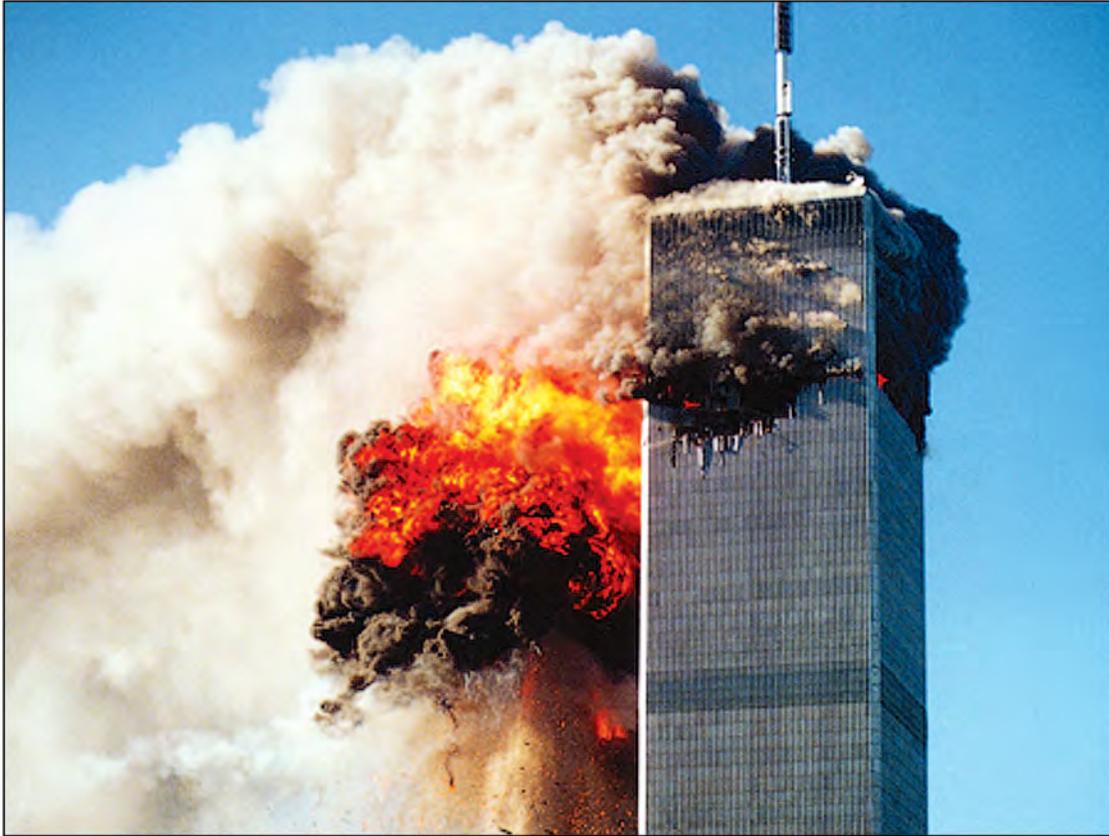
Figure 1-5 Fireball erupts on the north face of WTC 2 as United Airlines Flight 175 strikes the building.

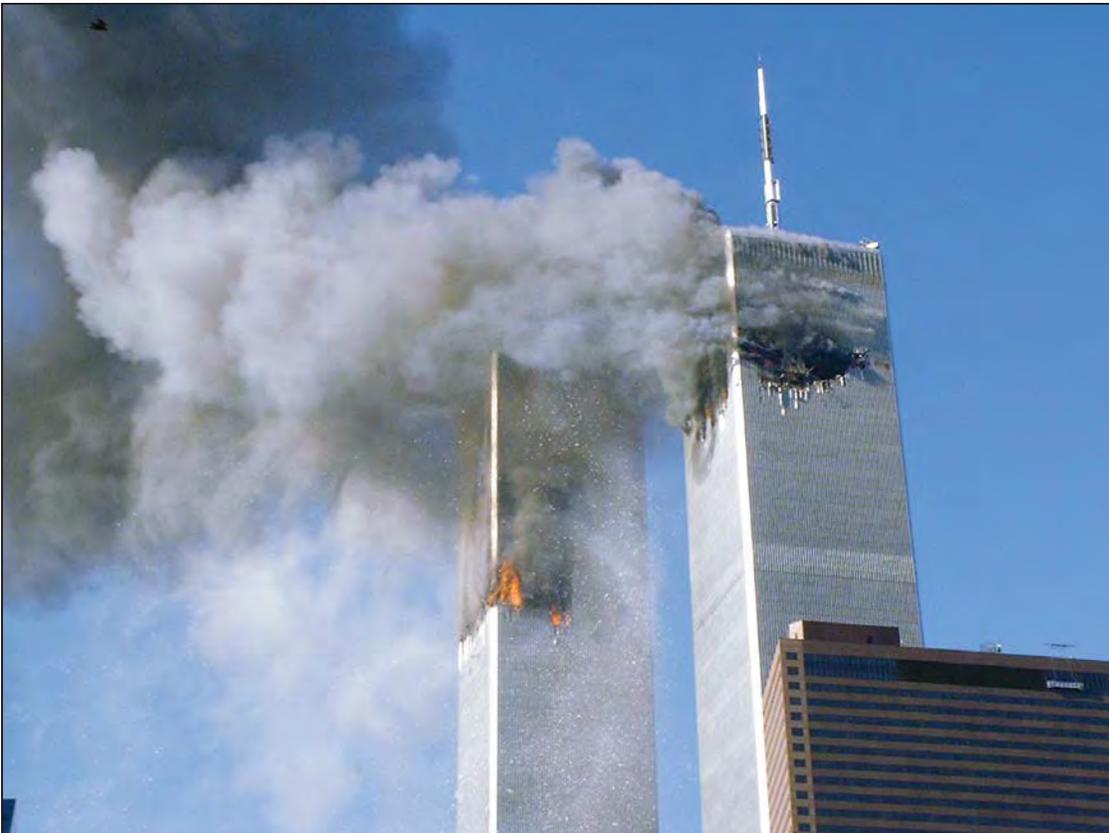
Figure 1-6 View of the north and east faces showing fire and impact damage to both towers.

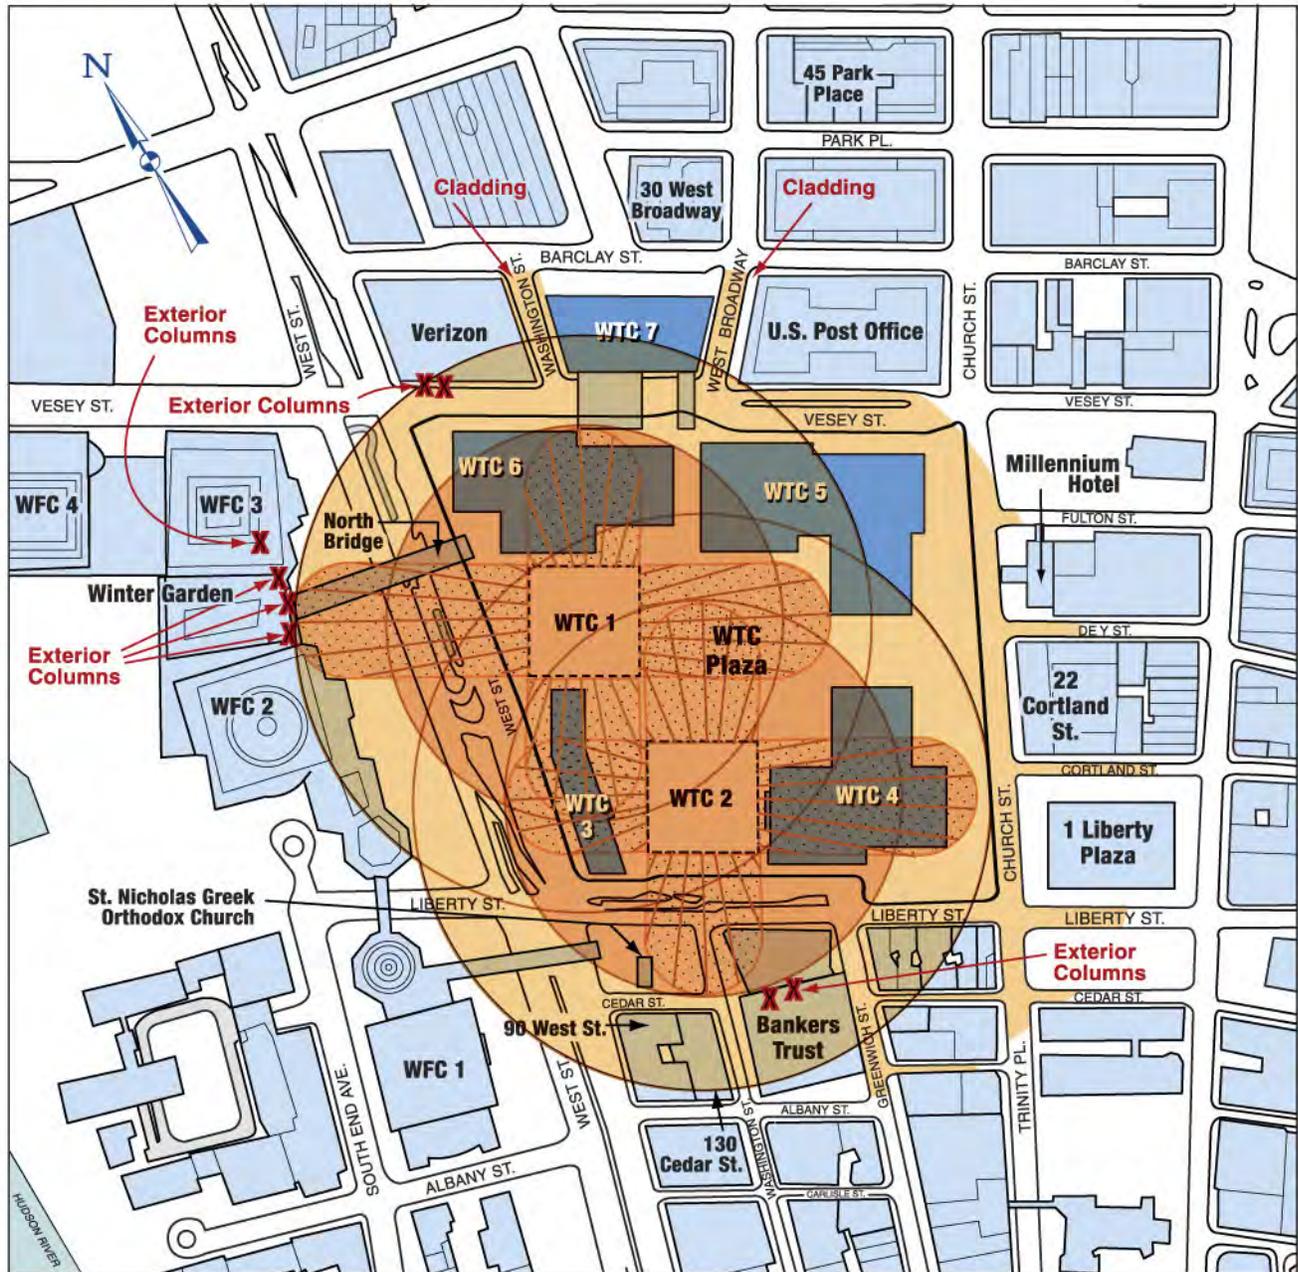
Debris from the collapsing towers, some of it still on fire, rained down on surrounding buildings, causing structural damage and starting new fires (Figure 1-7). The sudden collapse of each tower sent out air pressure waves that spread dust clouds of building materials in all directions for many blocks. The density and pressure of the dust clouds were strong enough to carry light debris and lift or move small vehicles and break windows in adjacent buildings for several blocks around the WTC site. Most of the fires went unattended as efforts were devoted to rescuing those trapped in the collapsed towers. The 22-story Marriott World Trade Center Hotel (WTC 3) was hit by a substantial amount of debris during both tower collapses. Portions of WTC 3 were severely damaged by debris from each tower collapse, but progressive collapse of the building did not occur. However, little of WTC 3 remained standing after the collapse of WTC 1. WTC 4, 5, and 6 had floor contents and furnishings burn completely and suffered significant partial collapses from debris impacts and from fire damage to their structural frames. WTC 7, a 47-story building that was part of the WTC complex, burned unattended for 7 hours before collapsing at 5:20 p.m. The falling debris also damaged water mains around the WTC site at the following locations:

Figure 1-7 Schematic depiction of areas of collapse debris impact, based on aerial photographs and documented damage. Striped areas indicate predominant locations of exterior steel columns. Inner circles indicate approximate radius of exterior steel columns and other heavy debris. Outer circles indicate approximate radius of aluminum cladding and other lighter debris. Heavy Xs show where exterior steel columns were found outside the predominate debris areas.

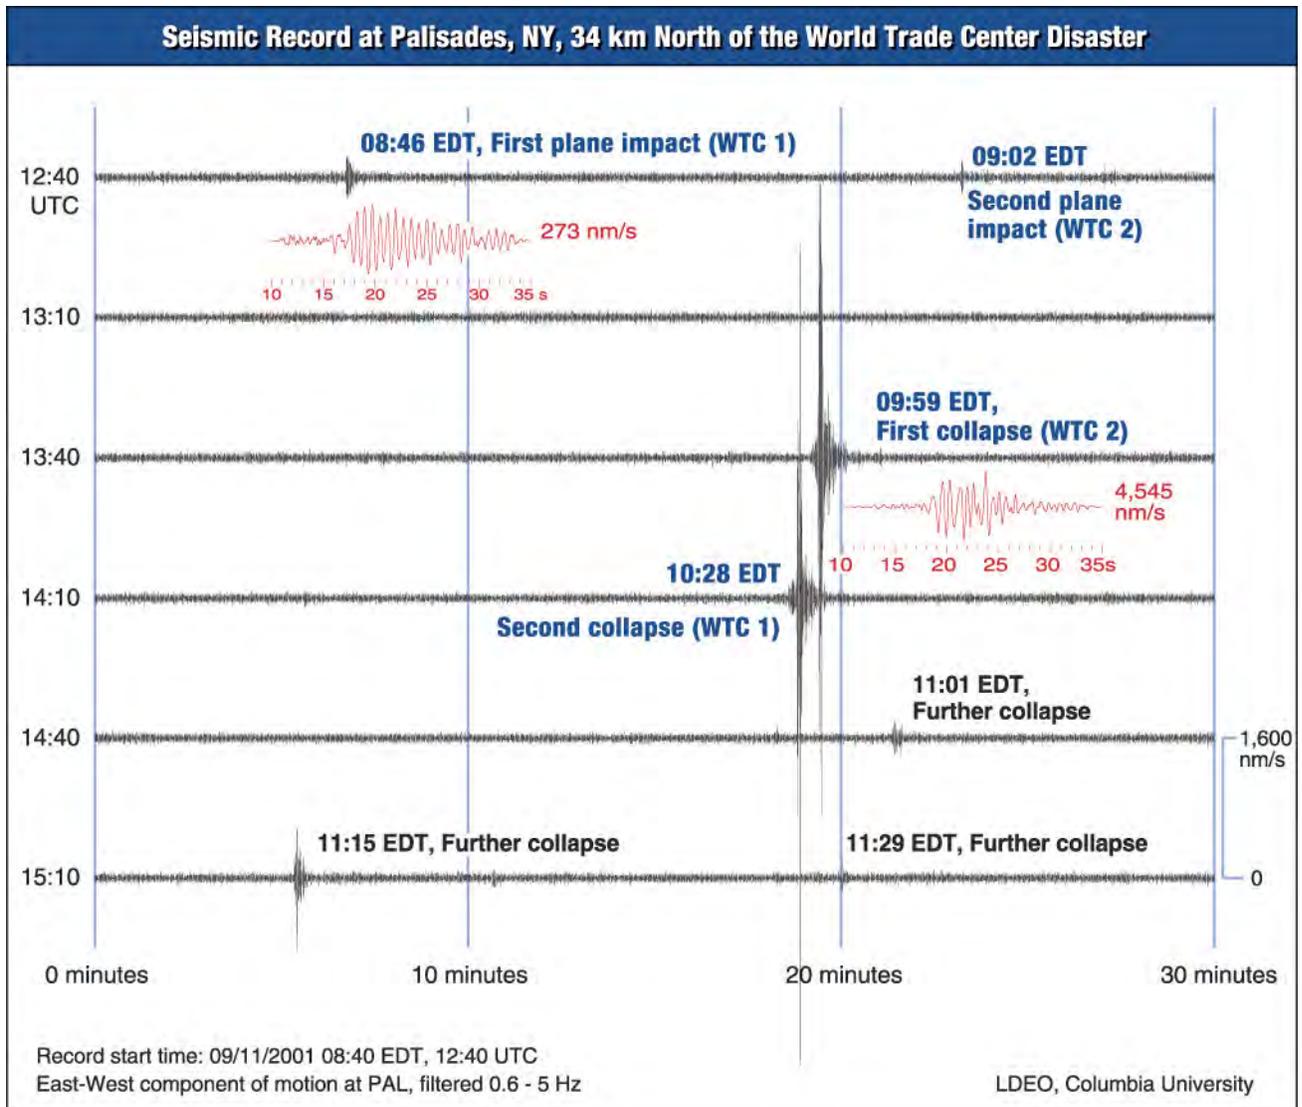
Figure 1-8 Seismic recordings on east-west component at Palisades, NY, for events at WTC on September 11, 2001, distance 34 km. Three hours of continuous data are shown starting at 08:40 EDT (12:40 UTC). The two largest signals were generated by the collapses of towers 1 and 2. Expanded views of first impact and first collapse are shown in red. The amplitude of the seismic signal is in nanometers per second (nm/s), and the peak amplitude of the ground motion at this station reached to 4,545 nm/s for the first collapse. Note the relatively periodic motions for impacts 1 and 2.

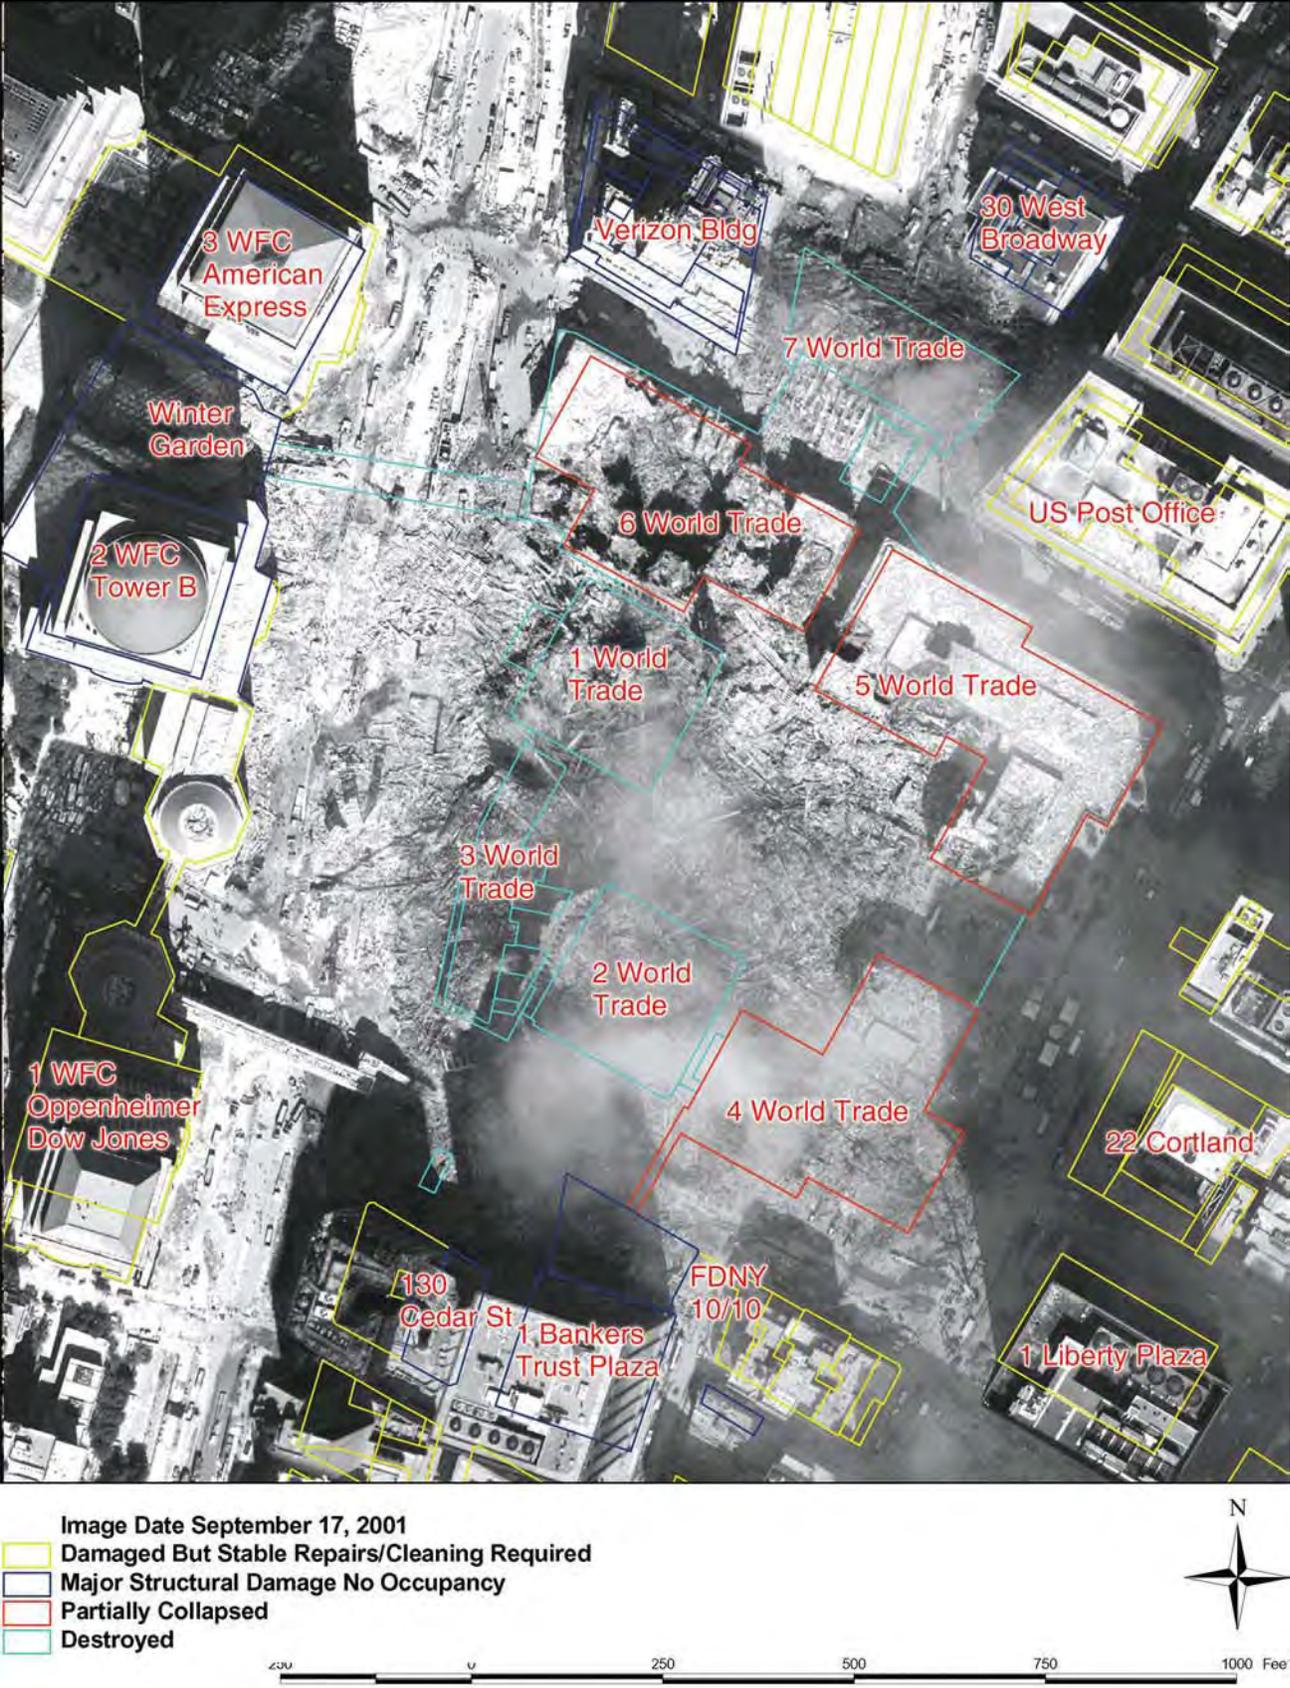
Figure 1-9B Satellite photograph of the WTC site taken after the attacks.

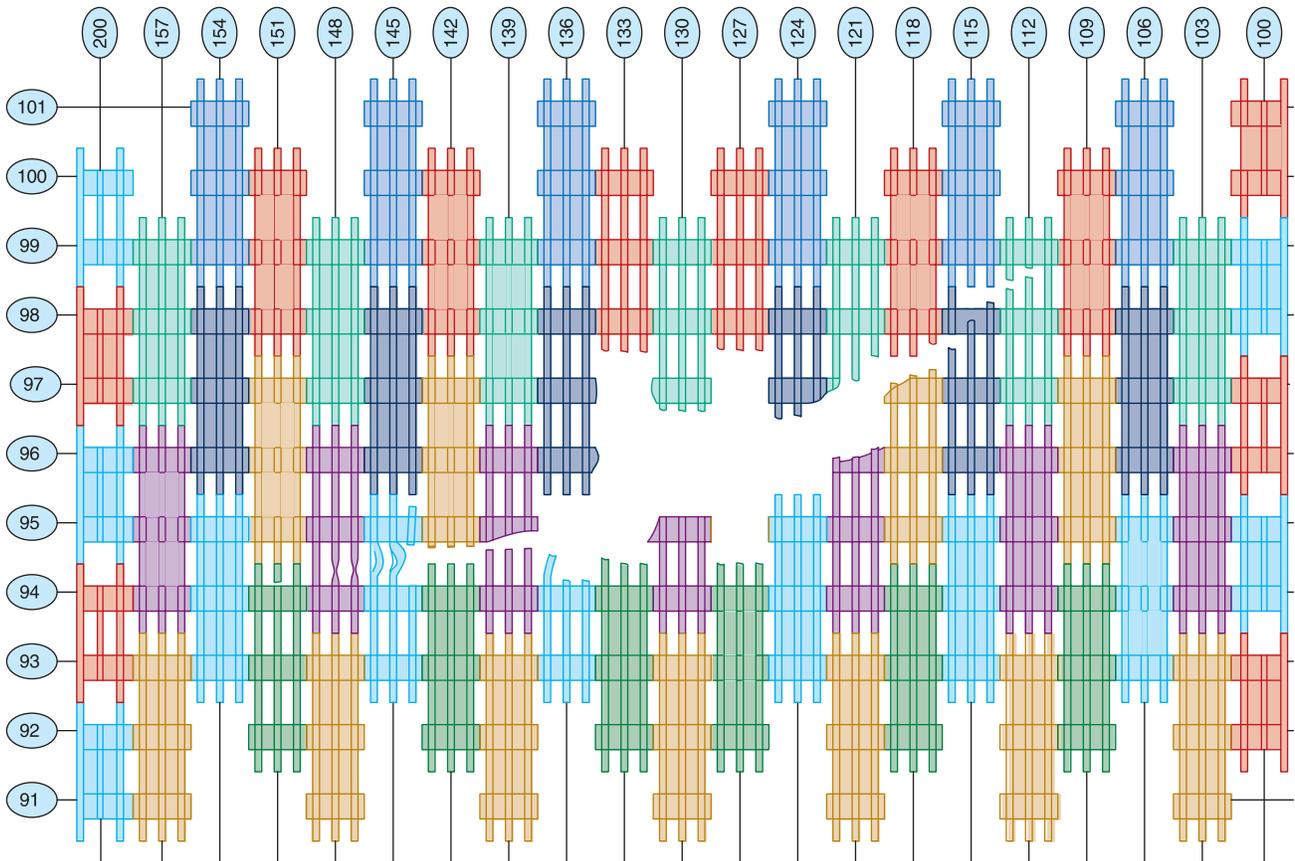
American Airlines Flight 11 struck the north face of WTC 1 approximately between the 94th and 98th floors (Figures 2-13 and 2-14), causing massive damage to the north face of the building within the immediate area (Figure 2-15). At the central zone of impact corresponding to the airplane fuselage and engines, at least five of the prefabricated, three-column sections that formed the exterior walls were broken loose of the structure, and some were pushed inside the building envelope. Locally, floors supported by these exterior wall sections appear to have partially collapsed, losing their support along the exterior wall. Away from this central zone, in areas impacted by the outer wing structures, the exterior columns were fractured by the force of the collision. Interpretation of photographic evidence suggests that from 31 to 36 columns on the north building face were destroyed over portions of a four-story range. Partial collapse of floors in this zone appear to have occurred over a horizontal length of wall of approximately 65 feet, while floors in other portions of the building appear to have remained intact. Figure 2-16 shows the damage to the exterior columns on the impacted face of WTC 1.

Figure 2-16 Impact damage to exterior columns on the north face of WTC 1.

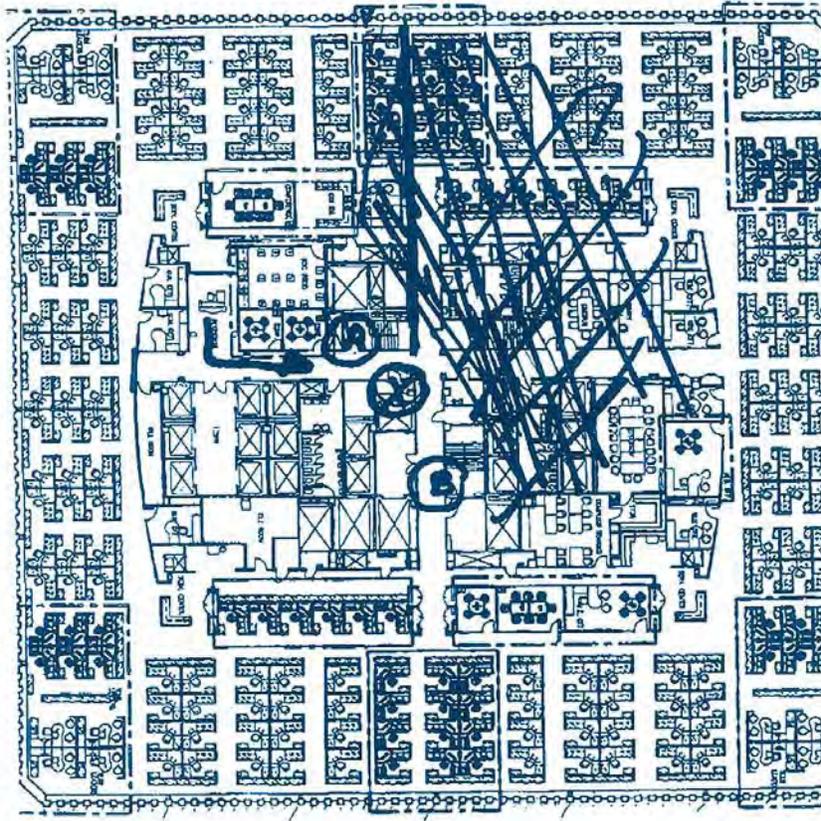
In addition to this damage at the building perimeter, a significant but undefined amount of damage also occurred to framing at the central core. Interviews were conducted with persons who were present in offices on the 91st floor of the building at the north face of the structure, three floors below the approximate zone of impact. Their descriptions of the damage evident at this floor level immediately following the aircraft impact suggest relatively slight damage at the exterior wall of the building, but progressively greater damage to the south and east. They described extensive building debris in the eastern portion of the central core, preventing their access to the easternmost exit stairway. This suggests the possibility of immediate partial collapse of framing in the central core. These persons also described the presence of debris from collapsed partition walls from upper floors in stairways located further to the west, suggesting the possibility of some structural damage in the northwestern portion of the core framing as well. Figure 2-17 is a sketch made during an interview with building occupants indicating portions of the 91st floor that could not be accessed due to accumulated debris.

Figure 2-17  
Approximate debris location on the 91st  
floor of WTC 1.

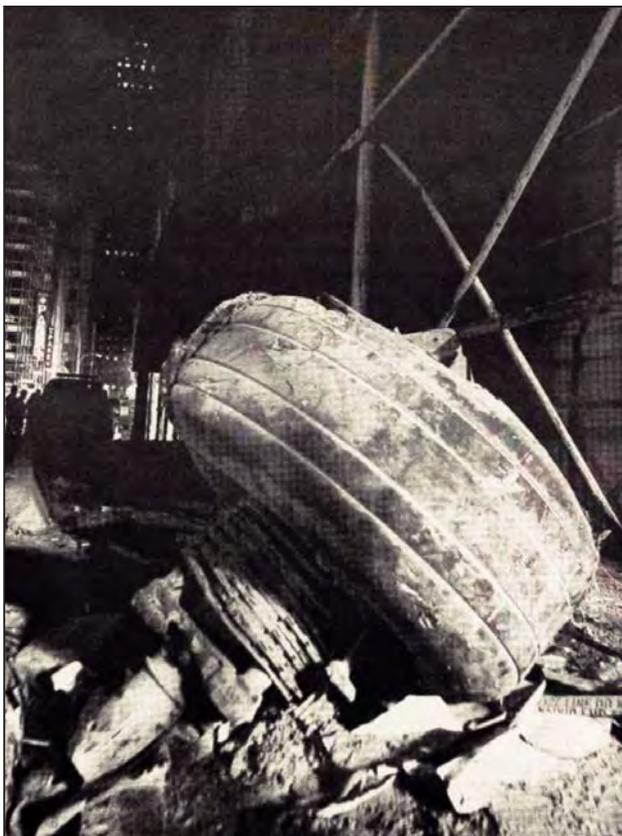
Figure 2-18  
Landing gear found at the corner of West and Rector Streets.

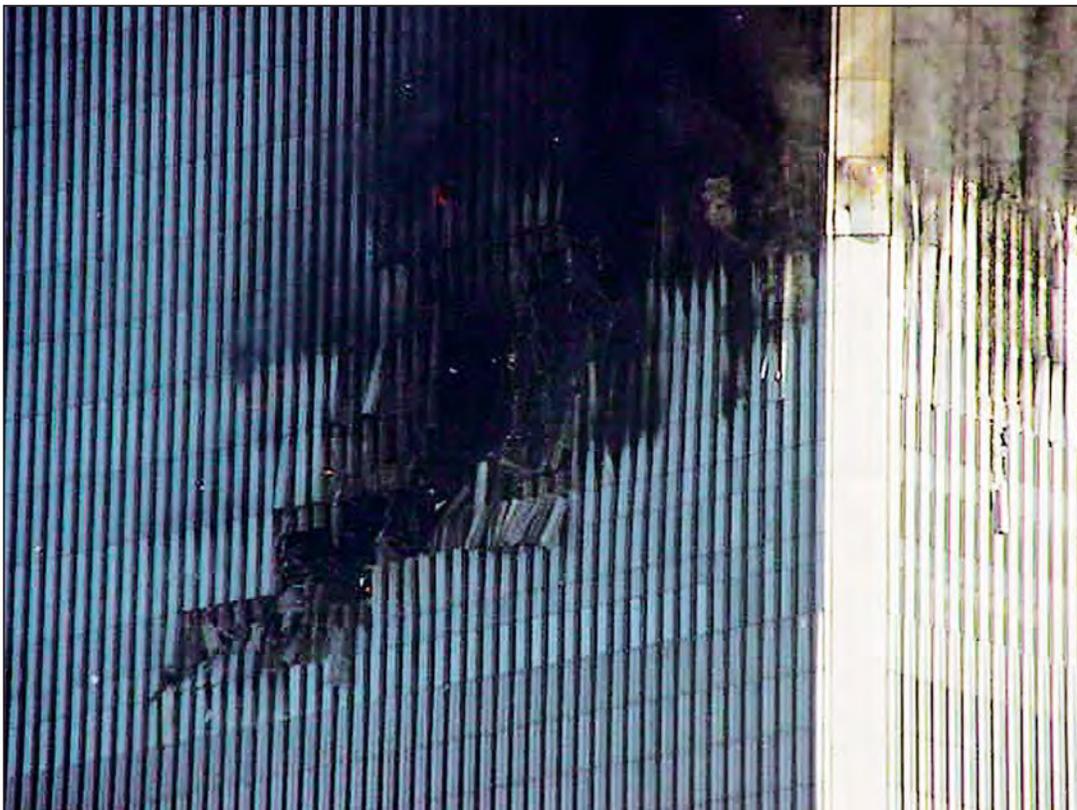
United Airlines Flight 175 struck the south face of WTC 2 approximately between the 78th and 84th floors. The zone of impact extended from near the southeast corner of the building across much of the building face (Figures 2-24 and 2-25). The aircraft caused massive damage to the south face of the building in the zone of impact (Figures 2-26 and 2-27). At the central zone of impact corresponding to the airplane fuselage and engines, six of the prefabricated, three-column sections that formed the exterior walls were broken loose from the structure, with some of the elements apparently pushed inside the building envelope. Locally, as was the case in WTC 1, floors supported by these exterior wall sections appear to have partially collapsed. Away from this central zone, in the areas impacted by the outer wing structures, the exterior steel columns

Figure 2-24 Southeast corner of WTC 2 shortly after aircraft impact.

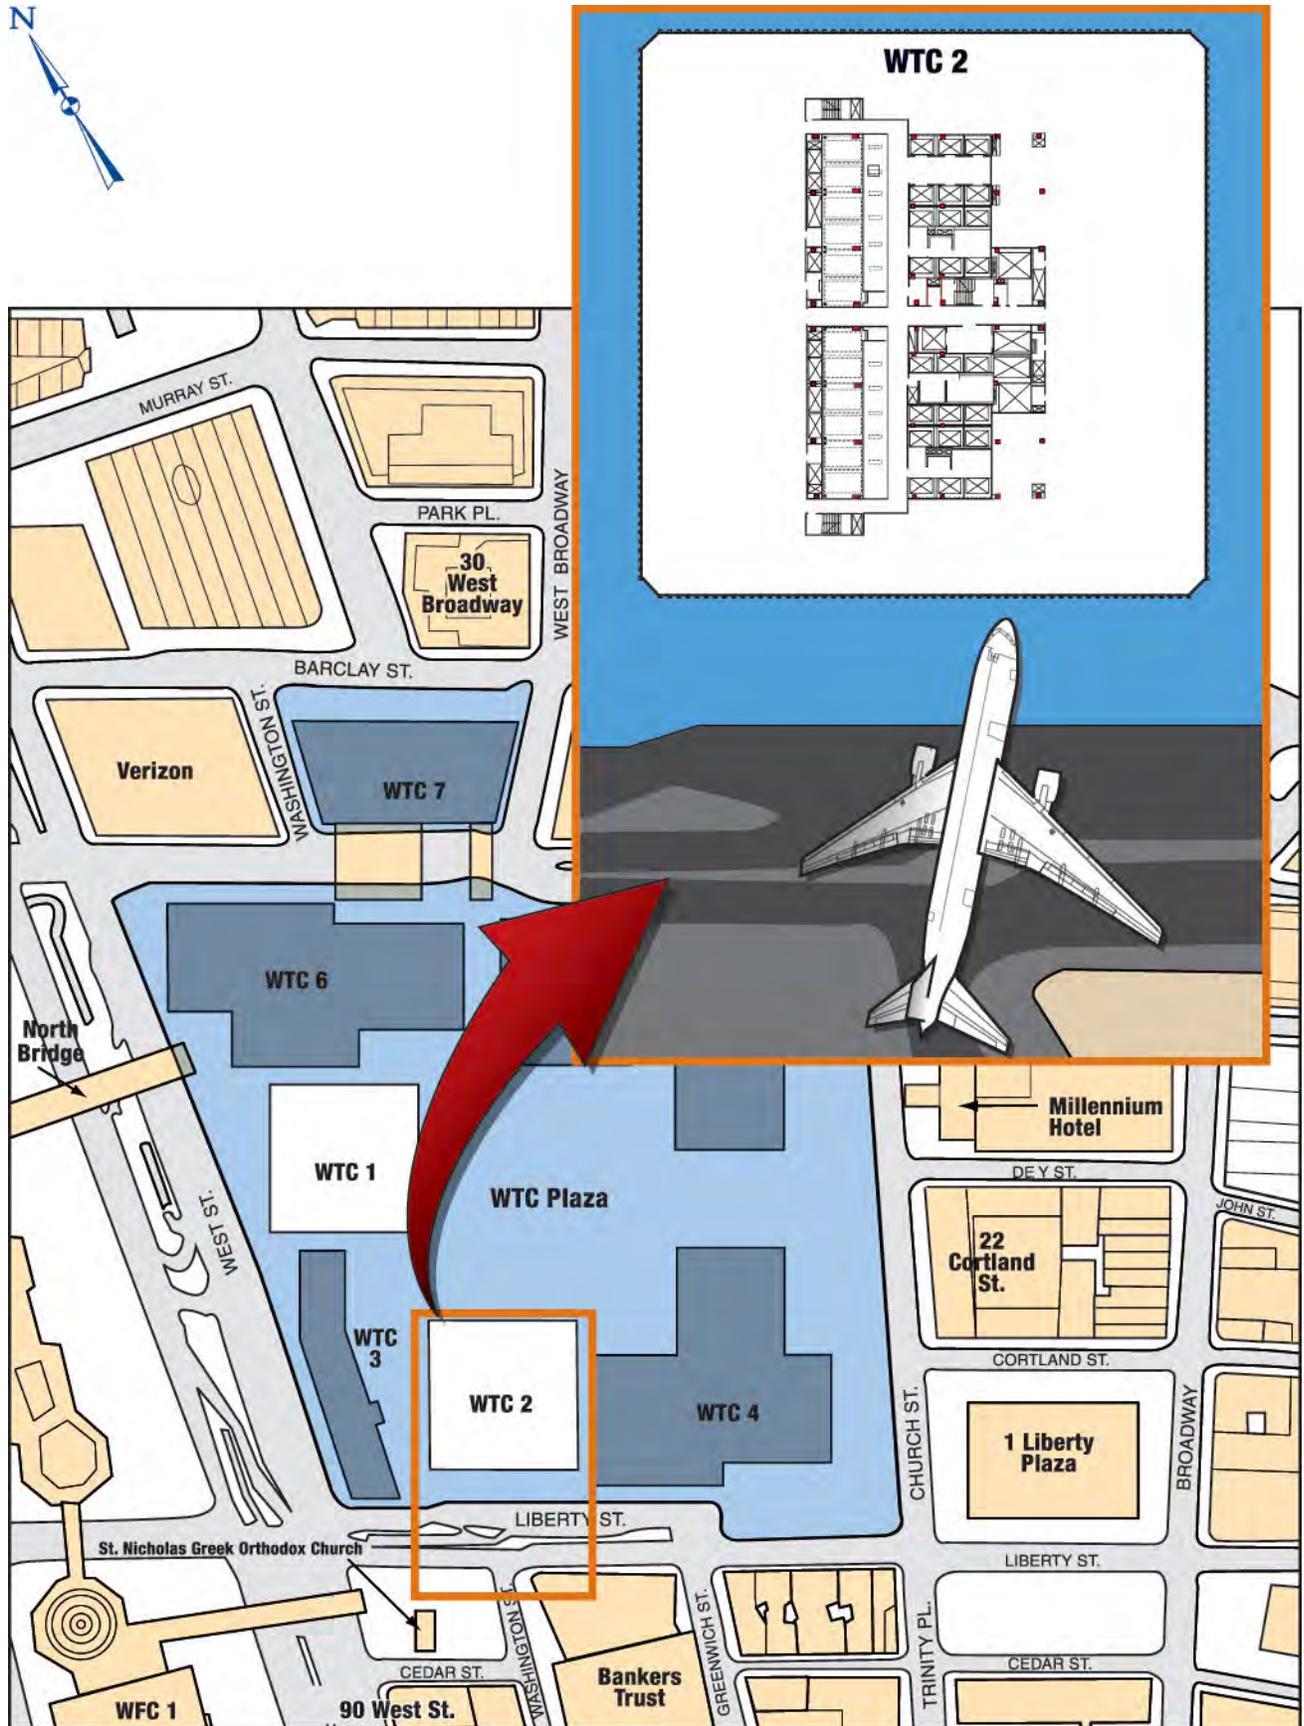
Figure 2-25 Approximate zone of impact of aircraft on the south face of WTC 2.

were fractured by the impact. Photographic evidence suggests that from 27 to 32 columns along the south building face were destroyed over a five-story range. Partial collapse of floors in this zone appears to have occurred over a horizontal length of approximately 70 feet, while floors in other portions of the building appeared to remain intact. It is probable that the columns in the southeast corner of the core also experienced some damage because they would have been in the direct travel path of the fuselage and port engine (Figure 2-25).

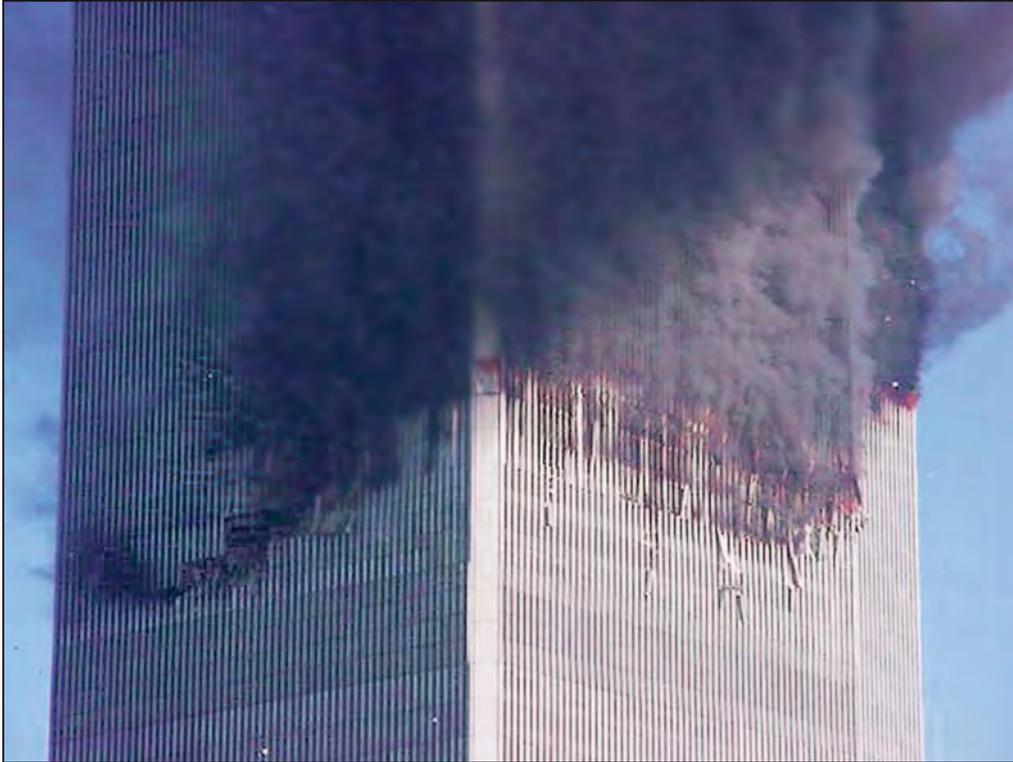
Figure 2-26 Impact damage to the south and east faces of WTC 2.

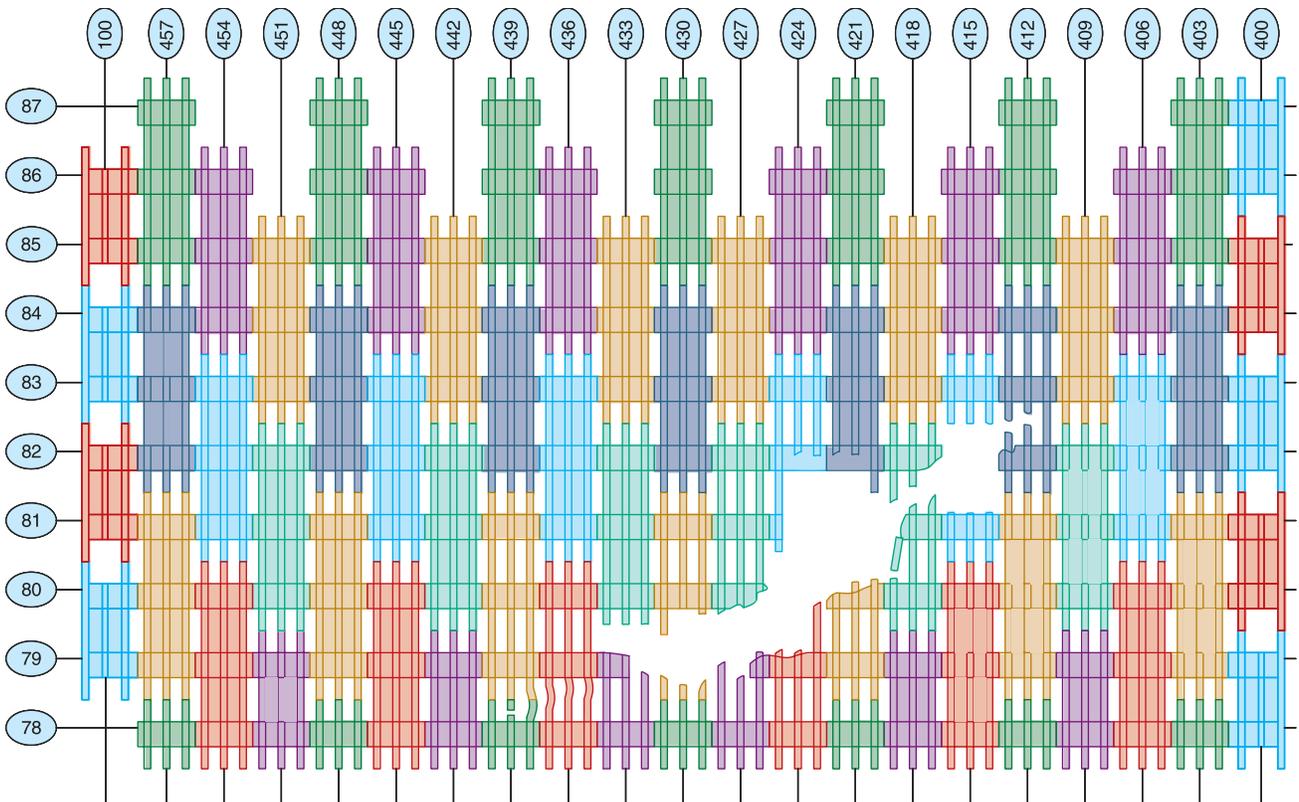
Figure 2-27 Impact damage to exterior columns on the south face of WTC 2.

A second analysis was conducted to estimate the demands on columns immediately following aircraft impact and before fire effects occurred. Exterior columns were removed from the model to match the damage pattern illustrated in Figure 2-27. Although some core columns were probably damaged by the aircraft impact, the exact extent of this damage is not known and therefore was not considered in the model. As a result, this analysis is thought to underestimate the true stress state in the columns immediately after impact. The analysis indicates that most of the loads initially carried by the damaged exterior columns were transferred by Vierendeel truss action to the remaining exterior columns immediately adjacent to the impact area. If the floors at this level are assumed to remain intact and capable of providing lateral support to the columns, this raised the utilization ratio for the most heavily loaded column immediately adjacent to the damage area to approximately a value of 1.0. At a value of 1.0, columns would lose stiffness and shift load to adjacent columns. Based on this analysis, it appears that the structure had significant remaining margin

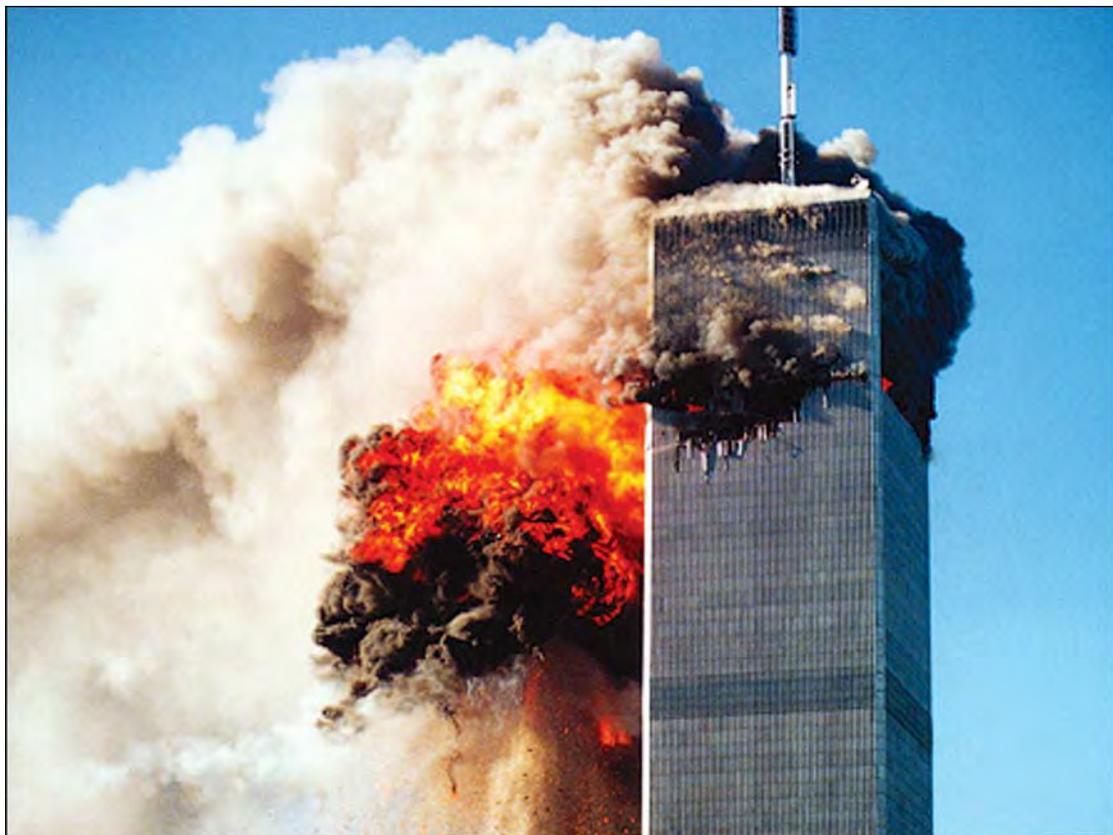
It is known that debris from the aircraft traveled completely through the structure. For example, a landing gear from the aircraft that impacted WTC 2 was found to have crashed through the roof of a building located six blocks to the north, and one of the jet engines was found at the corner of Murray and Church Streets. The extent to which debris scattered throughout the impact floors is also evidenced by photographs of the fireballs that occurred as the aircraft struck the building (Figure 2-28). Figure 2-29 shows a portion of the fuselage of the aircraft, lying on the roof of WTC 5.

Figure 2-28 Conflagration and debris exiting the north wall of WTC 2, behind WTC 1.

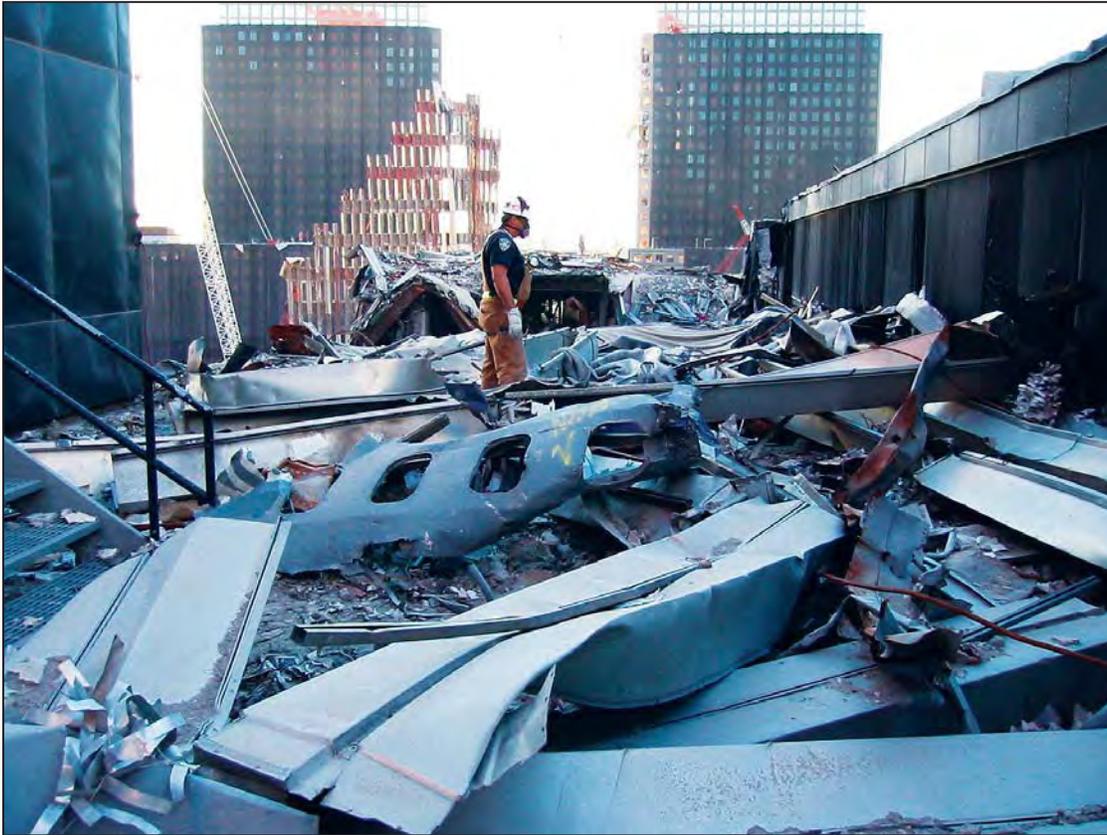
Figure 2-29 A portion of the fuselage of United Airlines Flight 175 on the roof of WTC 5.

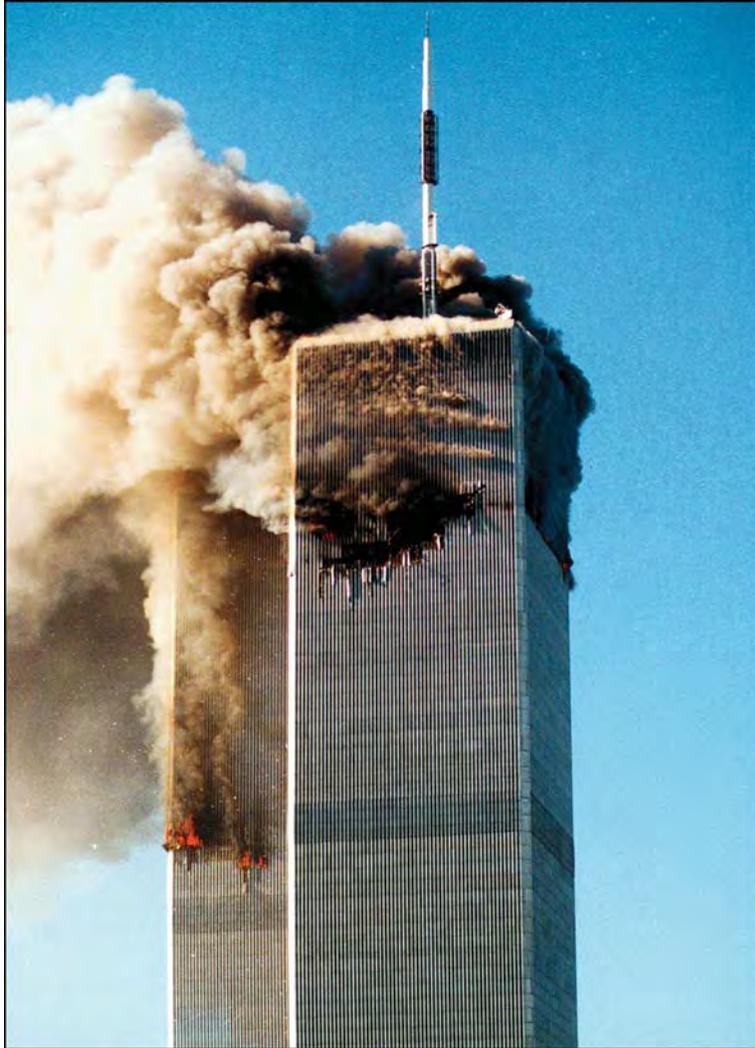
As described for WTC 1, this debris doubtless caused some level of damage to the structure across the floor plates, including interior framing; core columns at the southeast corner of the core; framing at the north, east, and west walls; and the floor plates themselves. Figure 2-30, showing the eastern side of the north face of the WTC 2 partially hidden behind WTC 1, suggests that damage to the exterior walls was not severe except at the zone of impact. The exact extent of this damage will likely never be known with certainty. It is evident that the structure retained sufficient integrity and strength to remain globally stable for a period of approximately 56 minutes.

*Figure 2-30  
North face of WTC 2 opposite the zone of impact  
on the south face, behind WTC 1.*

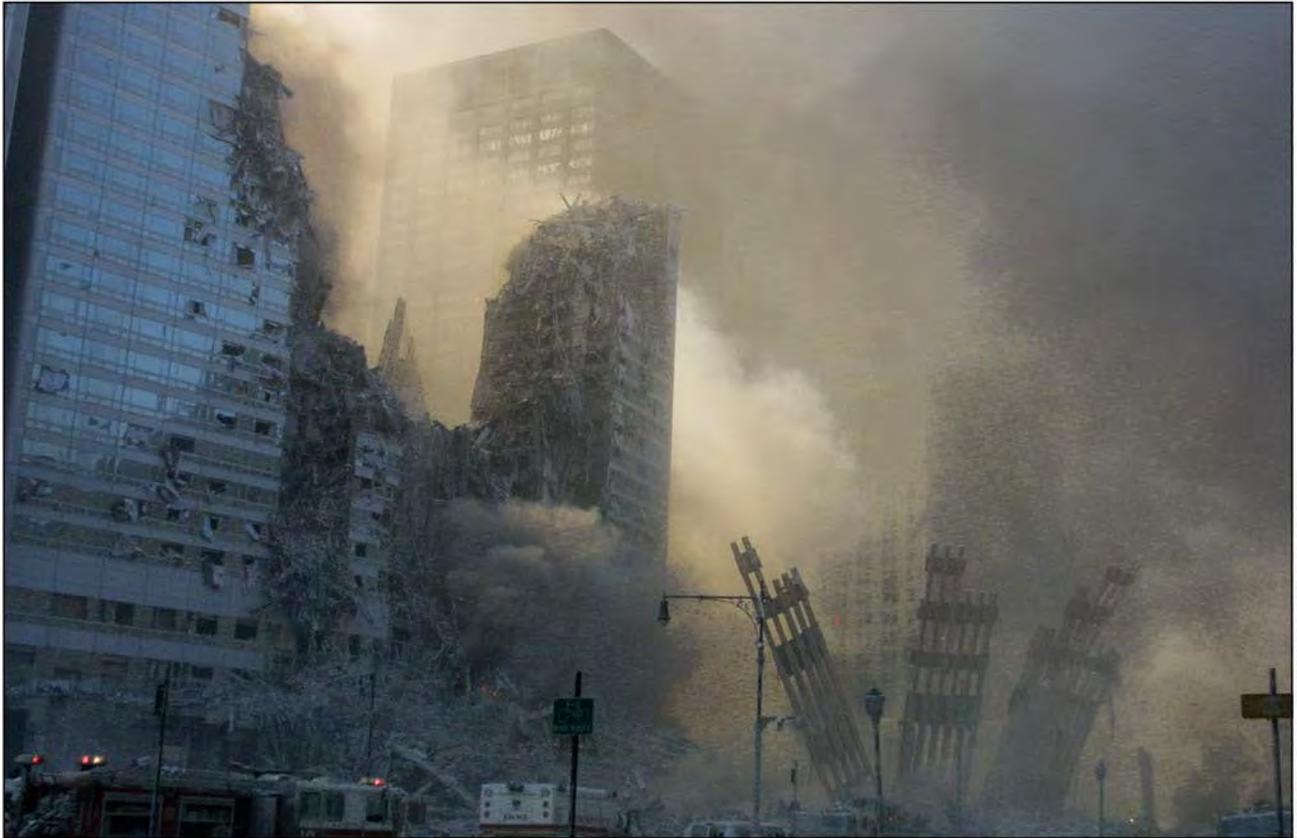
Debris from WTC 2 struck the building with sufficient force to crush approximately 16 stories in the center of the building, as shown in Figure 3-7. In spite of this extensive damage, the collapse did not

Figure 3-7 Partial collapse of WTC 3 after collapse of WTC 2.
