# World Trade Center Building Performance Study:

*Data Collection, Preliminary  
Observations, and  
Recommendations*

**Federal Emergency Management Agency**

FEMA 403 / September 2002

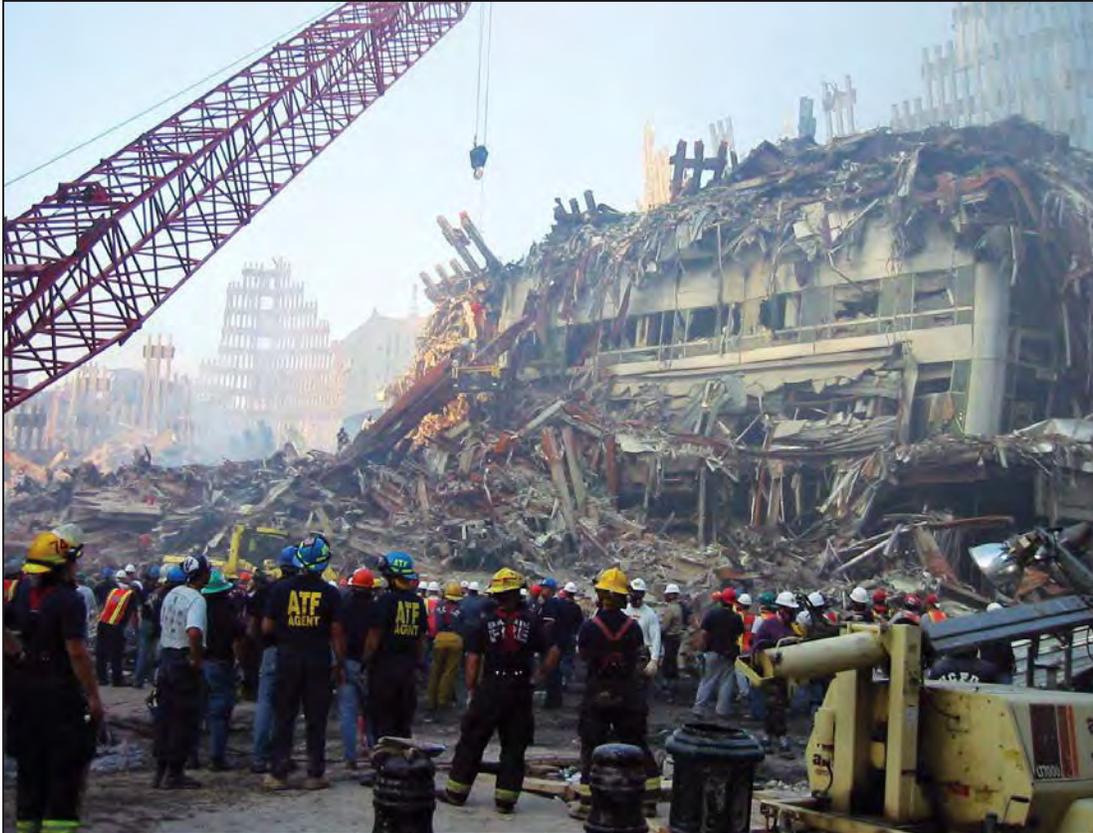
The second loading event was the collapse of WTC 1. Debris from WTC 1 fell along the entire length of the hotel. Lower floors at the southwest end of WTC 3 survived although they suffered extensive damage. The remaining portions of the building after both collapses of WTC 1 and WTC 2 are shown in Figure 3-8.

Figure 3-8 Remains of WTC 3 after collapse of WTC 1 and WTC 2.

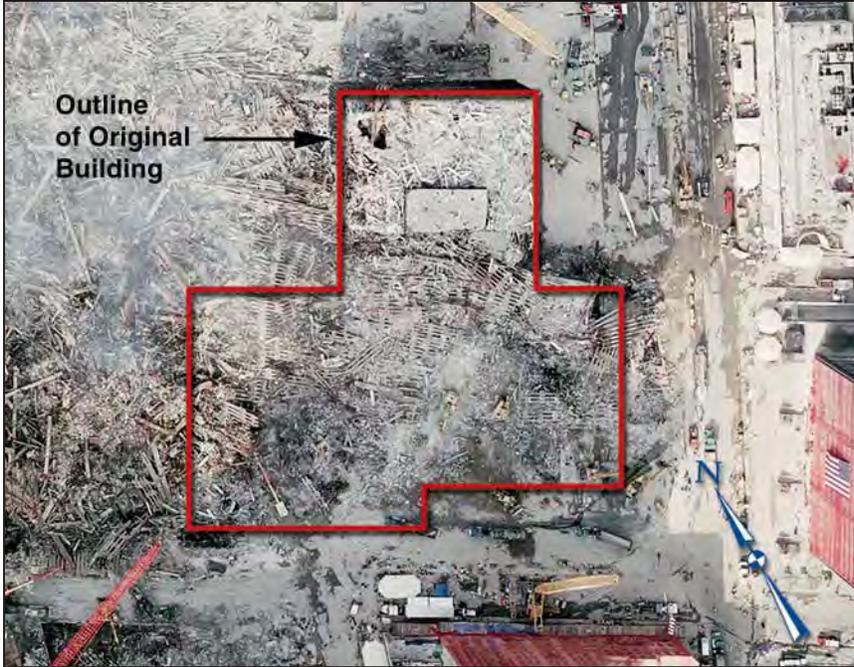
There was major impact to WTC 4 from the collapse of one or both of the WTC towers (most likely WTC 2) that destroyed all but the northern 50 feet of the building. Extensive damage is evident in Figure 4-5.

Figure 4-5 Damage to WTC 4.

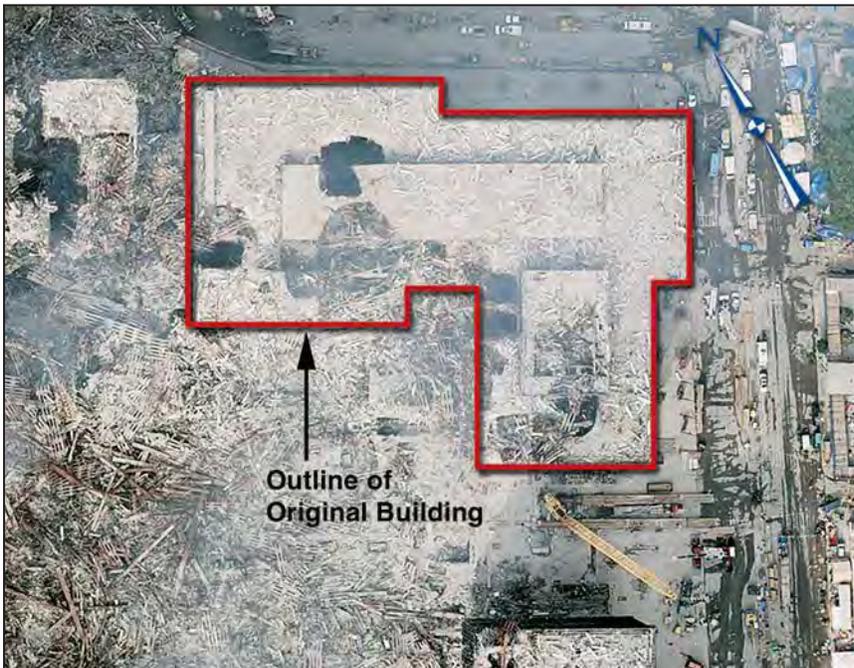
WTC 5 was damaged by impact and subsequent fires. The impact damage areas in WTC 5 are shown in Figure 4-6. The debris damage caused localized collapses from the roof to the 3rd floor in most of the areas where exterior columns impacted the structure. Ensuing fires that burned unchecked in the building caused a localized collapse from the 9th floor to the 4th floor. Figure 4-7 diagrammatically shows the damaged and collapsed areas of WTC 5 due to impact and fire.

Figure 4-6 Damage to WTC 5.

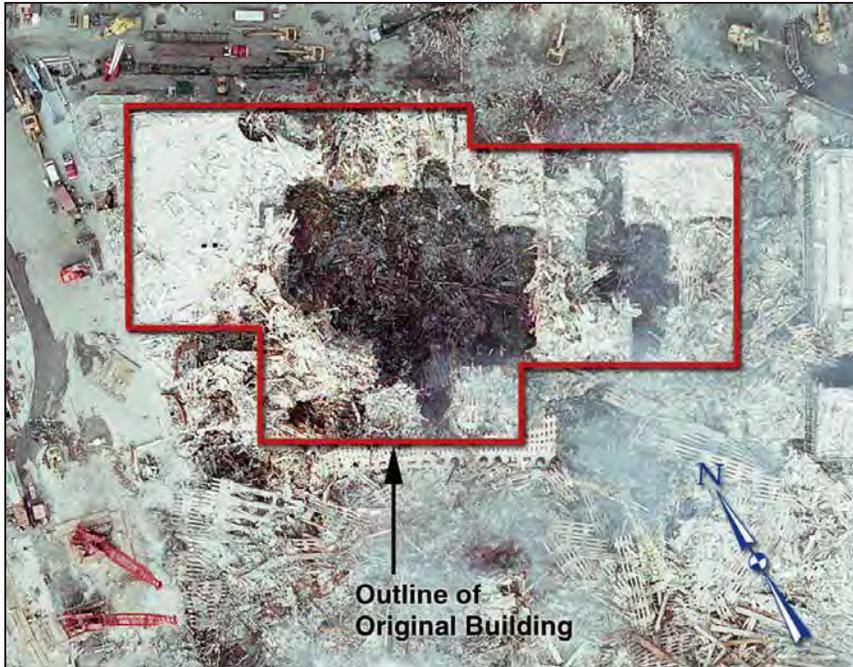
Figure 4-8 Damage to WTC 6. Note the edge of WTC 5 on the right hand side.

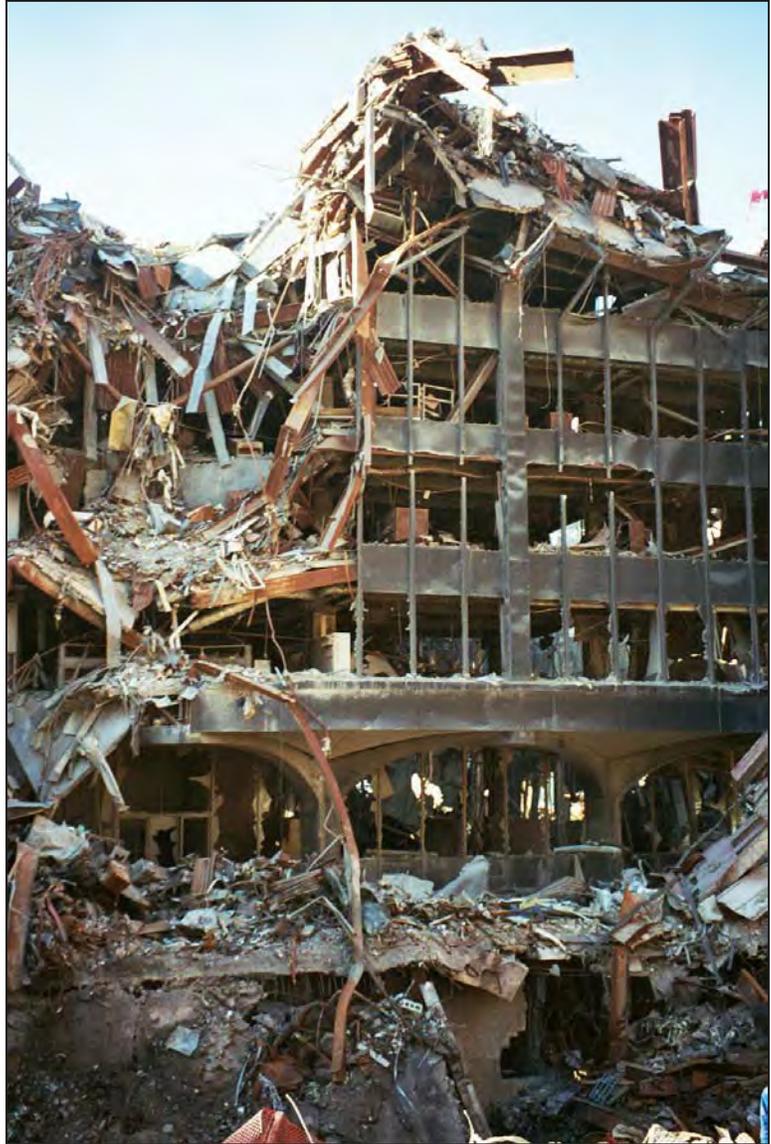
Figure 4-10 Impact damage to the exterior façade of WTC 6.

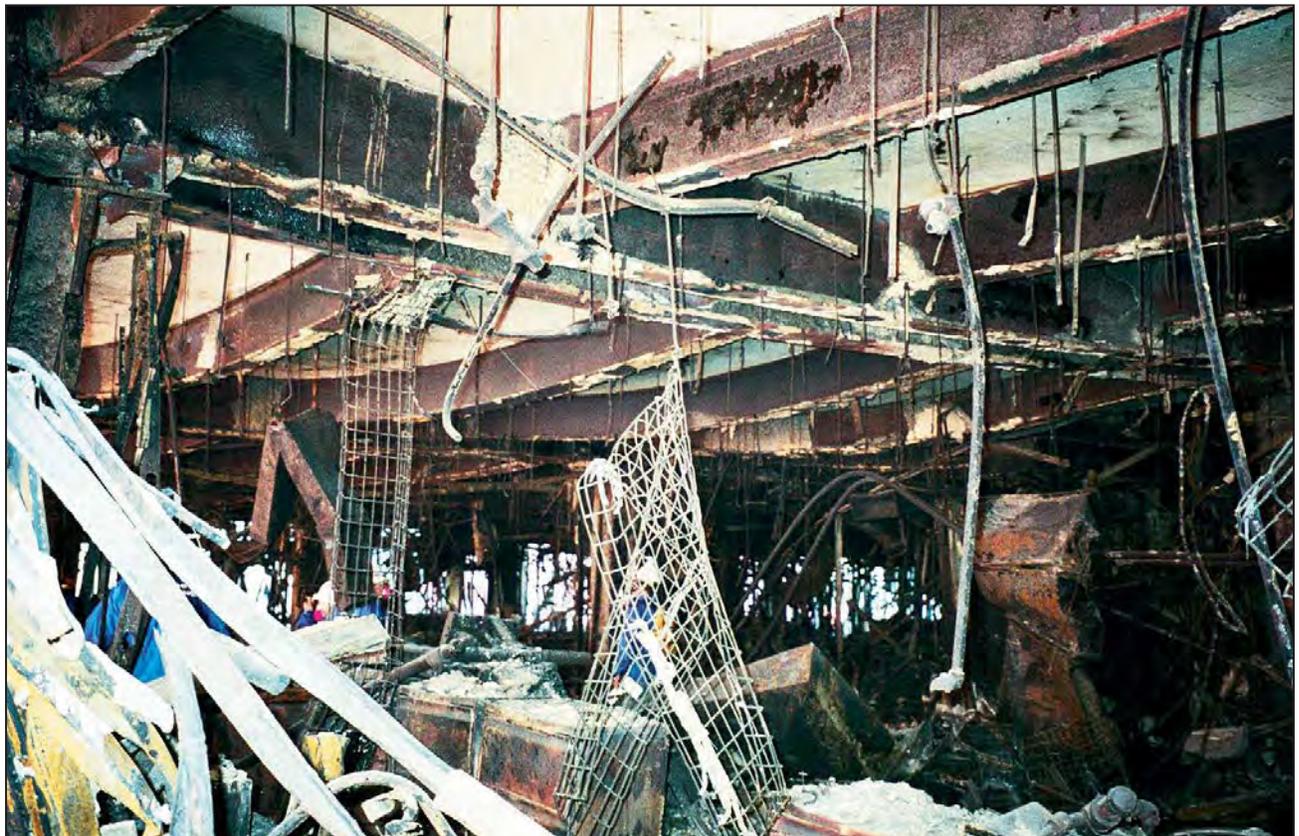
Figure 4-14 Deformed beams in WTC 5.

The steel generally behaved as expected given the fire conditions in WTC 5. Many beams developed catenary action as illustrated in Figure 4-14. Some columns buckled, as shown in Figure 4-17. The one exception is the limited internal structural collapse in WTC 5. The fire-induced failure that led to this collapse was unexpected. As in the rest of the building, the steel beams were expected to deflect significantly, yet carry the load. This was not the case where the beam connections failed. The failure most likely occurred during the heating of the structure because the columns remained straight and freestanding after the collapse.

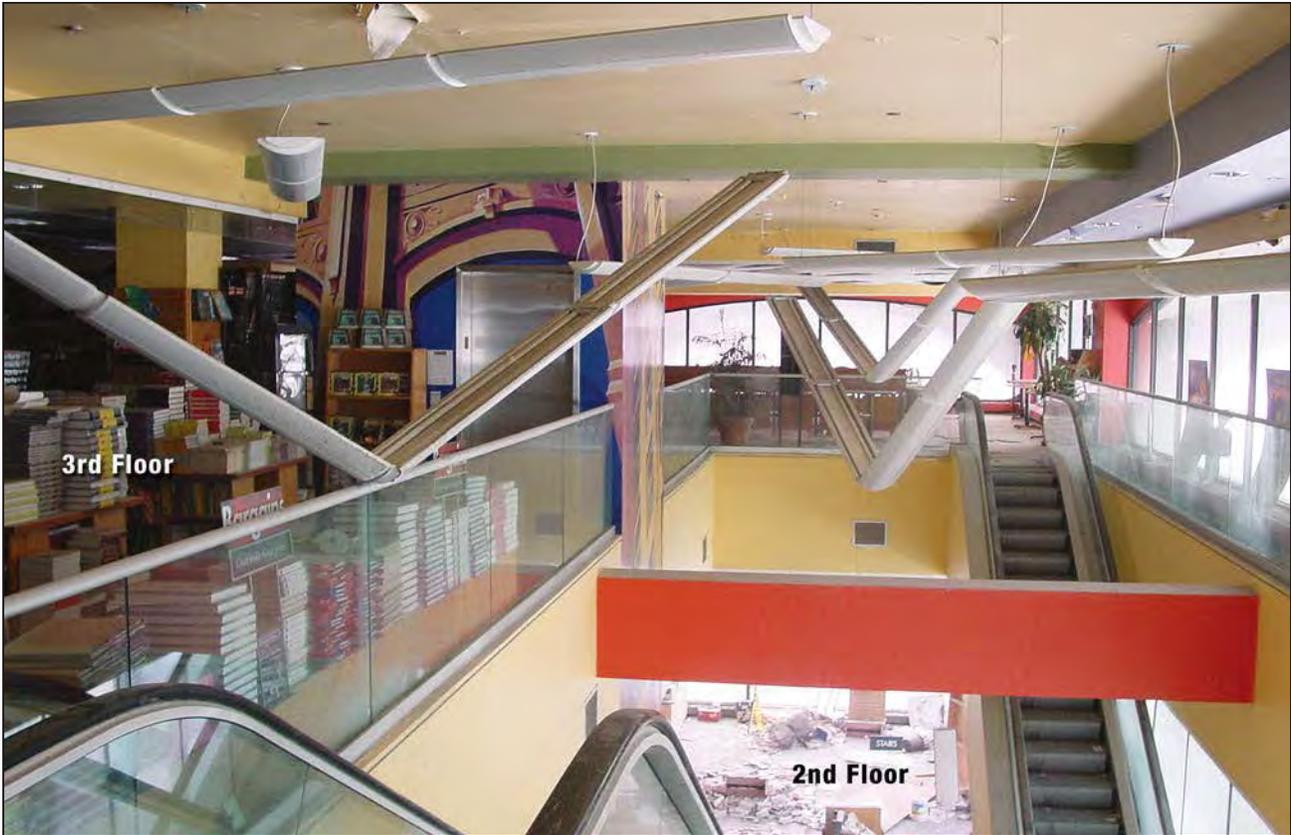
Figure 4-15 Unburned bookstore in WTC 5.

The automatic sprinkler system did not control the fires. Some sprinkler heads fused, but there was no evidence of significant water damage, due to a lack of water. This is consistent with the lack of water damage in the bookstore on the lower level and the complete burnout of the upper floors.

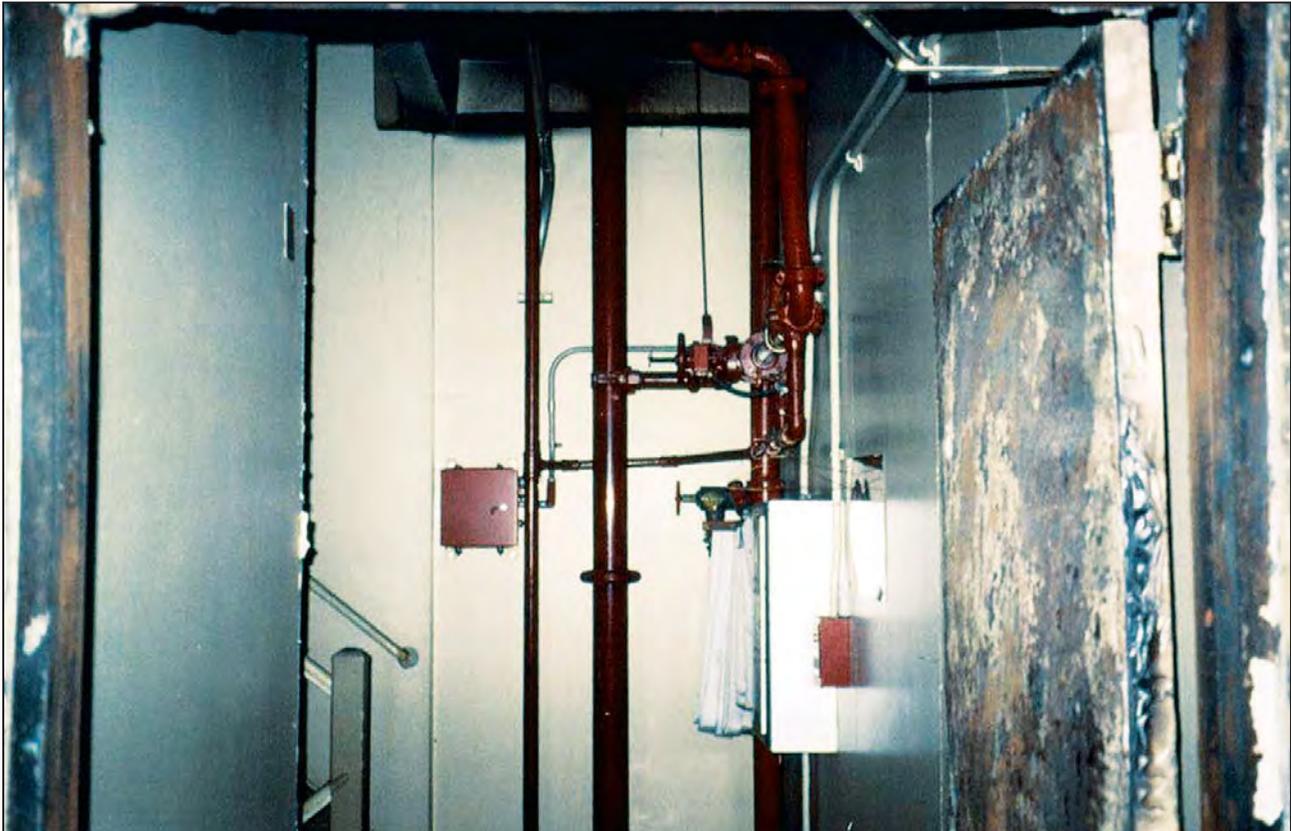
Figure 4-16 Looking through the door into the undamaged stair tower in WTC 5.

All three buildings suffered extensive fire and impact damage and significant partial collapse. The condition of the stairways in WTC 5 indicates that, for the duration of this fire, the fire doors and the fire protective covering on the walls performed well. There was, however, damage to the fire side of the painted fire doors, and the damage-free condition on the inside or stairwell side of those same doors indicates the doors performed as specified for the fire condition that WTC 5 experienced. These stairway enclosures were unusual for buildings that have experienced fire because they were not impacted by water from firefighting operations. In addition, the stairway doors were not opened during the fire and remained latched and closed throughout the burnout of the floors. Therefore, general conclusions regarding the effectiveness of this type of stairway construction may not be warranted.

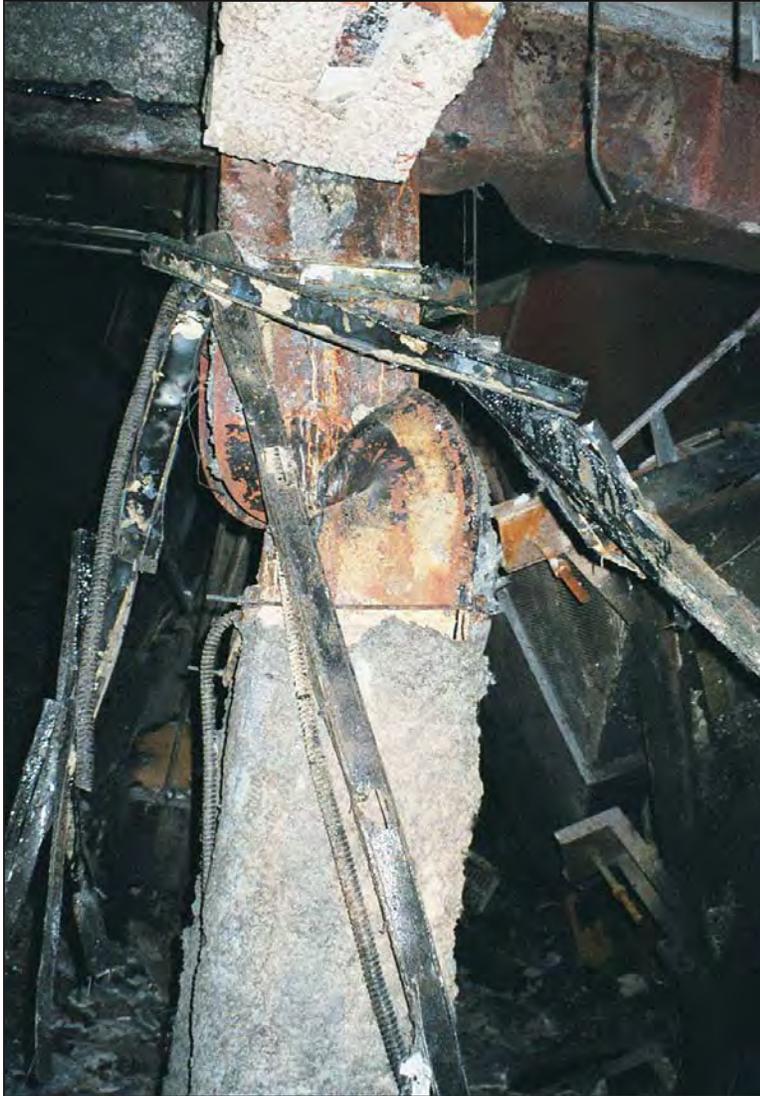
*Figure 4-17*  
*Buckled beam flange and column on the 8th floor of WTC 5 that was weakened by fire.*

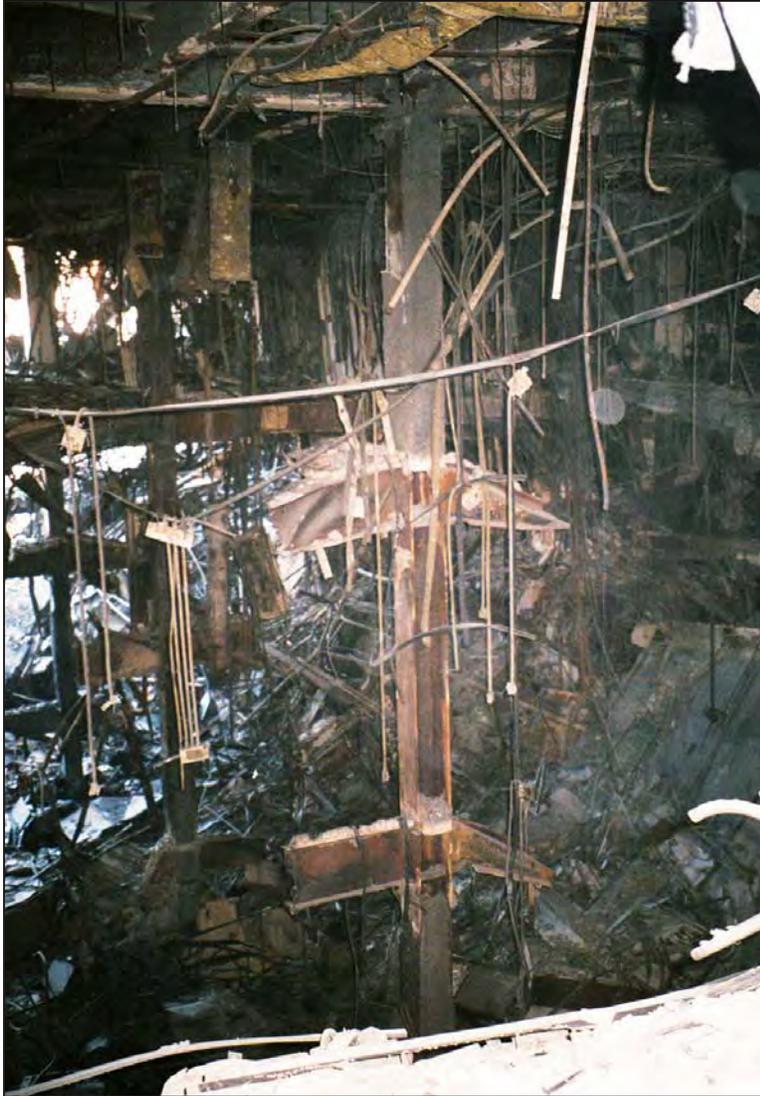
Figure 4-19  
Internal collapsed area in WTC 5.

The structural redundancy provided by the exterior wall pipe columns helped to support the cantilevered floors. This was important because it kept the cantilevers from buckling near the columns as might be expected.

The limited structural collapse in WTC 5 due to fire impact as described in Section 4.3.2 appeared to be caused by a combination of excessive shear loads and tensile forces acting on the simple shear connections of the infill beams. The existence of high shear loads was evident in many of the column tree beam stub cantilevers that formed diagonal tension field failure mechanisms in the cantilever webs, as seen in Figure 4-19.

The end bearing resistance of the beam web was less than the double shear strength of the high-strength bolts. An increased edge distance might have prevented this collapse by increasing the connections' tensile strength. The failure most likely began on the 8th floor and progressed downward, because the 9th floor did not collapse. The 4th floor and those below remained intact.

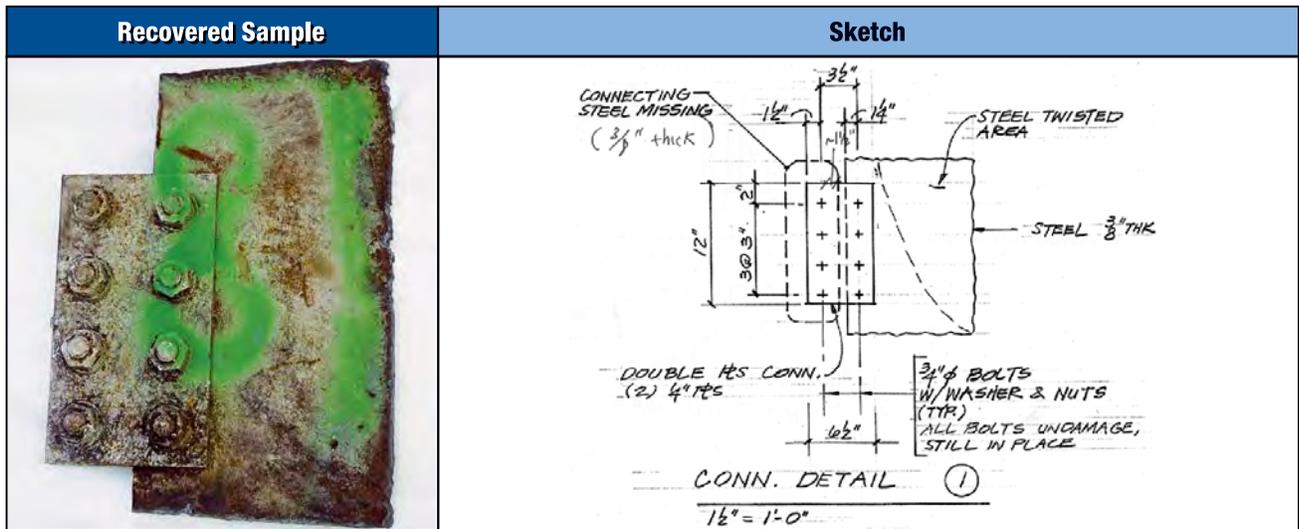
Recovered From: WTC 5, 8<sup>th</sup> Floor

Steel framing connection samples were recovered from floors 6, 7, and 8 of WTC 5 with the aid of the New York Department of Design and Construction (DDC) and are described in Figure 4-22. These samples have not been analyzed and are being preserved for future study. The photographs of connection samples in Figure 4-22 indicate that the deformed structure subjected the bolted shear connection to a large tensile force. At 550 °C (1,022 °F), the ultimate resistance of the three bolts is about 45 kips. The capacity increases to approximately 90 kips at room temperature. Connection failure likely occurred between these bounds.

Failure Mode: Web tear-out at bolts

- There is insufficient understanding of the performance of connections and their adequacy under real fire exposures as discussed in Appendix A. This is an area that needs further study. The samples discussed in Section 4.3.2 should be useful in such a study.
- A determination of the combined structural and fire properties of the critical structural connections should be made to permit prediction of their behavior under overload conditions. This can be accomplished with a combination of thermal transfer modeling, structural finite element modeling (FEM), and full-scale physical testing.

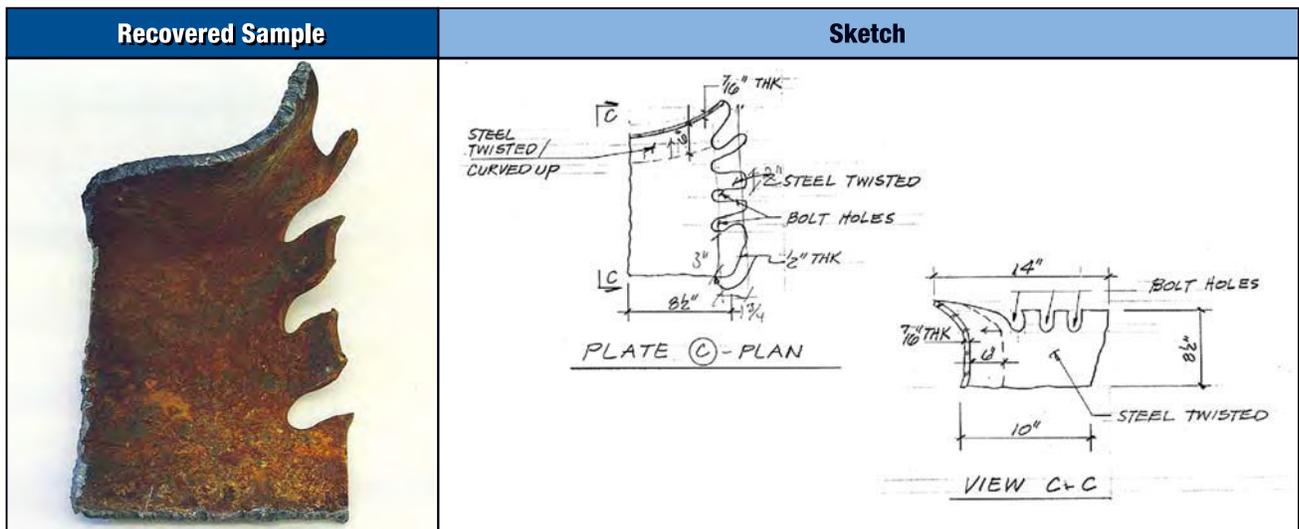
Recovered From: WTC 5, 7<sup>th</sup> Floor

Failure Mode: Web tear-out at bolts

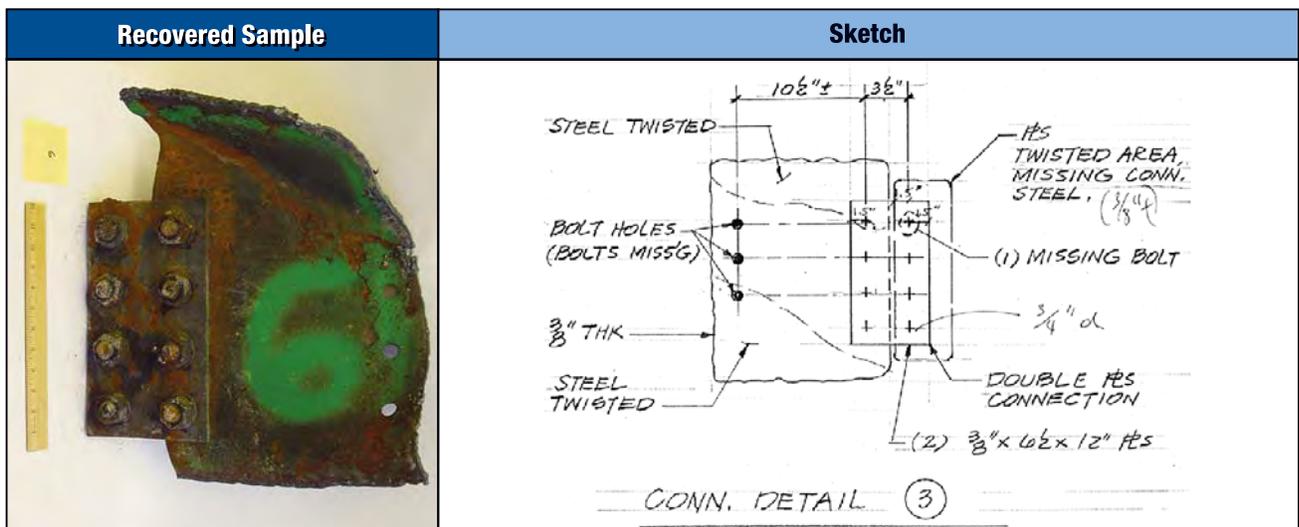
Recovered From: WTC 5, 6<sup>th</sup> Floor

Failure Mode: Web tear-out at bolts

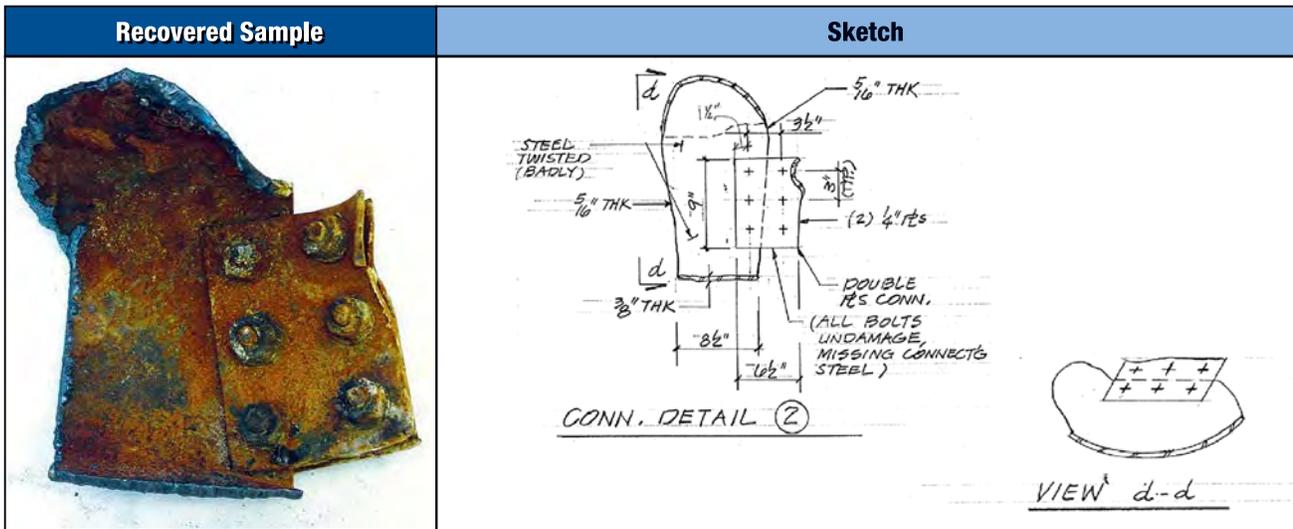
Recovered From: WTC 5, 6<sup>th</sup> Floor

Failure Mode: Web tear-out at bolts

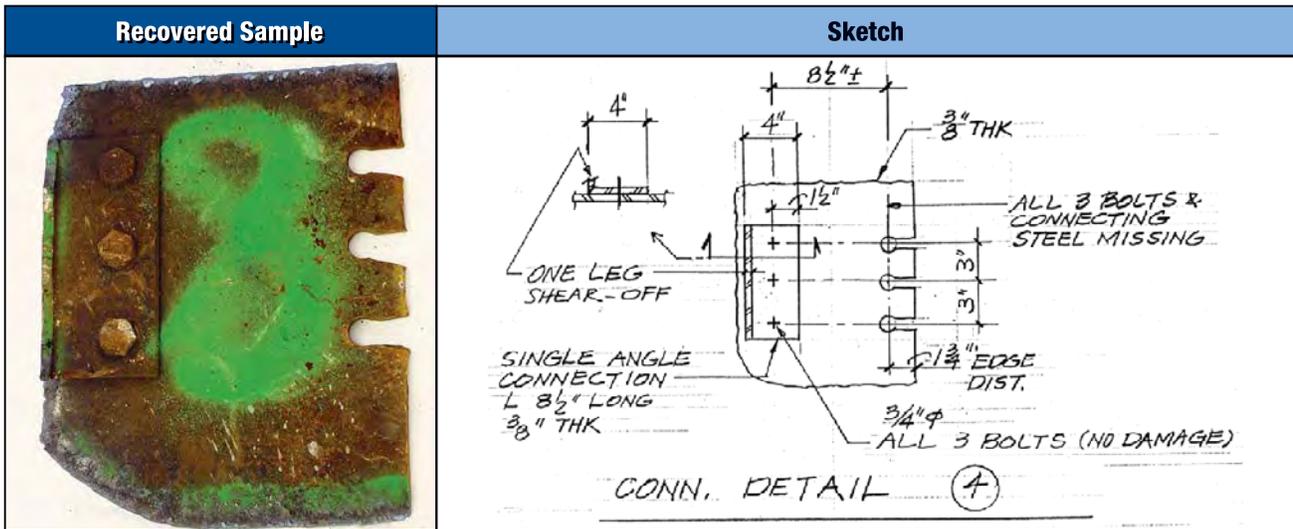
Recovered From: WTC 5, 8<sup>th</sup> Floor

Failure Mode: Plate tear-out at bolts

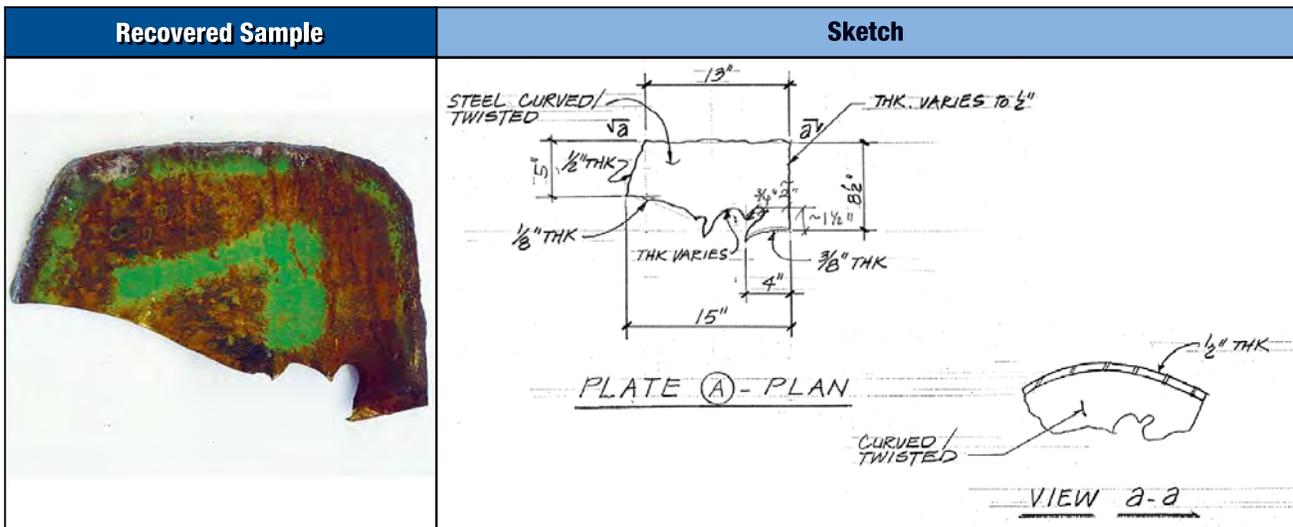
Recovered From: WTC 5, 7<sup>th</sup> Floor

Failure Mode: Connection web plate or splice block shear

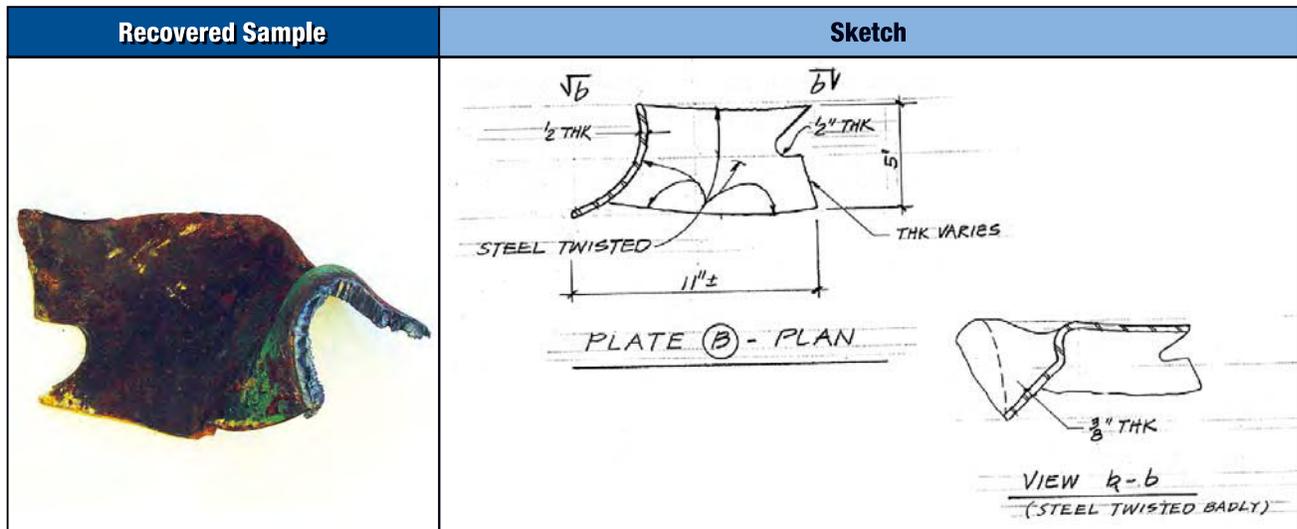
Recovered From: WTC 5, Floor undetermined

Failure Mode: Column buckling due to heat exposure

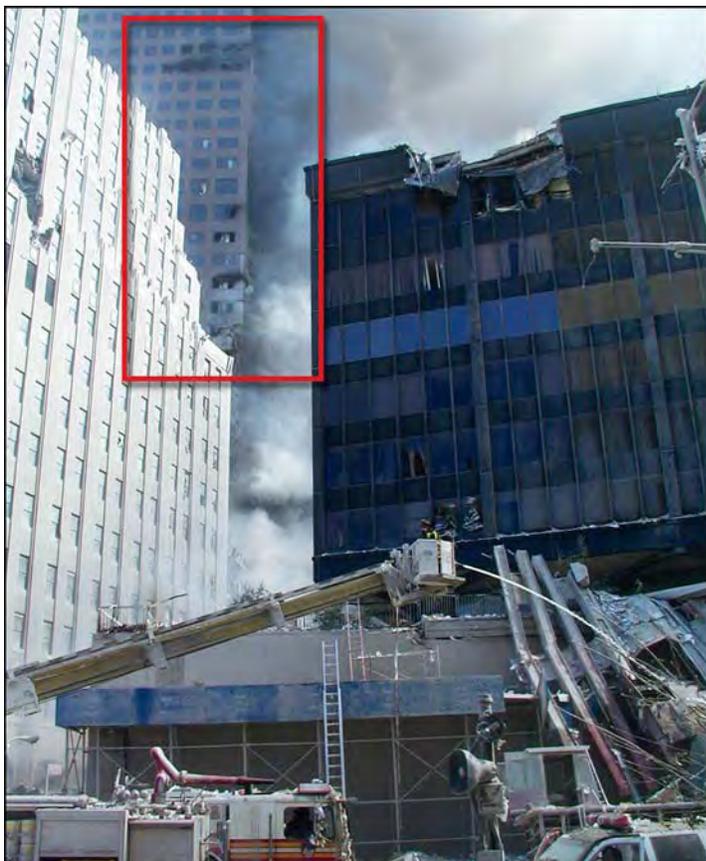
It does not appear that the collapse of WTC 1 affected the roof, or the east, west, and north elevations of WTC 7 in any significant way. However, there was damage to the southwest corner of WTC 7 at approximately floors 8 to 20, 24, 25, and 39 to 46, as shown in Figure 5-16, a photograph taken from West Street.

Figure 5-16  
Damage to southwest corner of WTC 7 (see box),  
looking from West Street.

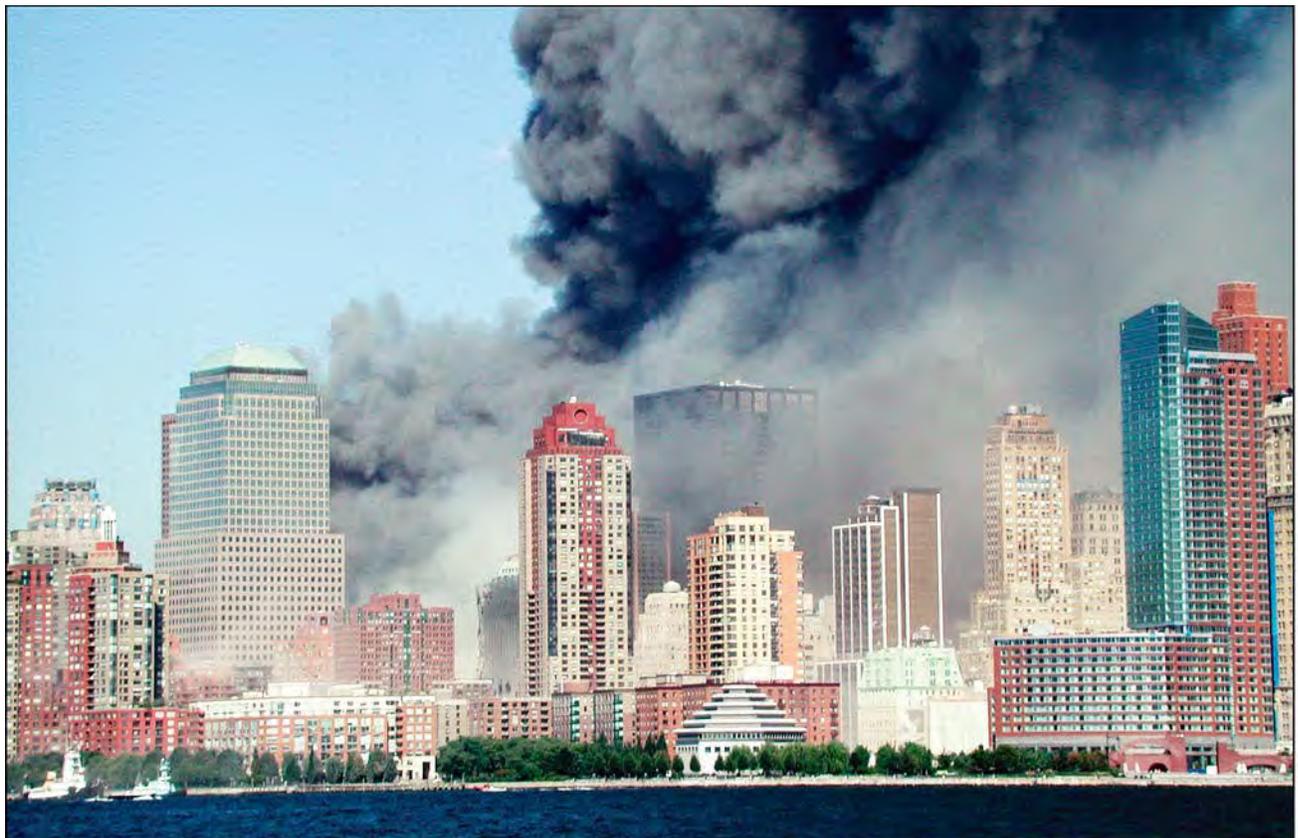
News coverage after 1:30 p.m. showed light-colored smoke flowing out of openings on the upper floors of the south side of the building. Another photograph (Figure 5-18) of the skyline at 3:25 p.m., taken from the southwest, shows a large volume of dark smoke coming from all but the lowest levels of WTC 7, where white smoke is emanating. The mode of fire and smoke spread was unclear; however, it may have been propagated through interior shafts, between floors along the south façade that may have been damaged, or other internal openings, as well as the floor slab/exterior façade connections.

*Figure 5-18 WTC 7, with a large volume of dark smoke rising from it, just visible behind WTC 1 (left). A much smaller volume of white smoke is seen rising from the base of WTC 7. Note that the lower, lighter-colored smoke (to right) is thought to be from the two collapsed towers*

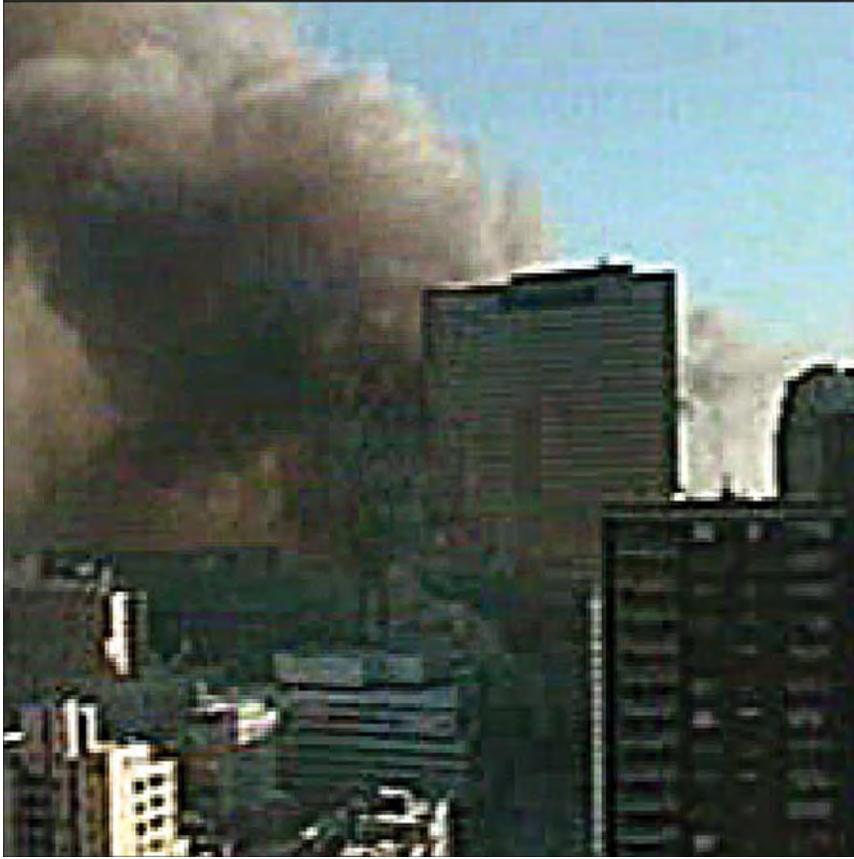
**~5:21:03 p.m.** Approximately 30 seconds later, Figure 5-21 shows the east mechanical penthouse disappearing into the building. It takes a few seconds for the east penthouse to “disappear” completely.

*Figure 5-21  
East mechanical penthouse collapsed.  
(From video.)*

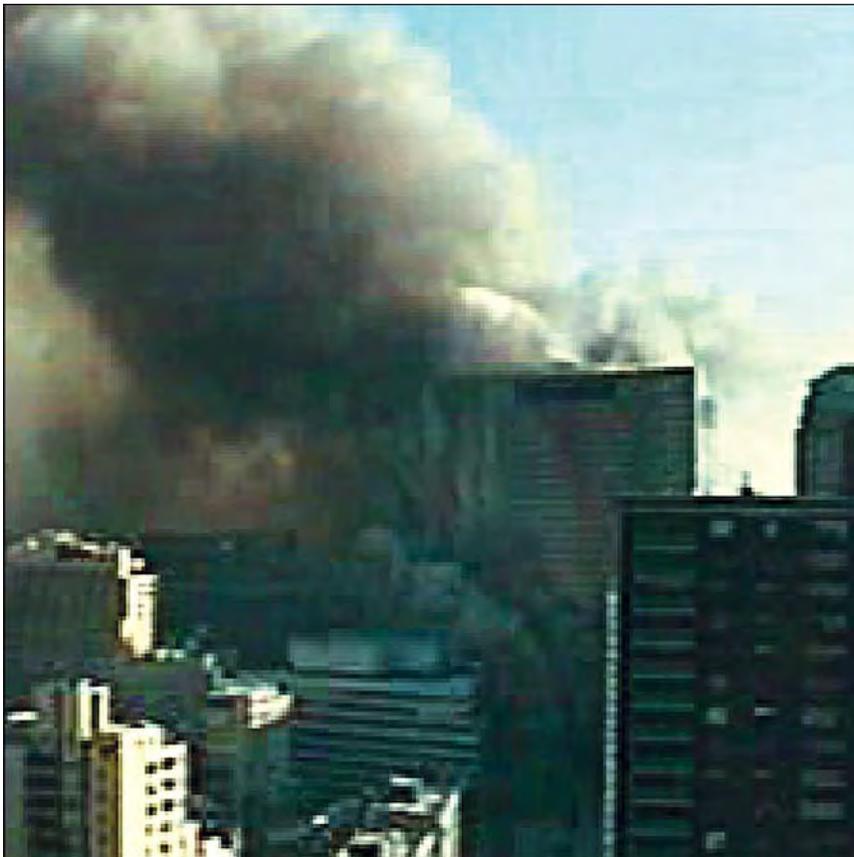
**~5:21:08 p.m.** Approximately 5 seconds later, the west mechanical penthouse disappears (Figure 5-22) or sinks into WTC 7.

*Figure 5-22  
East and now west mechanical  
penthouses gone. (From video.)*

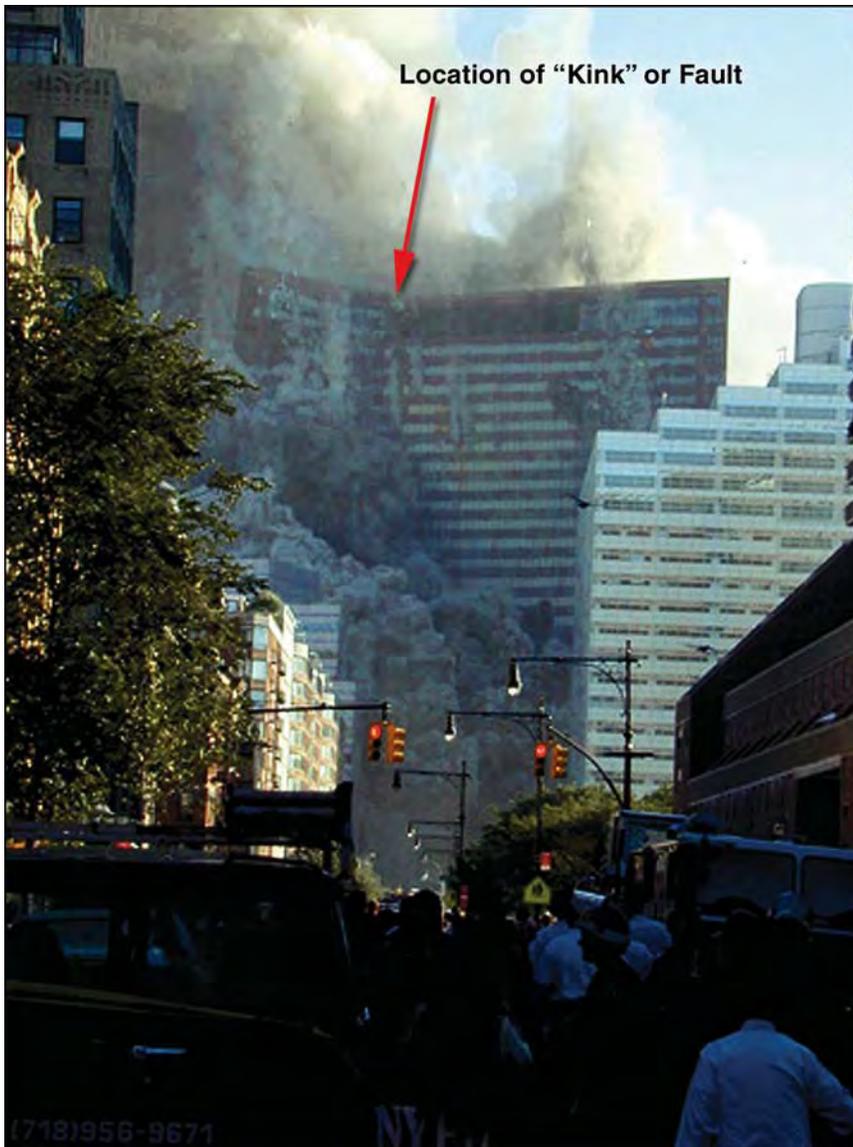
**~5:21:09 p.m.** Approximately 1 or 2 seconds after the west penthouse sinks into WTC 7, the whole building starts to collapse. A north-south “kink” or fault line develops along the eastern side as the building begins to come down at what appears to be the location of the collapse initiation (see Figures 5-23 and 5-24).

Figure 5-23  
View from the north of the "kink" or fault developing in WTC 7.

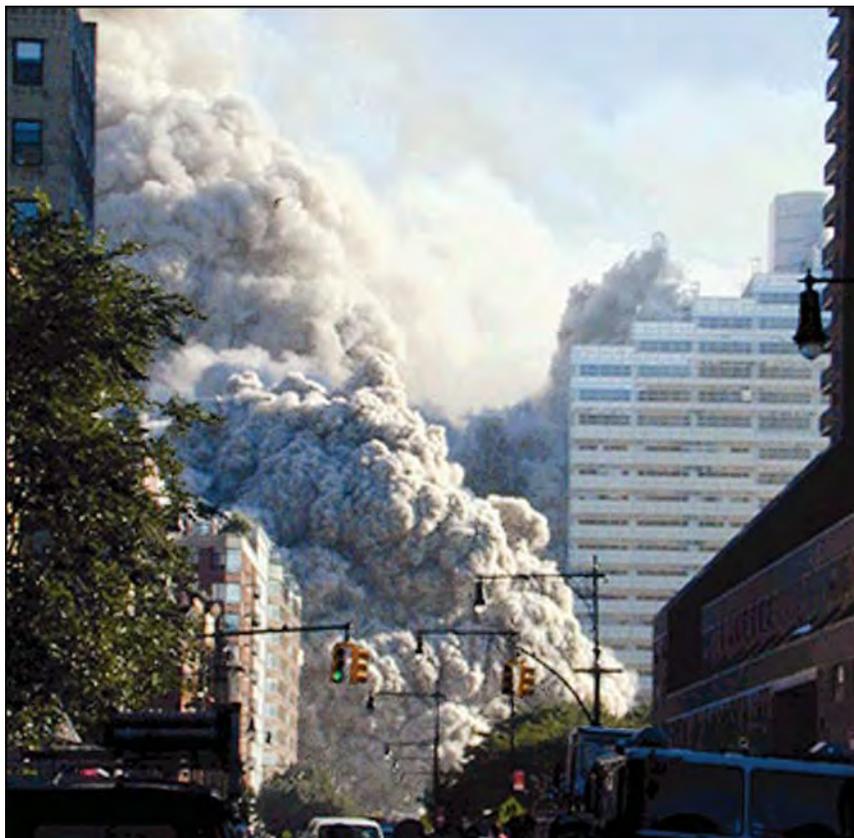
**~5:21:10 p.m.** WTC 7 collapses completely after burning for approximately 7 hours (Figure 5-25). The collapse appeared to initiate at the lower floors, allowing the upper portion of the structure to fall.

Figure 5-25 Debris cloud from collapse of WTC 7.

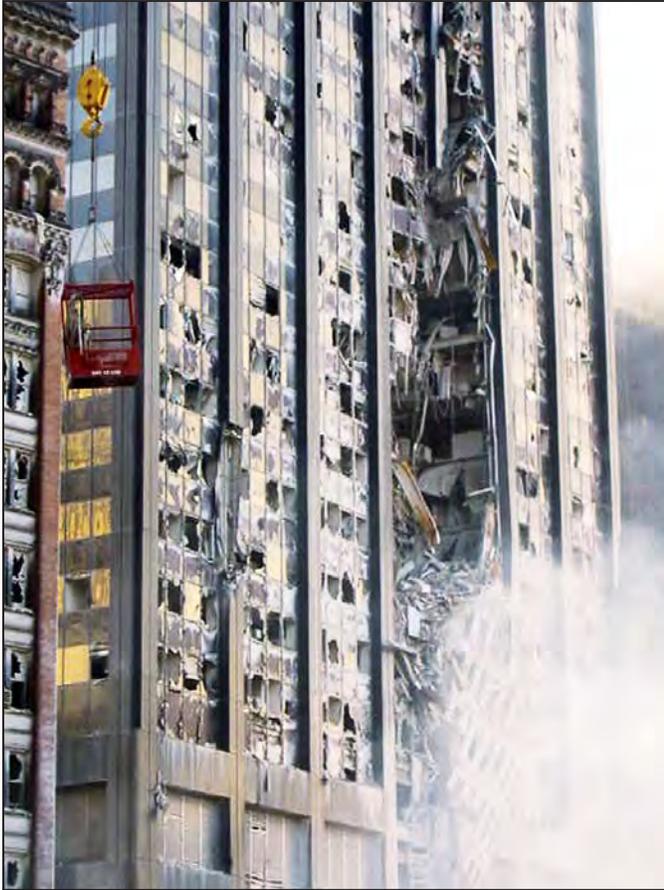
*Figure 6-1  
North face of Bankers Trust building with impact damage  
between floors 8 and 23.*

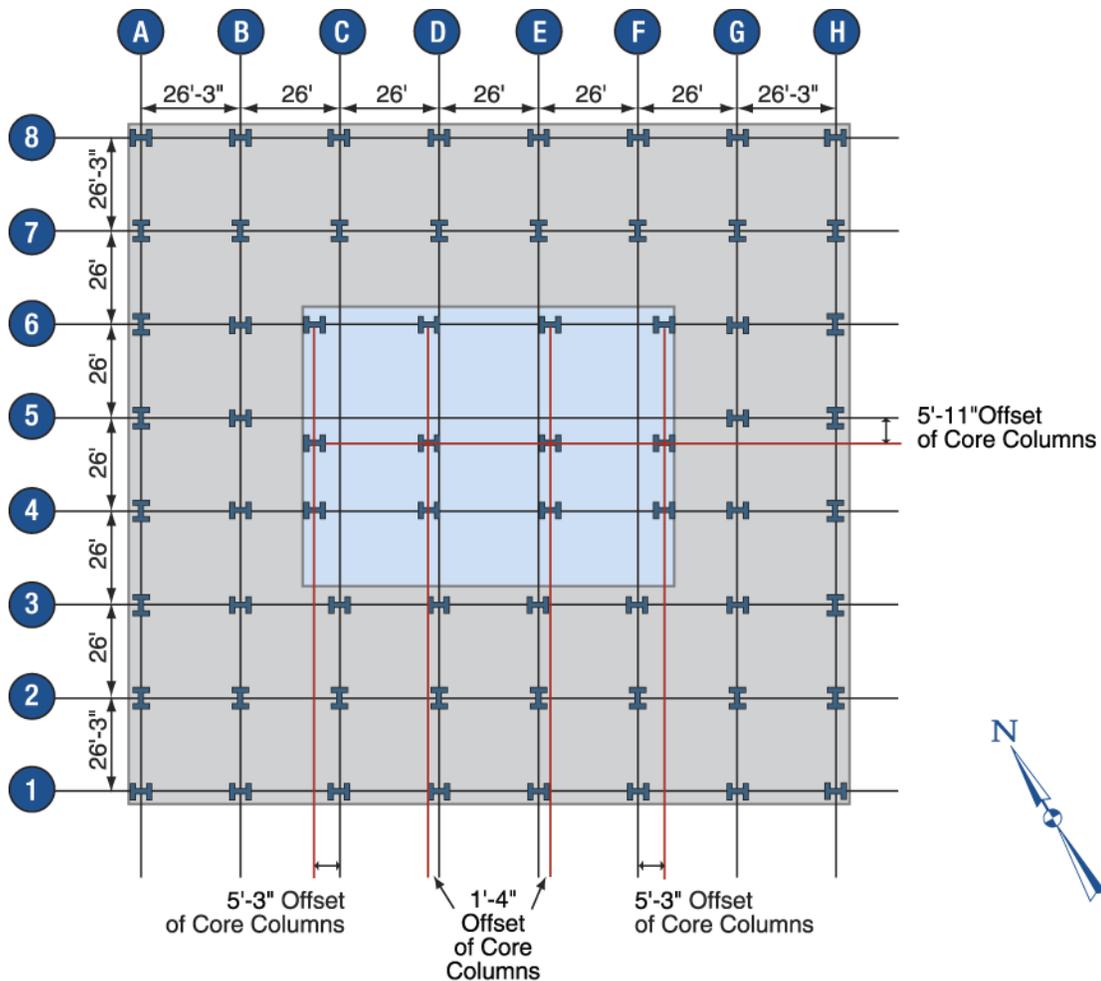
Figure 6-3 Floor plan above the 2nd level (ground floor extension not shown).

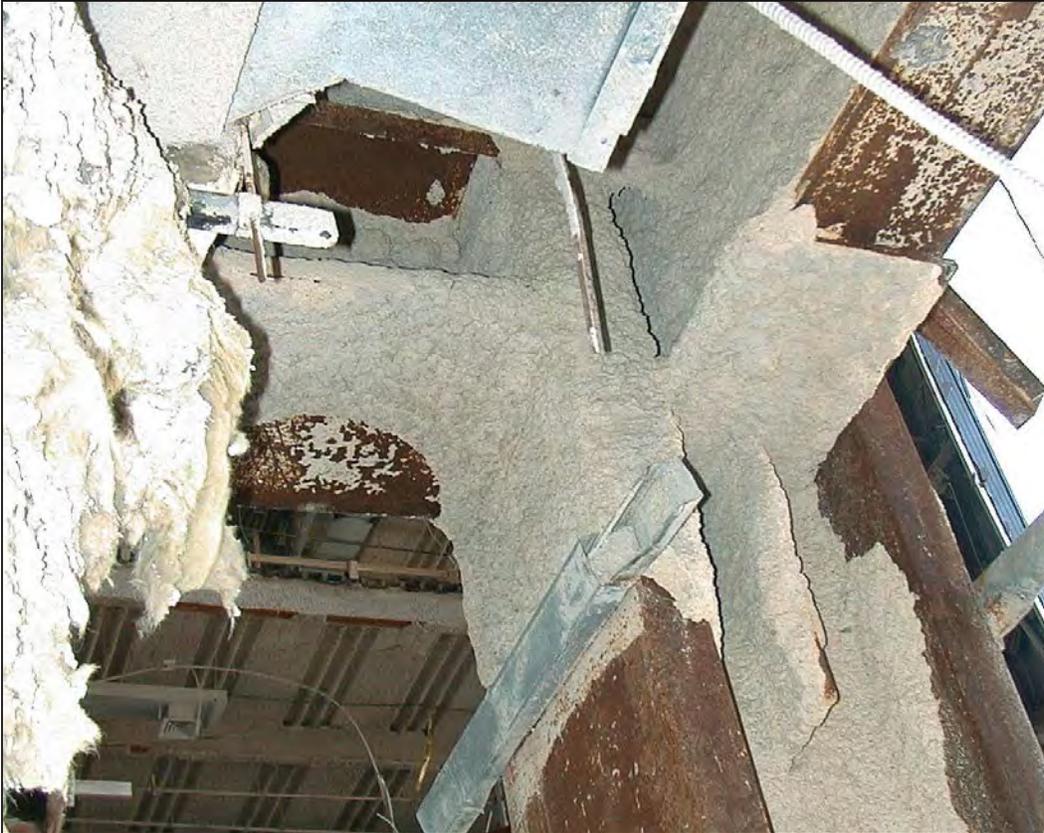
Figure 6-6 *Moment-connected beams to columns.*
