# World Trade Center Building Performance Study:

*Data Collection, Preliminary  
Observations, and  
Recommendations*

**Federal Emergency Management Agency**

FEMA 403 / September 2002

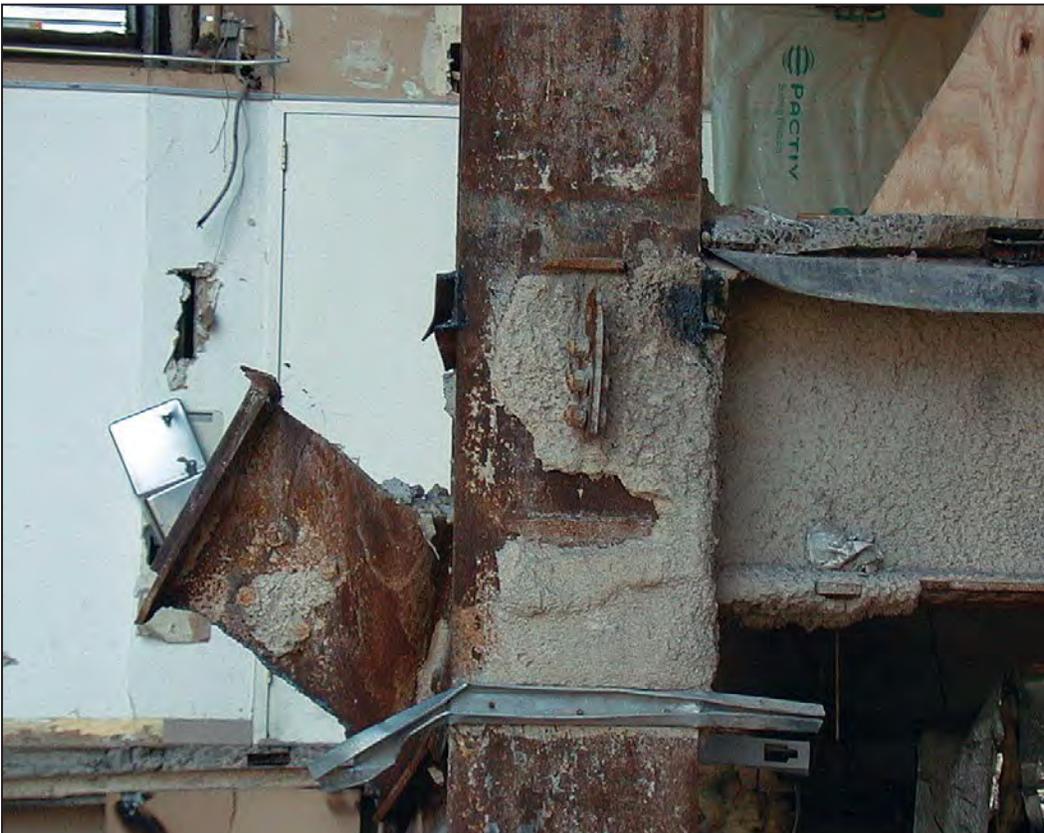
Figure 6-7 *Column with the remains of two moment connections.*

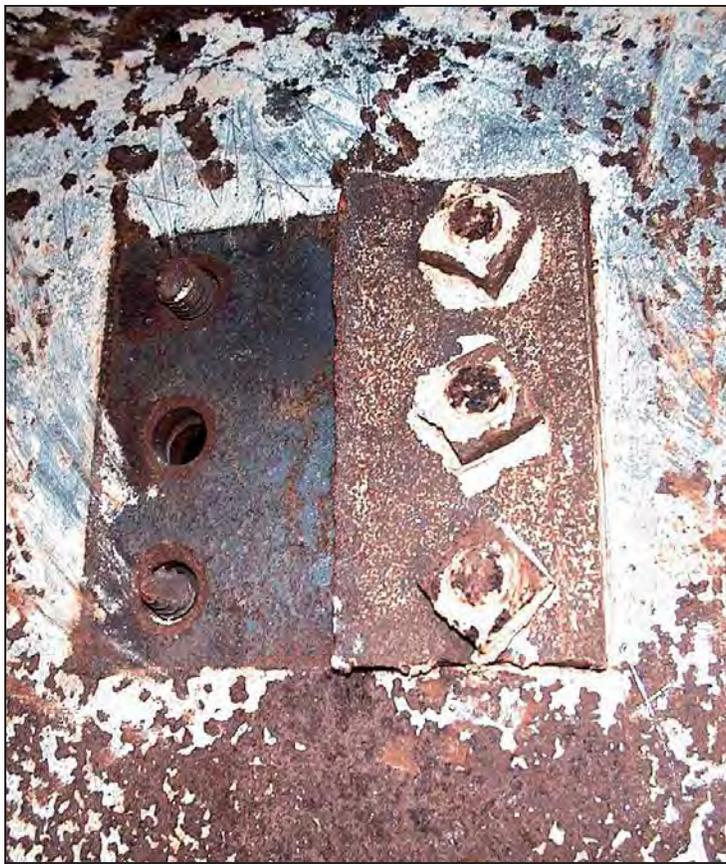
Floor-beam-to-girder connections typically used a partial-depth end plate welded to the floor beam web and bolted to the girder with A307 bearing bolts. Typically, failure occurred in one of two modes, either the bolts were overloaded in tension and the connection pulled off, or the partial end plate sheared at or near the weld line. At most of the connections, it appears there was some amount of bolt failure. Figure 6-8 shows a shear connection with half of the end plate remaining in place.

*Figure 6-8*  
*Failed shear connection of beam web to column web.*

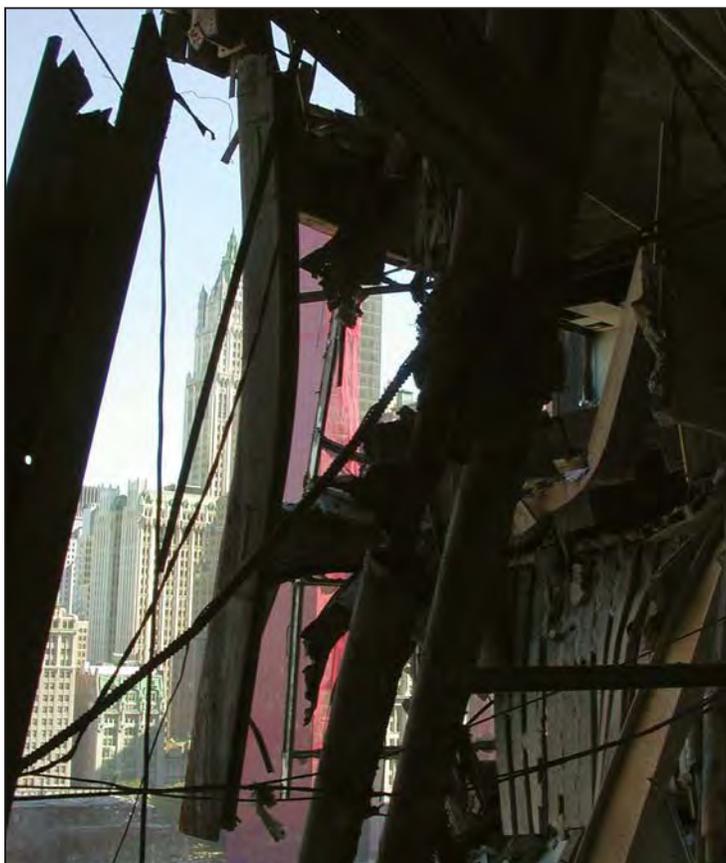
Column splices are typically located at every second floor and are composed of thin splice plates bolted to the column flanges. Large axial tension loads were probably not a design condition for the column splices, and the splice plates appear to be minimal in thickness, offering little resistance to separation. The D-8 column splices at the 18th and 16th floors appear to have been overloaded, leaving a section of column suspended from the spandrels at floors 16 through 18. The column below this level and down to the 8th

*Figure 6-9*  
*Suspended column D-8 at the 15th floor. Note separation at column splices.*

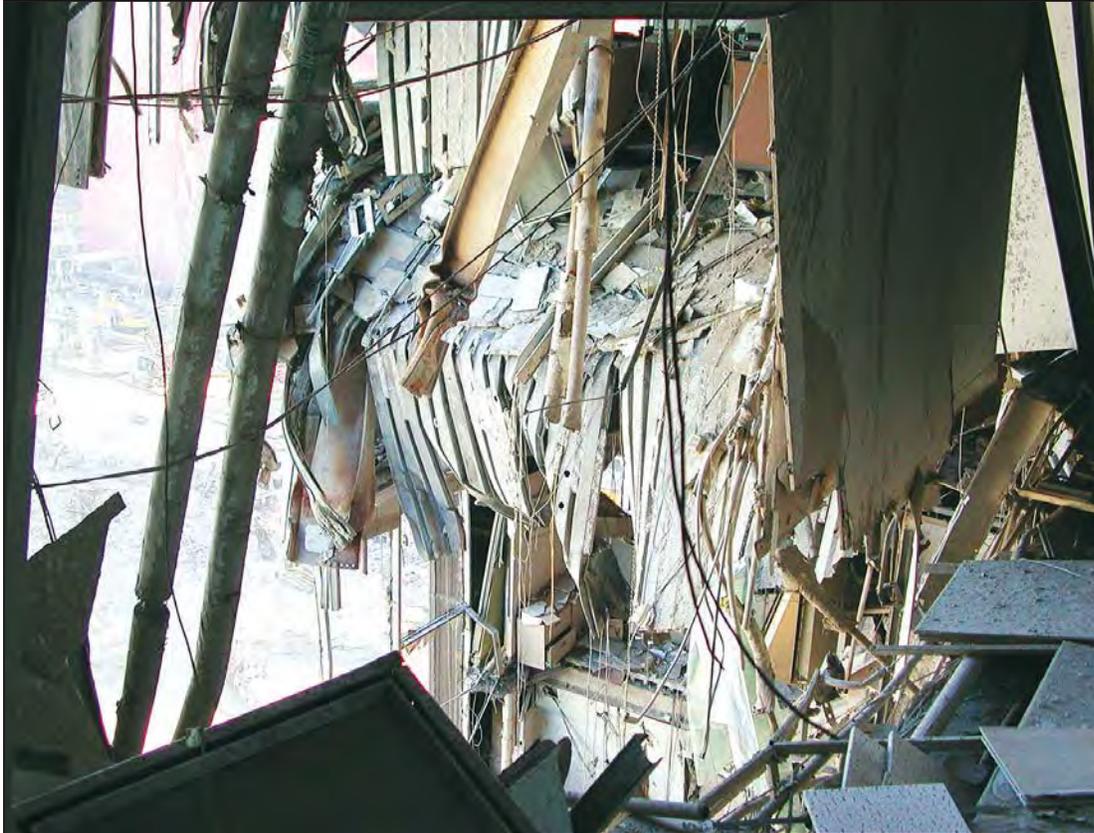
*Figure 6-10 Area of collapsed floor slab in bays between C-8, E-8, C-7, and E-7, from the 15th floor.*

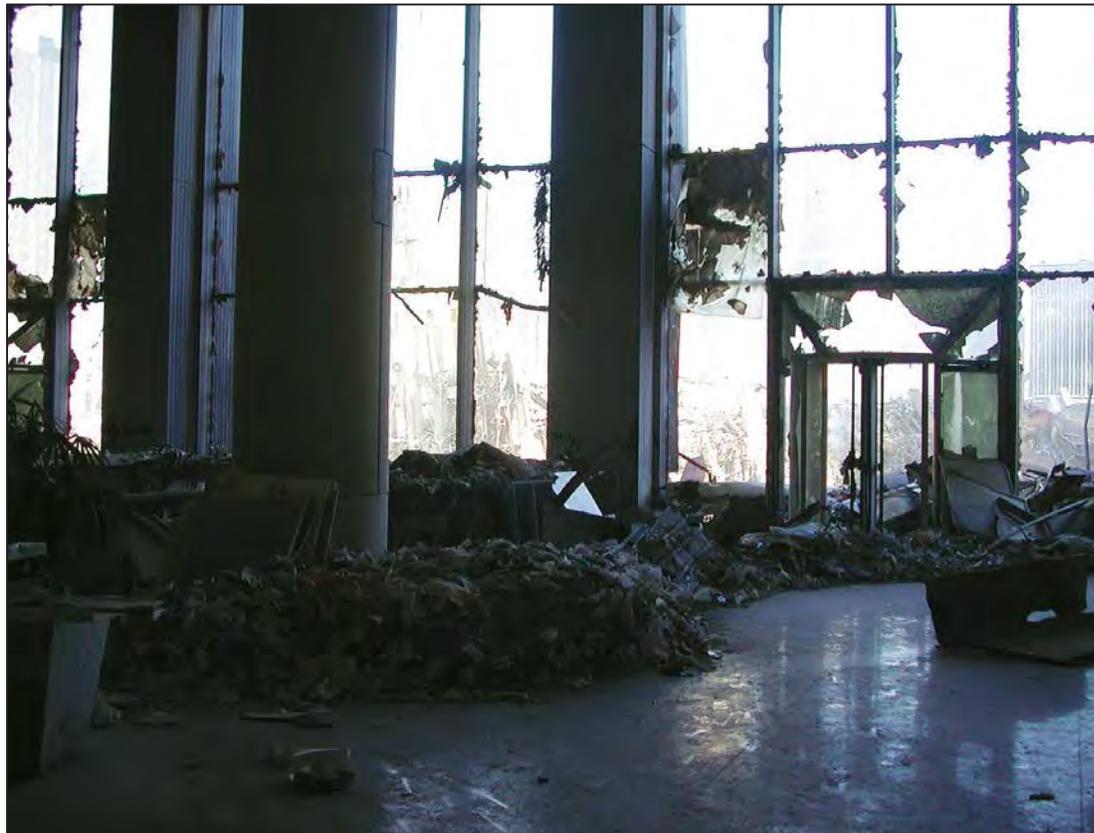
As the spandrel connections failed and the floor slabs collapsed, a portion of the rubble accumulated into a two-story pile while the remainder fell out of the building onto the low-rise roof on the north side of the building. The impact debris finally came to rest on the two-story-deep pile of debris that was on the 8th floor. Figures 6-9 and 6-10 illustrate the damage. A major component of WTC 2, approximately 40 feet tall by 30 feet wide, remained lodged in the debris pile and was clearly visible as it hung from the face of the building. Yet despite this weight, the floor supporting the debris deflected a maximum of 6 inches. Figure 6-11 shows the extent of debris in the lobby of the building.

*Figure 6-11 Bankers Trust lobby (note debris has been swept into piles).*

After the exterior glazing was penetrated by the debris, the dust cloud resulting from the collapse of the towers deposited a layer of dust an inch or more thick throughout the northern part of the building. The 2nd floor lobby area had extensive broken glass, general debris, and dust (Figure 6-11). Figure 6-12 shows a typical office near the collapsed area at the 8th floor.

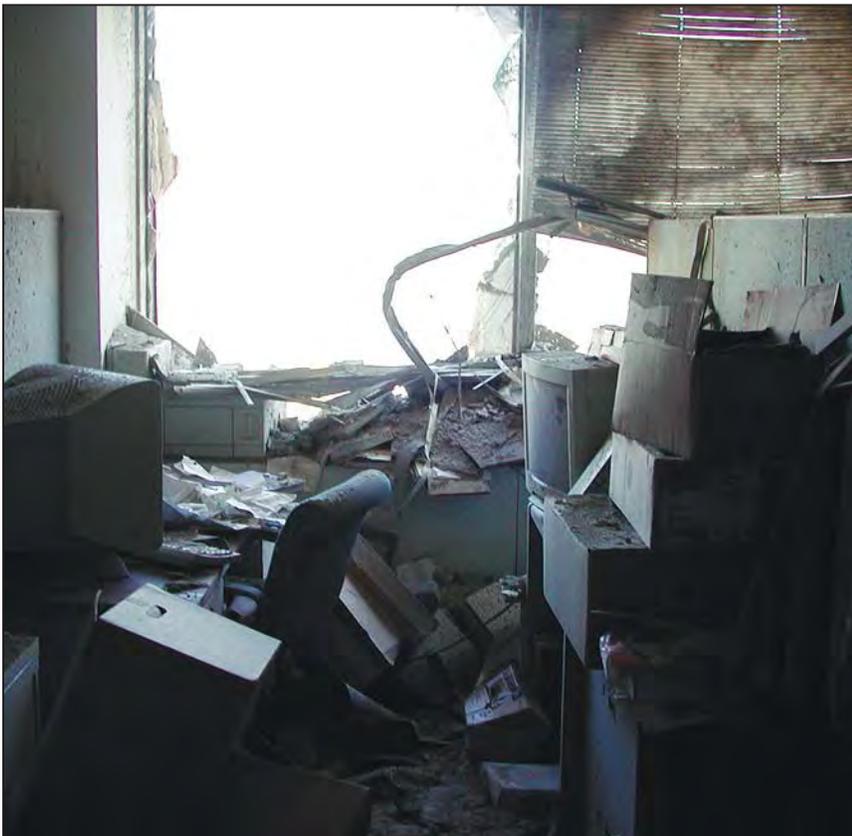
*Figure 6-12*  
*Office at the north side of the 8th floor.*

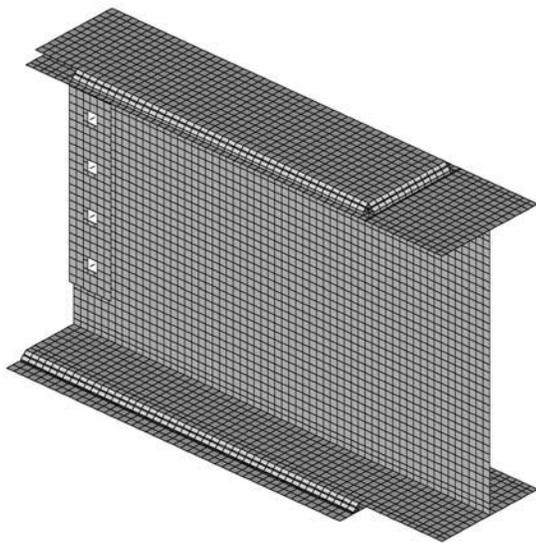
Both connections were modeled in three dimensions in ANSYS, using shell, beam, and continuum elements. All weld material was simulated with a bilinear kinematic hardening material with brittle fracture capabilities at a specified ultimate strain. Figures 6-13 and 6-14 illustrate the details of the finite element models of the two different connection details.

Figure 6-13  
3-D ANSYS model of flange and shear plate moment connection.

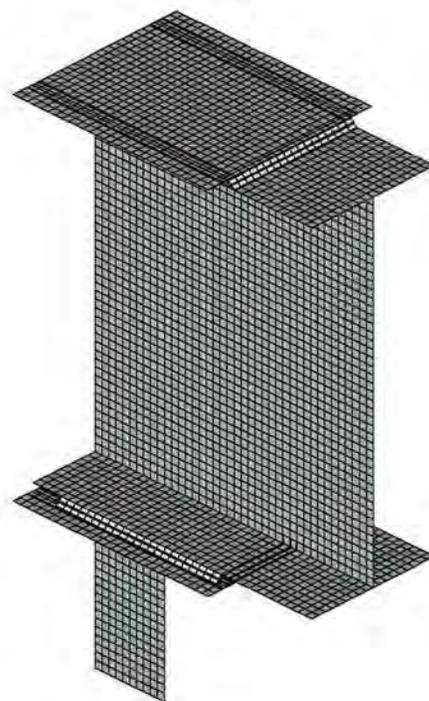
Figure 6-14  
3-D ANSYS model of flange and seat moment connection.

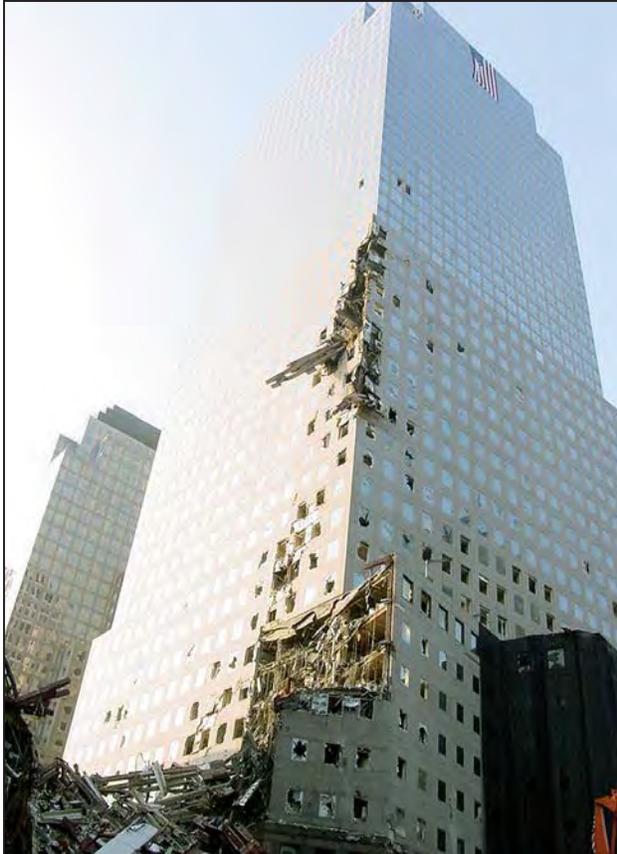
The 50-story WFC 3 building has a plan area of approximately 200 feet by 250 feet. Exterior column trees from WTC 1 were found hanging from the southeast corner of WFC 3 (Figure 7-2) and on the setback roof and against the east face of the Winter Garden (Figures 7-3 and 7-4). The impact of exterior column trees caused structural damage in both structures. Building faces not directly oriented toward the WTC site suffered minimal damage, even at the close proximity of several hundred yards.

Figure 7-2 Southeast corner of WFC 3.

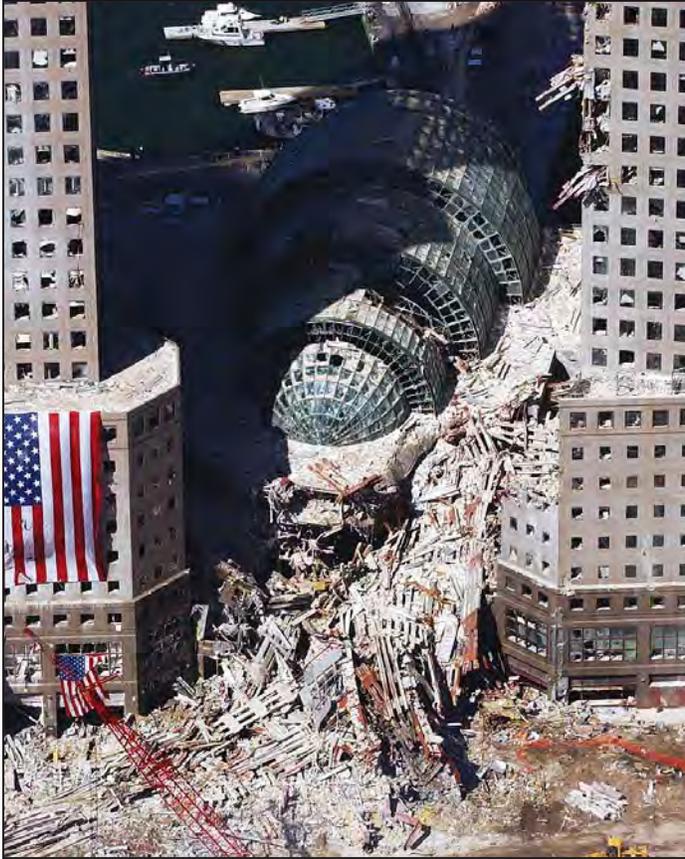
*Figure 7-3*  
View of Winter Garden damage from West Street, with WTC 1 debris in front of WFC 2.

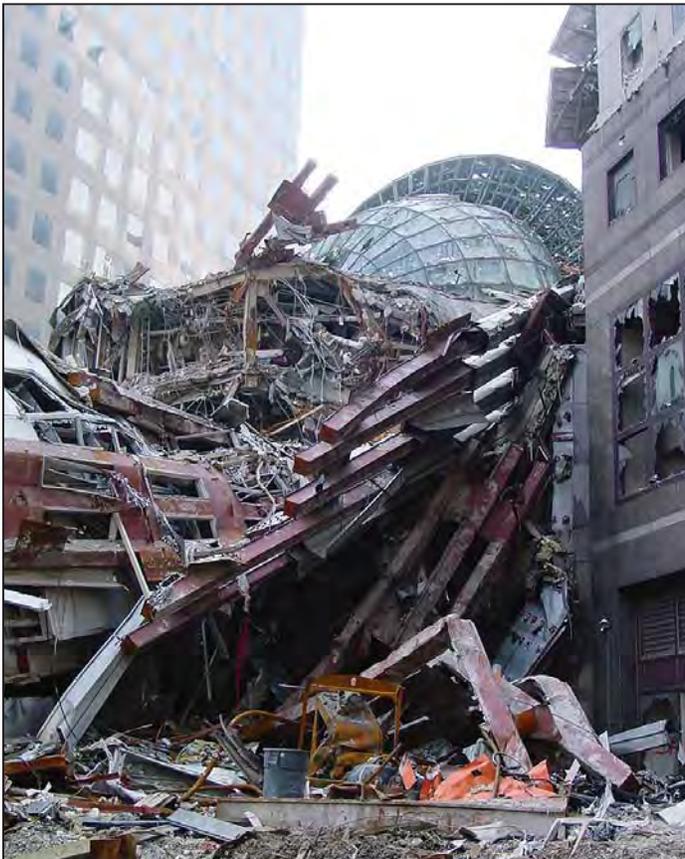
*Figure 7-4*  
View of Winter Garden damage from West Street, with WTC 1 debris leaning against WFC 3.

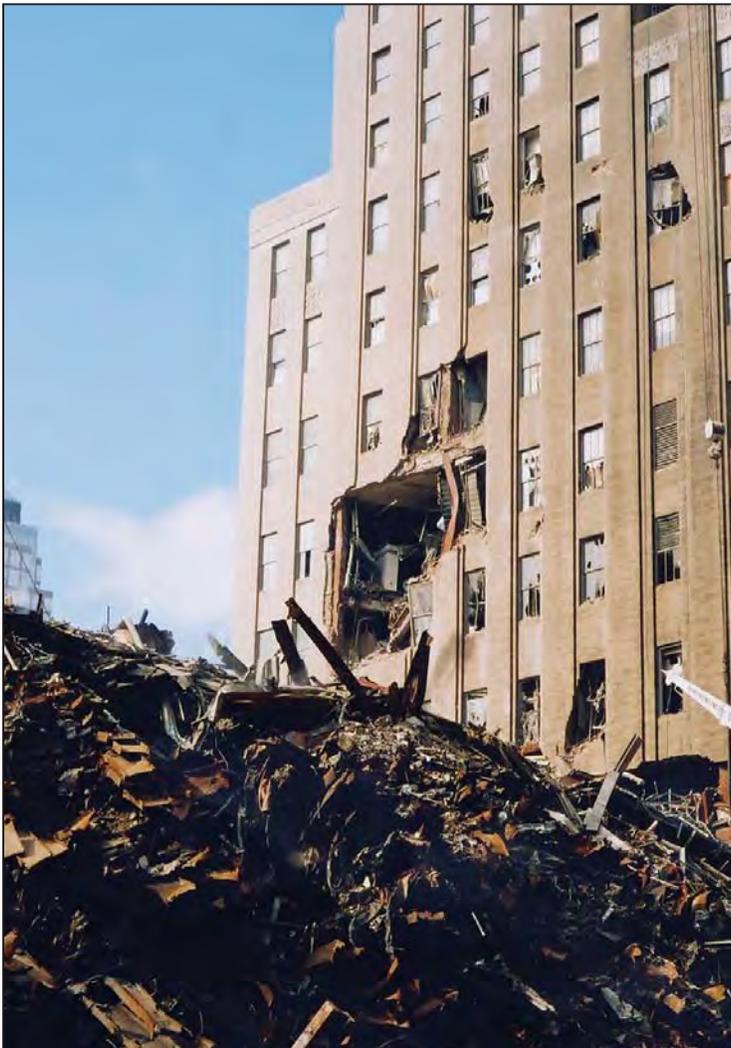
The east (Washington Street) side of the building was damaged from about the 9th floor down, primarily due to the impact of debris sliding out from the base of WTC 7 (Figures 7-6, 7-7, and 7-8). Some damage may have also been caused by WTC 1 debris. In addition to fairly extensive façade damage (bricks and windows), there was damage to two bays of slab and framing at the 1st, 4th, and 7th floors and to one

*Figure 7-6*  
*Verizon building – damage to east elevation*  
*(Washington Street).*

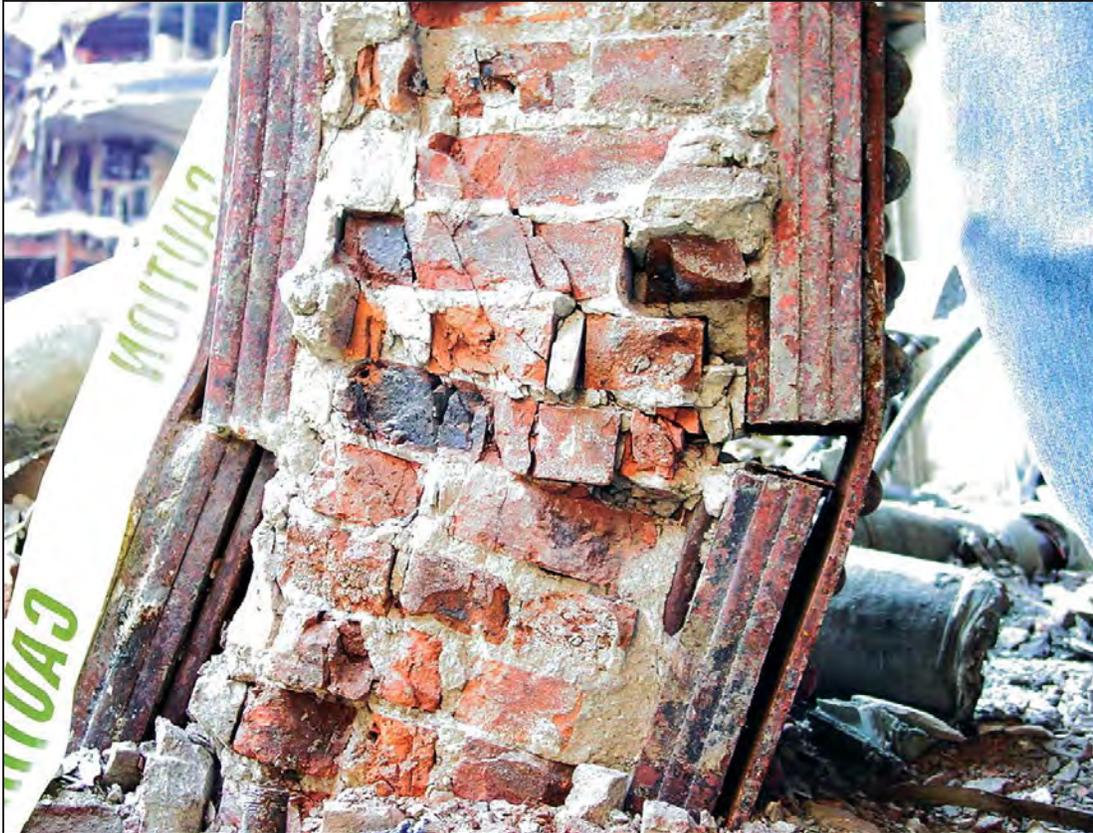
bay of slab and framing (including spandrel beam) at the 1st floor mezzanine and at the 5th floor. Two exterior columns suffered major damage between the 1st and 2nd floors (Figure 7-9), one exterior column suffered minor damage between the 3rd and 5th floors, and two exterior columns suffered major damage between the 6th and 8th floors. In addition, one interior column suffered minor damage below the 7th floor.

Figure 7-9 Verizon building – column damage on east elevation (Washington Street).

On the east (Washington Street) side of the building, most of the damage appeared to be due to the lateral pressure of the spreading debris at the base of WTC 7 (Figure 7-7). Two of the columns between the 1st and 2nd floors were deflected into the building by as much as 2 feet (with most of the rotation occurring at the column splice just above the 1st floor); at one of the columns, very little contact remained at the column splice (Figure 7-9). Even so, the columns did not buckle, and structural bays above did not collapse or deflect significantly. Similarly, the structural bays supported by the column between the 6th and 8th floors that was completely destroyed by the impact of projectile debris were essentially undamaged.

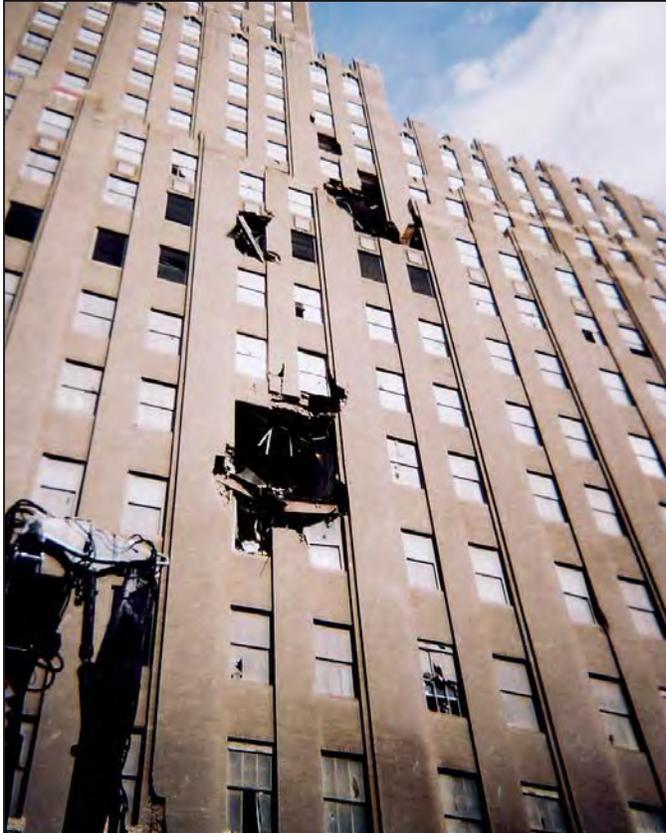
The south (Vesey Street) side of the building was damaged from approximately the 13th floor down, primarily due to the impact of projectile debris from the collapse of WTC 1 (Figure 7-10). In addition to fairly extensive façade damage (bricks and windows), two bays of slab and framing were damaged at the sidewalk arcade at the 1st floor, and one bay of slab and framing (including spandrel beams) was damaged at the 6th, 7th, 9th, 11th, 12th, and 13th floors (Figures 7–11 and 7-12). In addition, one interior column suffered minor damage below the 1st floor.

*Figure 7-10*  
Verizon building – damage to south elevation (Vesey Street).

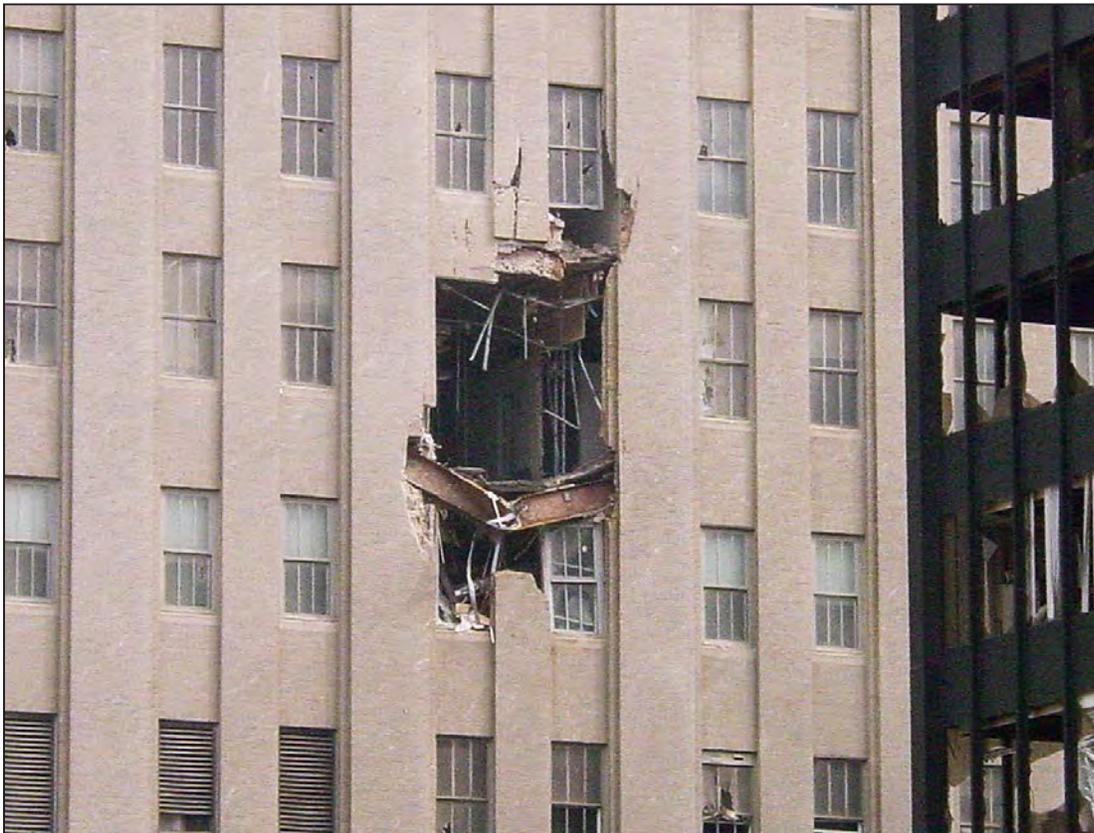
*Figure 7-11* Verizon building – localized damage to south elevation (Vesey Street).

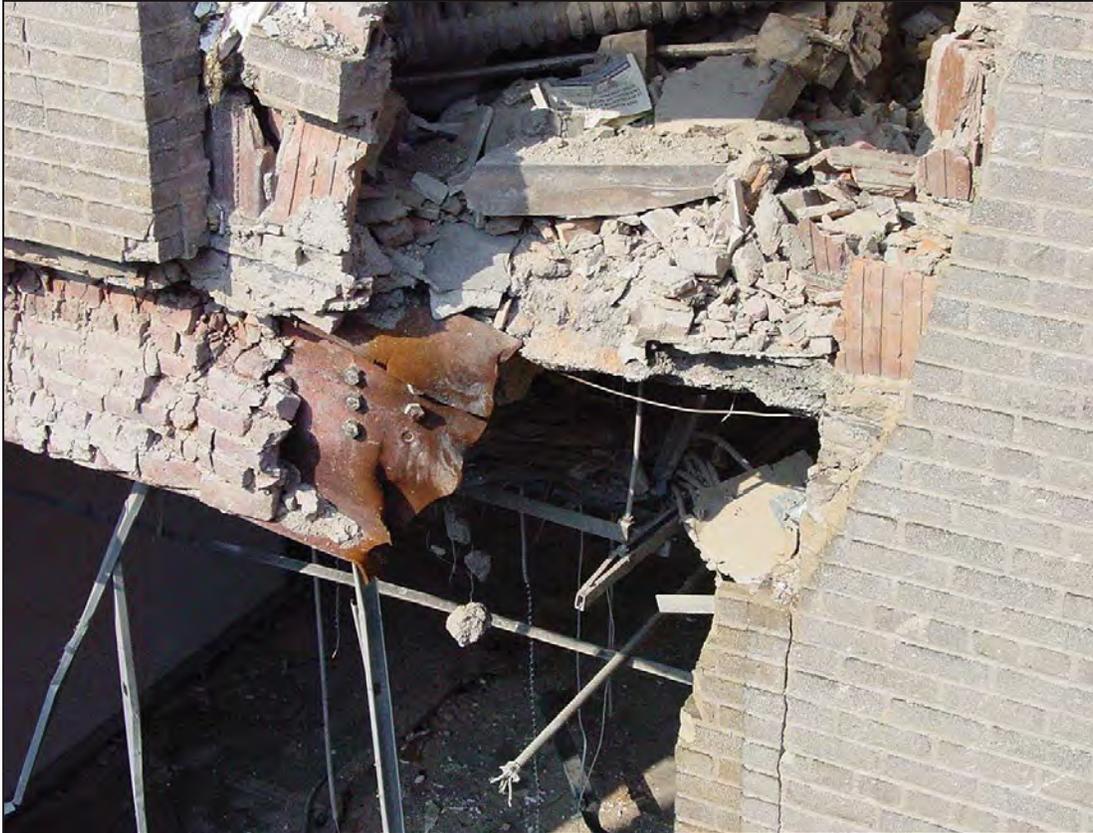
In general, the Verizon building performed well, especially given its close proximity to WTC 7. On the south (Vesey Street) side of the building, damage was extremely localized near the point of impact of projectile debris. In some cases, only a short section of spandrel beam and small area of floor slab were damaged, leaving the remainder of the structural bay intact (Figure 7-12).

Figure 7-12 Verizon building – detail of damage to south elevation (Vesey Street).

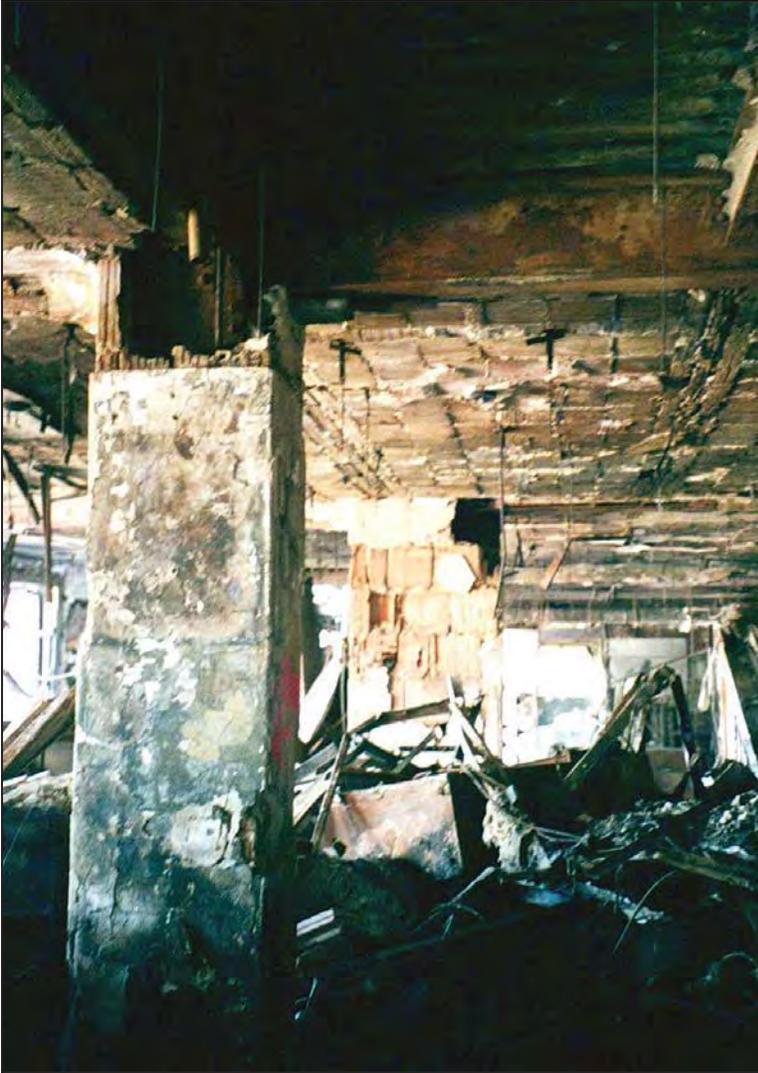
The roof was damaged by debris falling from WTC 2, and approximately half of the north face of the building experienced projectile impact and fire damage. WTC 2 projectiles severed spandrel beams at floors 8 to 11 in the 2nd bay from the west end, and in a middle bay at the 6th floor. Terra cotta slabs were damaged mostly in the exterior bay at these locations. In general, the projectiles damaged only the masonry and broke many terra cotta features. The damage to the interior structural terra cotta floor slabs was primarily due to the brittle fracture of the terra cotta slabs upon impact by large debris. Most of the damage was restricted to the two northernmost bays, with the exception of fire damage on the 1st through 5th, 7th through 10th, 14th, 21st, and 23rd floors. The fire did not spread to the south side of the building, except for the first 4 floors. Columns were buckled 1-2 inches on the 8th and 23rd floors, approximately a foot below the ceiling, as shown in Figures 7-16 and 7-17. A tube column supporting a north exit stair from the roof and a built-up column supporting the roof were the only other heat-induced buckling damage observed during initial inspections.

*Figure 7-16  
Buckling damage at top of column  
on floor 8 of 90 West Street. Note the loss of fire  
protection at the top of the column.*

fire load, is considered typical for this type of construction and fire protection; however, it has been suggested that the scaffolding that was in place for renovations contributed to the spread of fire between floors that may not have occurred otherwise. However, the only structural damage observed was buckling damage near the tops of two columns.

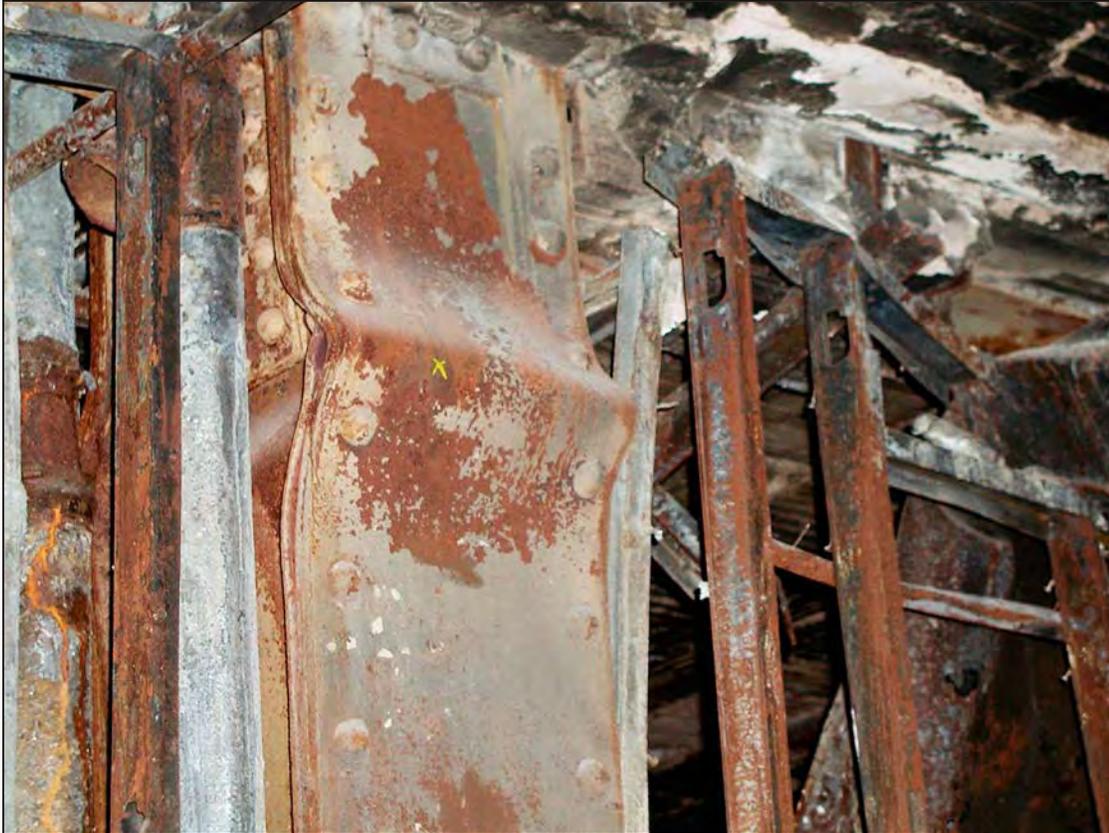
Figure 7-17 Buckling damage at top of column on floor 23 of 90 West Street.

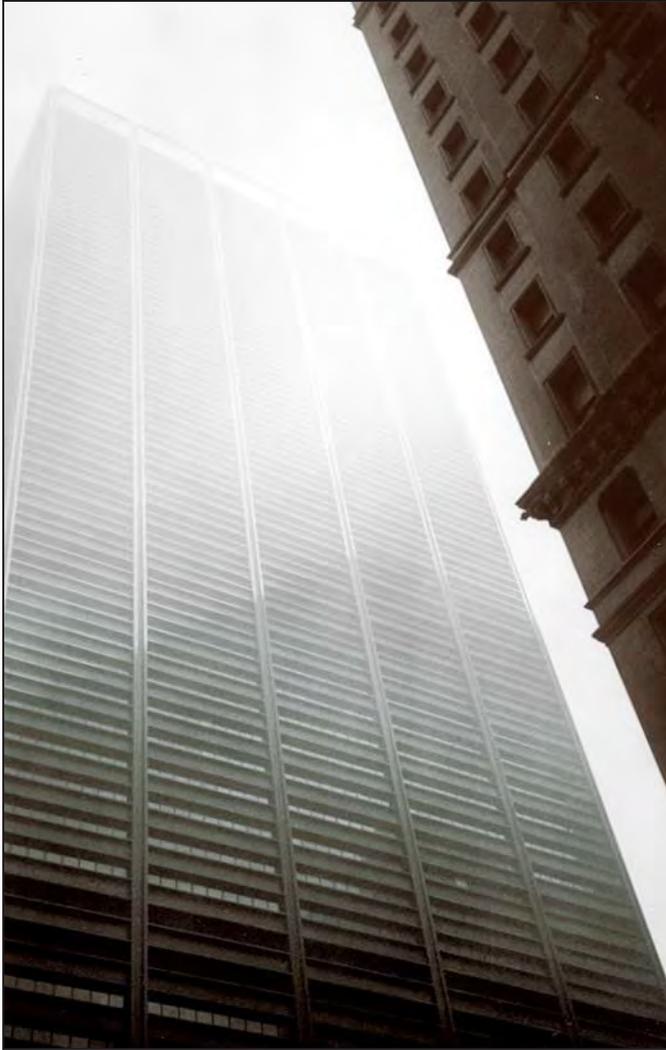
The majority of damage incurred at One Liberty consisted of broken window glass and frames. Most of that broken glass was in the lower six floors of the west-facing elevation, with less breakage on the floors above. There was, however, some broken glass on the north- and south-facing elevations as well. At those elevations, most of the broken glass was located at floors 1 through 6. There were approximately 550 broken lites of glass, and approximately 200 frames were damaged beyond repair.

*Figure 7-19*  
*One Liberty Plaza – south elevation, upper floors.*

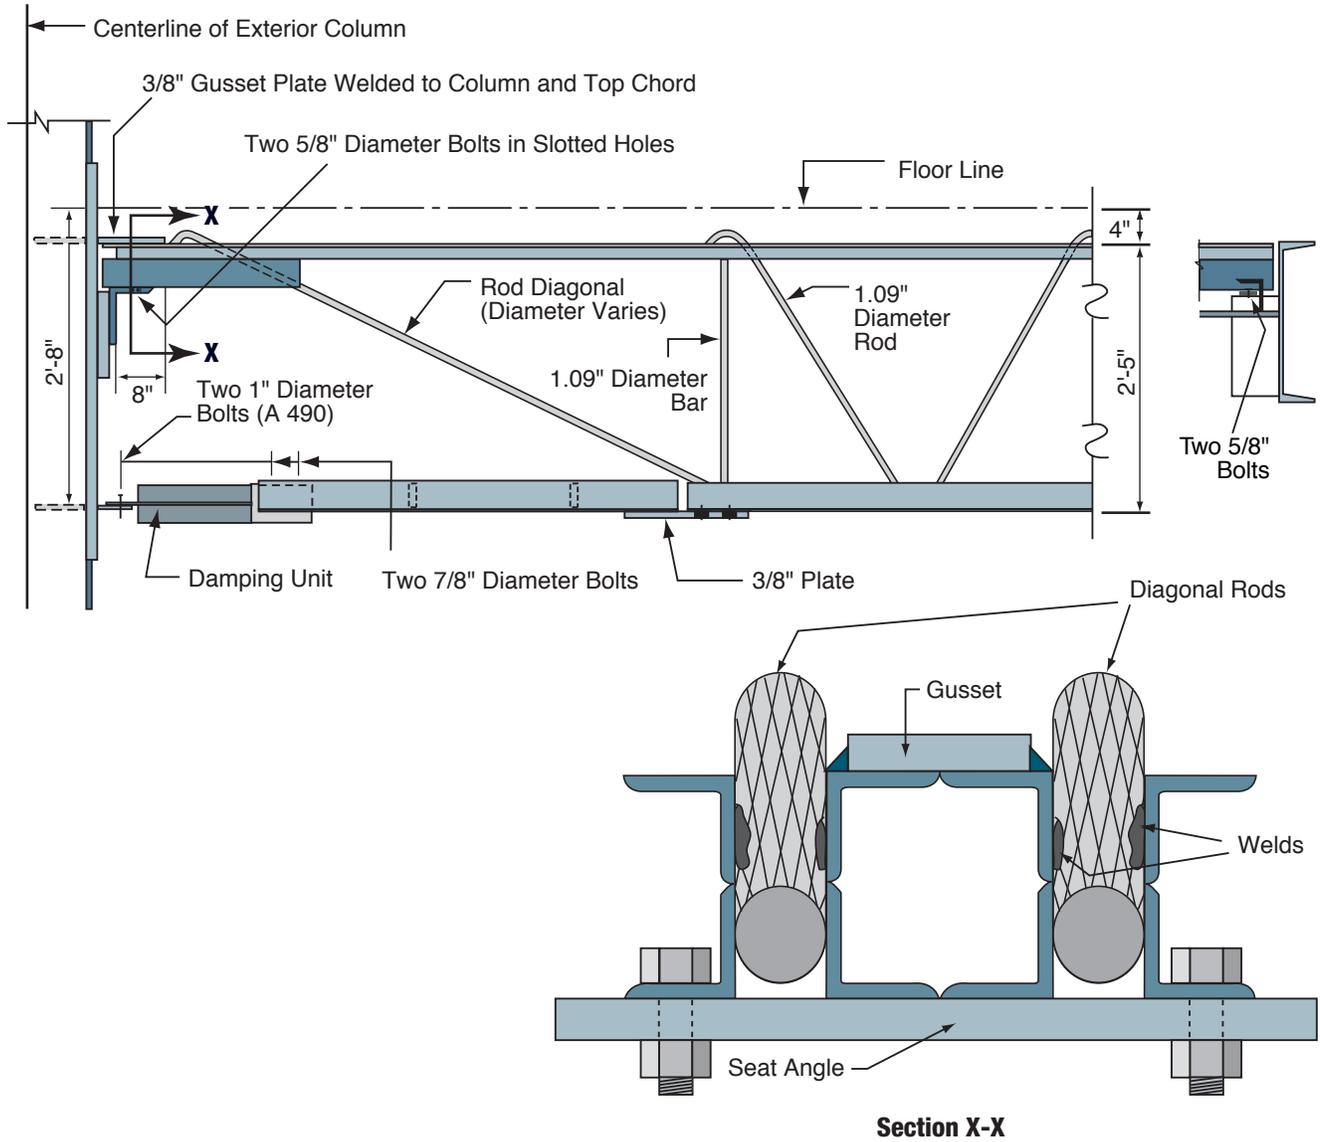
Figure B-8 Typical truss top chord connections to column/spandrel beam and to the core beam.

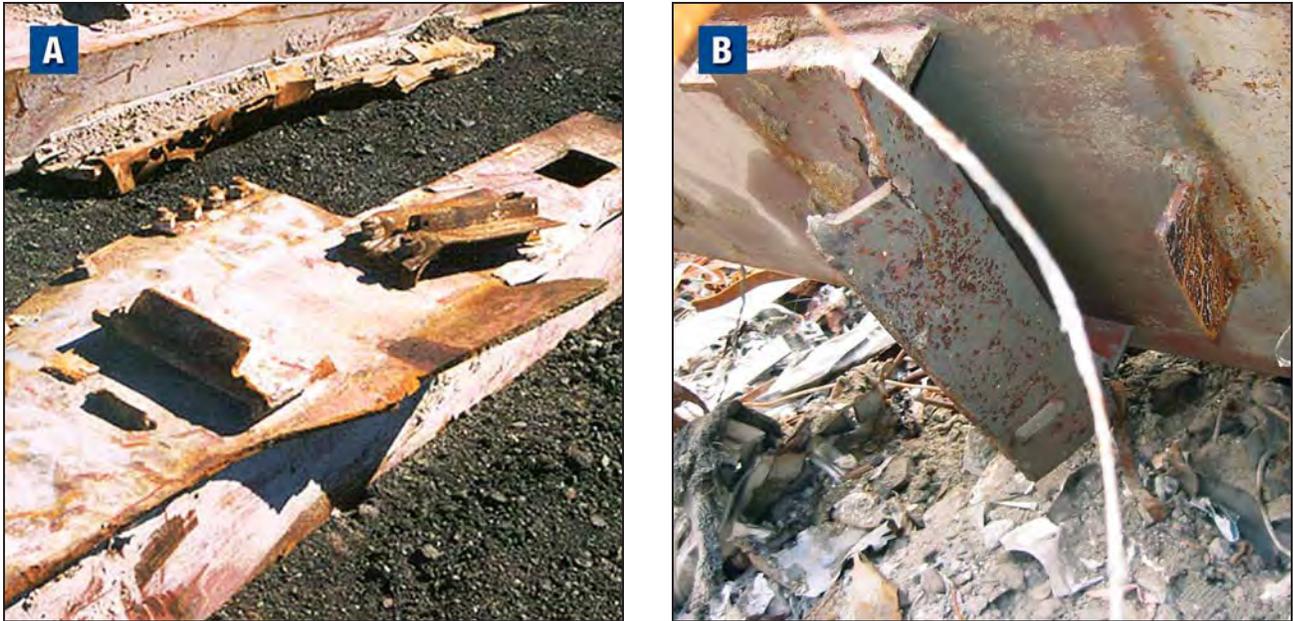
Figure B-9 shows several of the failure modes of the truss connections to the chord bearing seat and spandrel beam. The gusset plate welded to the spandrel beam and the top chord failed by tensile fracture of the plate. The gusset plate connection was primarily resisting the floor diaphragm support to the column. After fracture, the slotted holes in the seat would allow rigid body motion of the trusses until the 5/8-inch bolts came into bearing. That resulted in partial fracture in the seat of the fillet welds attaching the fill plate to the spandrel beam. The seat angle welded connection to the fill plate remained intact as this separation occurred and final block shear failure developed in the outstanding angle leg at the two slotted bolt holes.

It is probable that, once the 3/8-inch gusset plate fractures, the next lower bound resistance is provided by the bearing capacity of the two 5/8-inch bolts on the beam seat angle. This failure also tore off the ends of the angle even though the tensile capacity of those segments was predicted to be higher.

Figure B-9 (A) Visco-elastic damper angles bolted to angle welded to spandrel plate and (B) failed bearing seat connection.

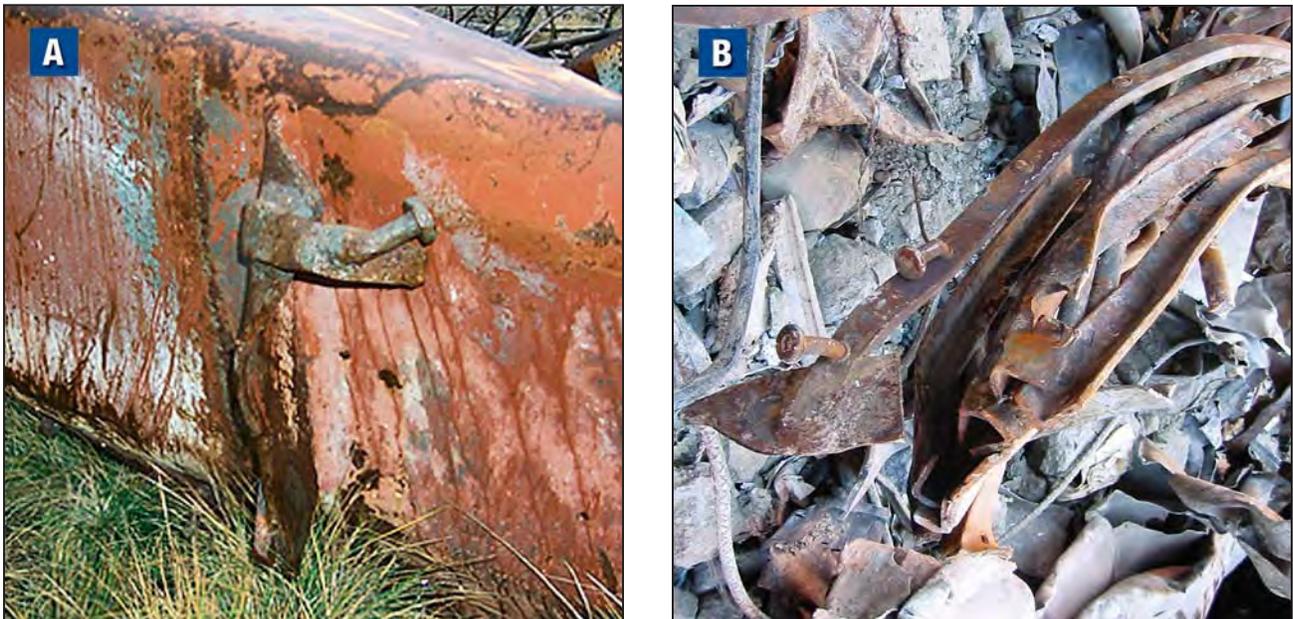
It should also be noted that each truss top chord provided a horizontal diagonal plate brace (1-1/2 inches x 1/2 inch) to the two adjacent columns. These members were welded to welded bracket plates on each adjacent column/spandrel member, as illustrated in Figure B-10. In this case, it would appear that the diagonal plate braces fractured on their gross section or tore the bracket plate. The component of ultimate strength of the two diagonal plate braces normal to the column/spandrel member is about 85 percent of the tensile capacity of braces, which would be 76 kips.

Figure B-10 (A) Bracket plate welded to the column/spandrel plate and (B) horizontal plate brace with shear connectors welded to the failed bracket.

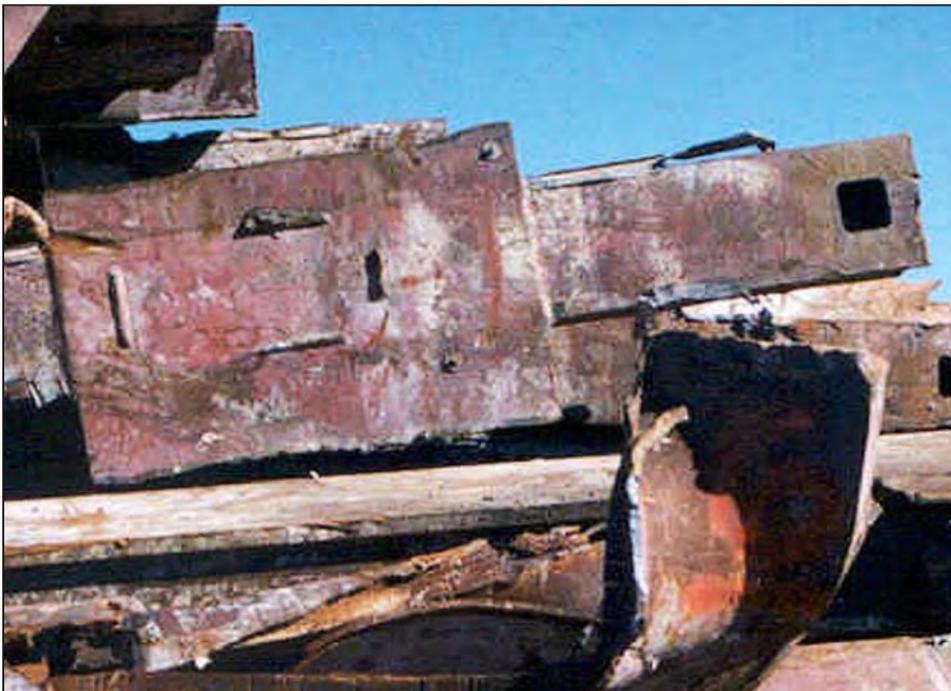
Many of the bearing seat brackets and the damper angle connections on the column/spandrel beam plate were completely sheared off. Only the weld segments remained on face of the column/spandrel beam plate (Figure B-11). This mode of failure appears to be due to excessive vertical overloads on the floor system. This is in contrast with the failure mode exhibited in Figure B-9 where the bearing seat bracket has pulled away from the column/spandrel plate, after fracture of the top chord gusset plate.

Figure B-11  
Shear failure of floor truss connections from column/spandrel plate.

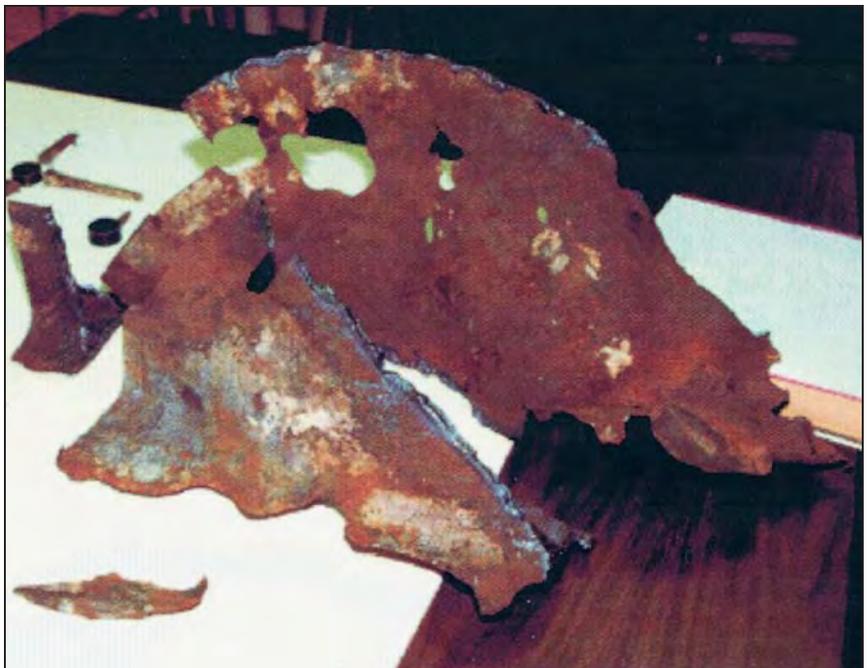
Several regions in the section of the beam shown in Figures C-1 and C-2 were examined to determine microstructural changes that occurred in the A36 structural steel as a result of the events of September 11, 2001, and the subsequent fires. Although the exact location of this beam in the building was not known, the severe erosion found in several beams warranted further consideration. In this preliminary study, optical and scanning electron metallography techniques were used to examine the most severely eroded regions as exemplified in the metallurgical mount shown in Figure C-3. Evidence of a severe high temperature corrosion attack on the steel, including oxidation and sulfidation with subsequent intergranular melting, was readily visible in the near-surface microstructure. A liquid eutectic mixture containing primarily iron, oxygen, and sulfur formed during this hot corrosion attack on the steel. This sulfur-rich liquid penetrated preferentially down grain boundaries of the steel, severely weakening the

Figure C-1 Eroded A36 wide-flange beam.

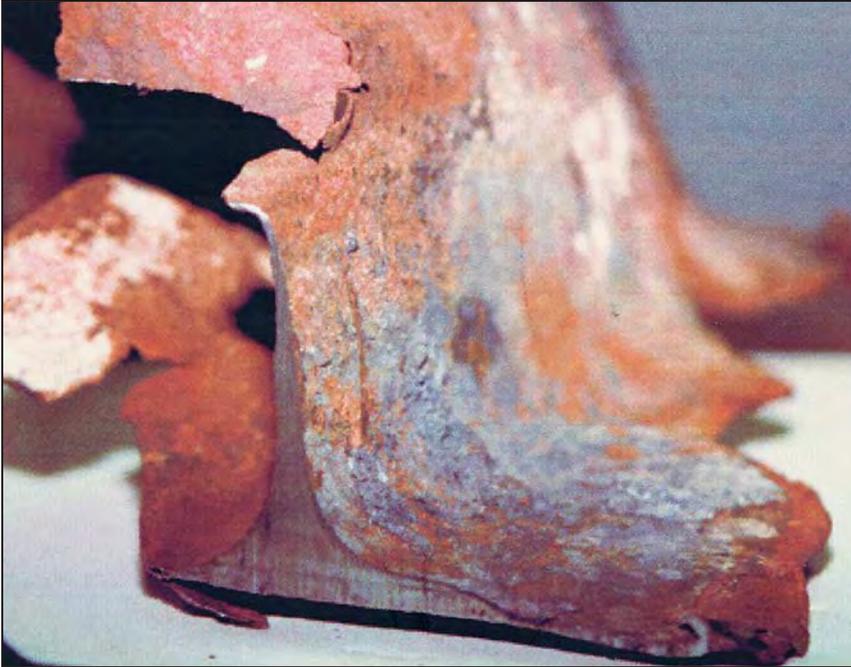
*Figure C-2*  
Closeup view of eroded wide-flange beam section.

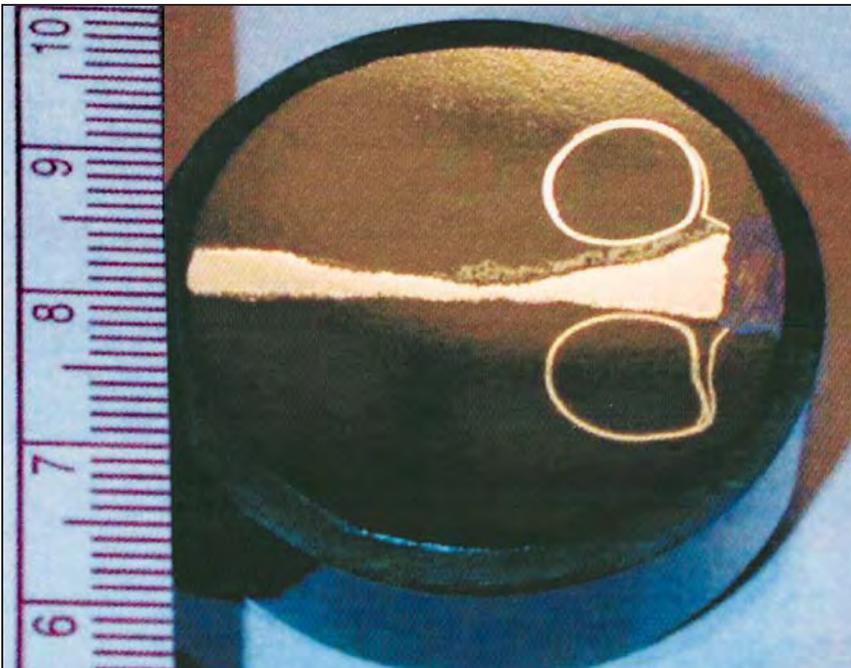
*Figure C-3*  
Mounted and polished severely thinned section removed from the wide-flange beam shown in Figure C-1.
