# World Trade Center Building Performance Study:

*Data Collection, Preliminary  
Observations, and  
Recommendations*

**Federal Emergency Management Agency**

FEMA 403 / September 2002

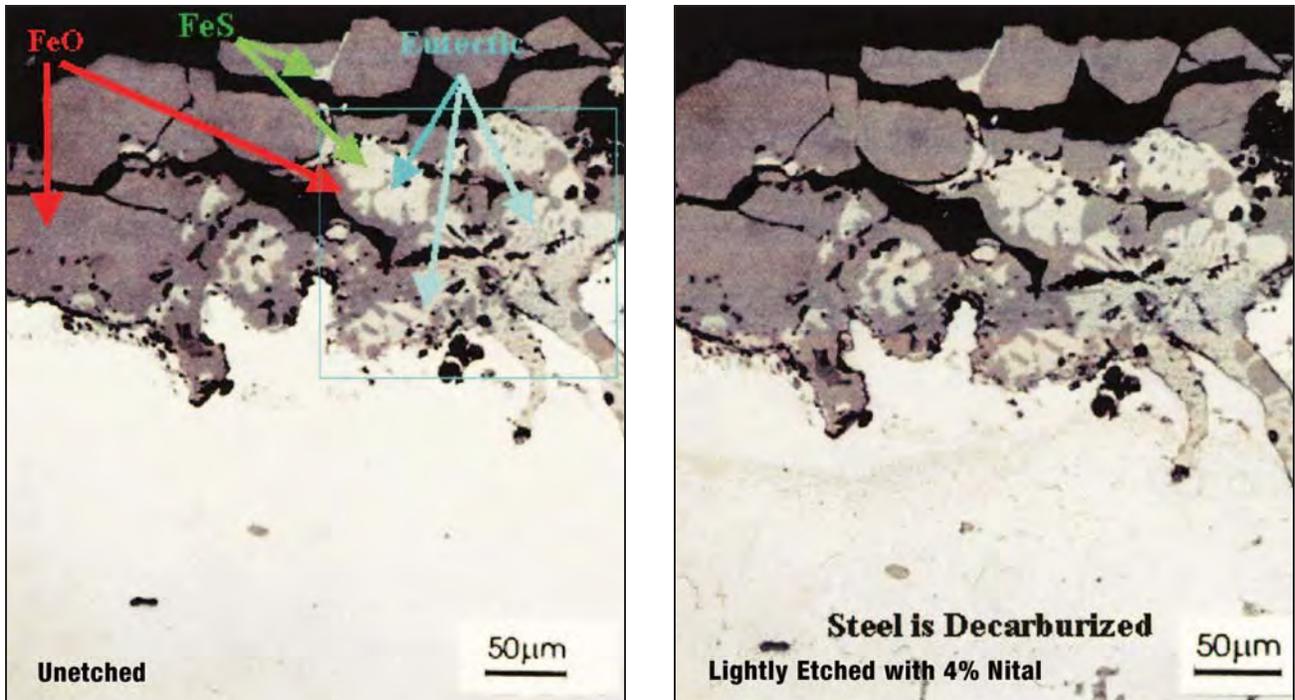
Figure C-4 Optical microstructure near the steel surface.

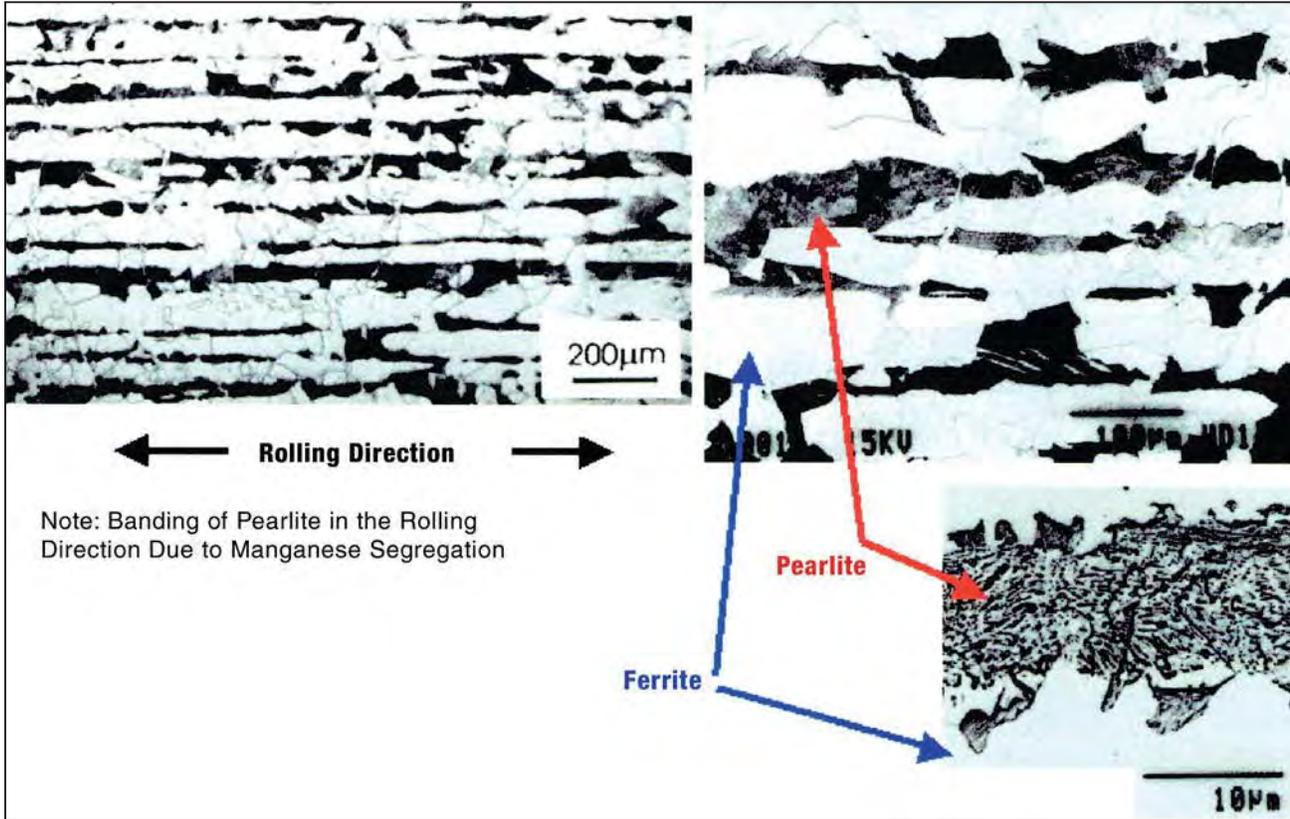
Figure C-6 Microstructure of A36 steel.

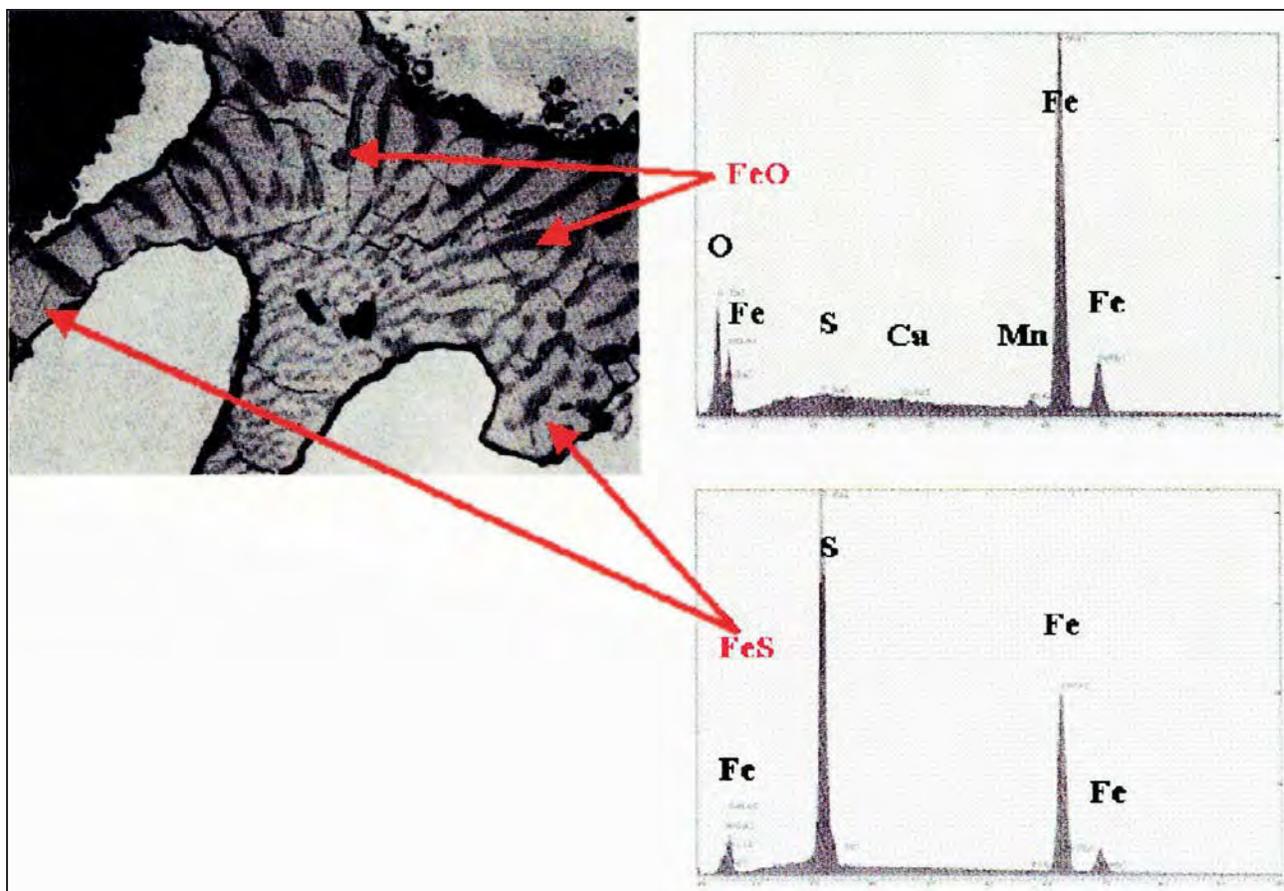
Figure C-8 Qualitative chemical analysis.

section of the steel that is unaffected by the hot corrosion. Figure C-7 illustrates the deep penetration of the liquid into the steel's structure. In order to identify the chemical composition of the eutectic, a qualitative chemical evaluation was done using energy dispersive X-ray analysis (EDX) of the eutectic reaction products. Figure C-8 illustrates the results of this analysis.

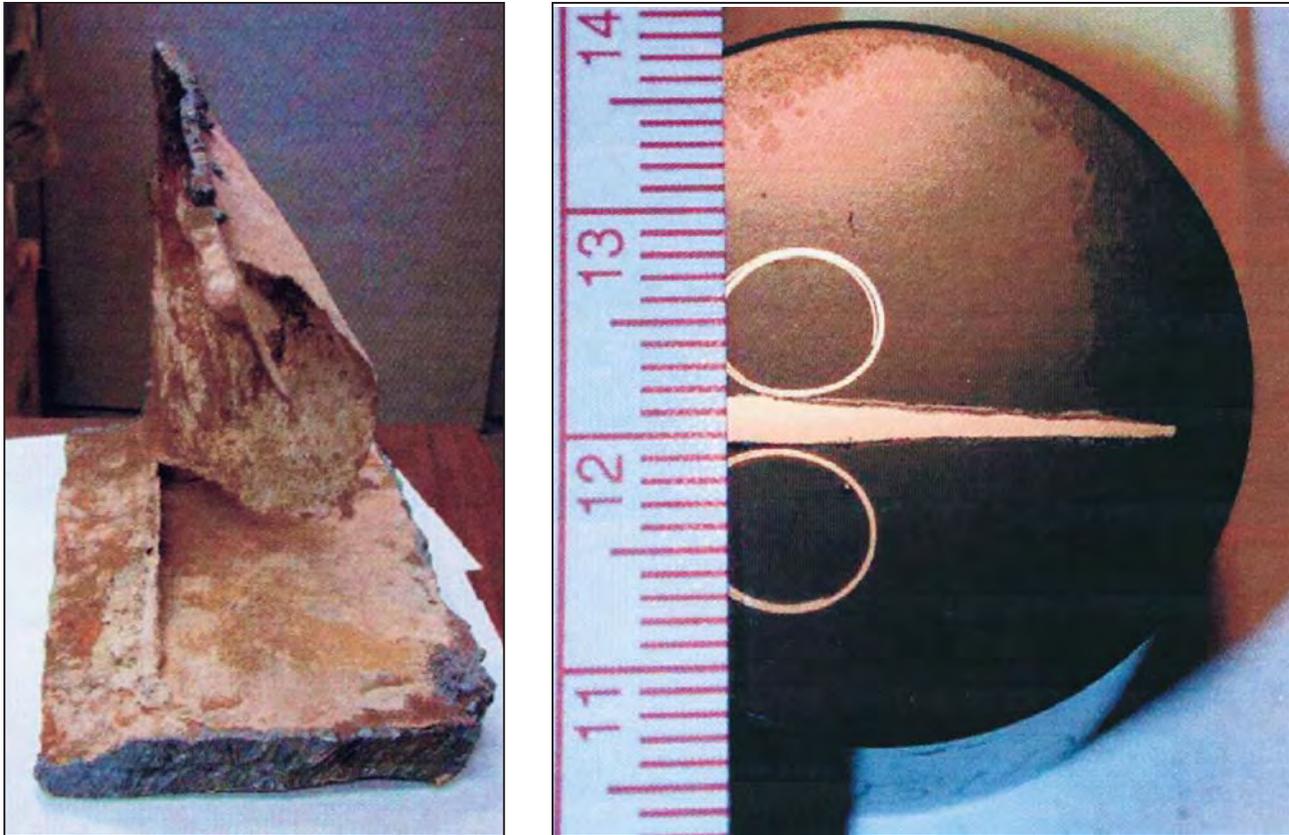
The origin of the steel shown in Figure C-9 is thought to be a high-yield-strength steel removed from a column member. The steel is a high-strength low-alloy (HSLA) steel containing copper. The unusual thinning of the member is most likely due to an attack of the steel by grain boundary penetration of sulfur forming sulfides that contain both iron and copper. Figures C-10, C-11, and C-12 show the region of severe corrosion at different levels of magnification.

Figure C-9 Qualitative chemical analysis.

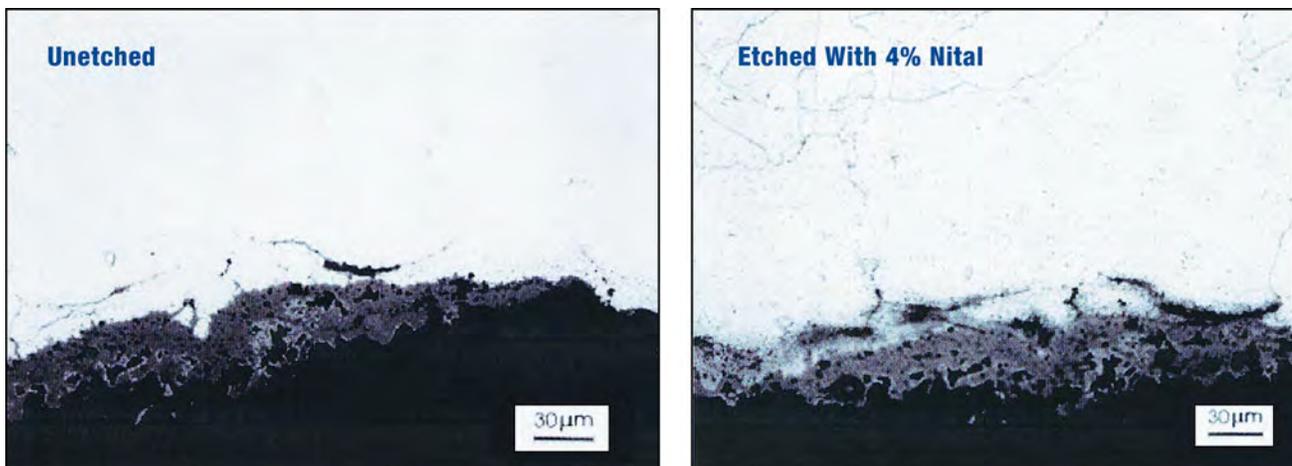
Figure C-10 Grain boundary corrosion attack.

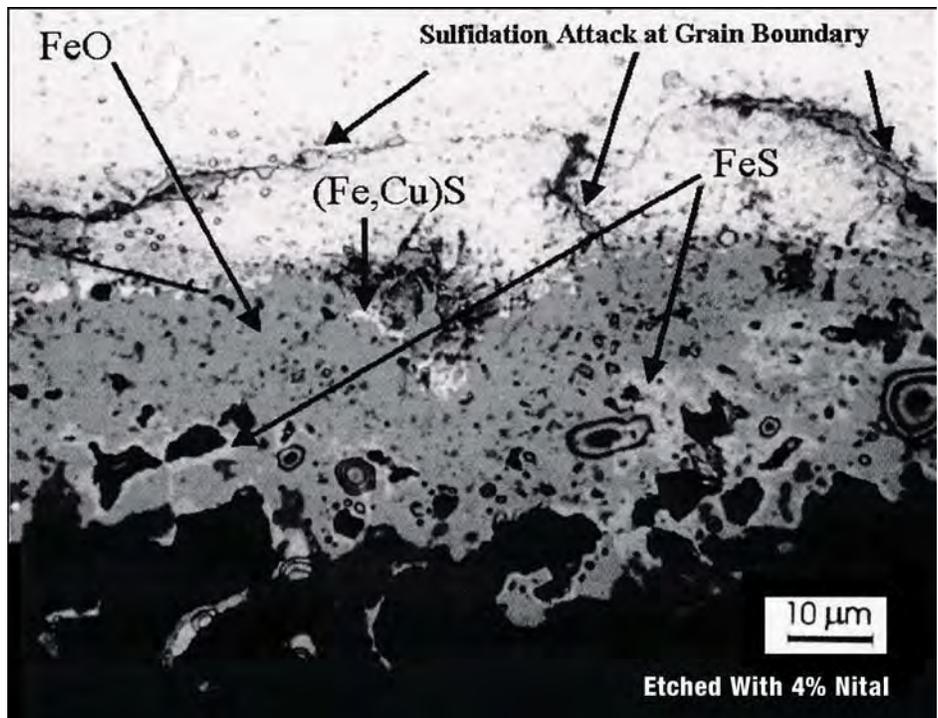
Figure C-12  
Higher magnification of the region  
shown in Figure C-10.

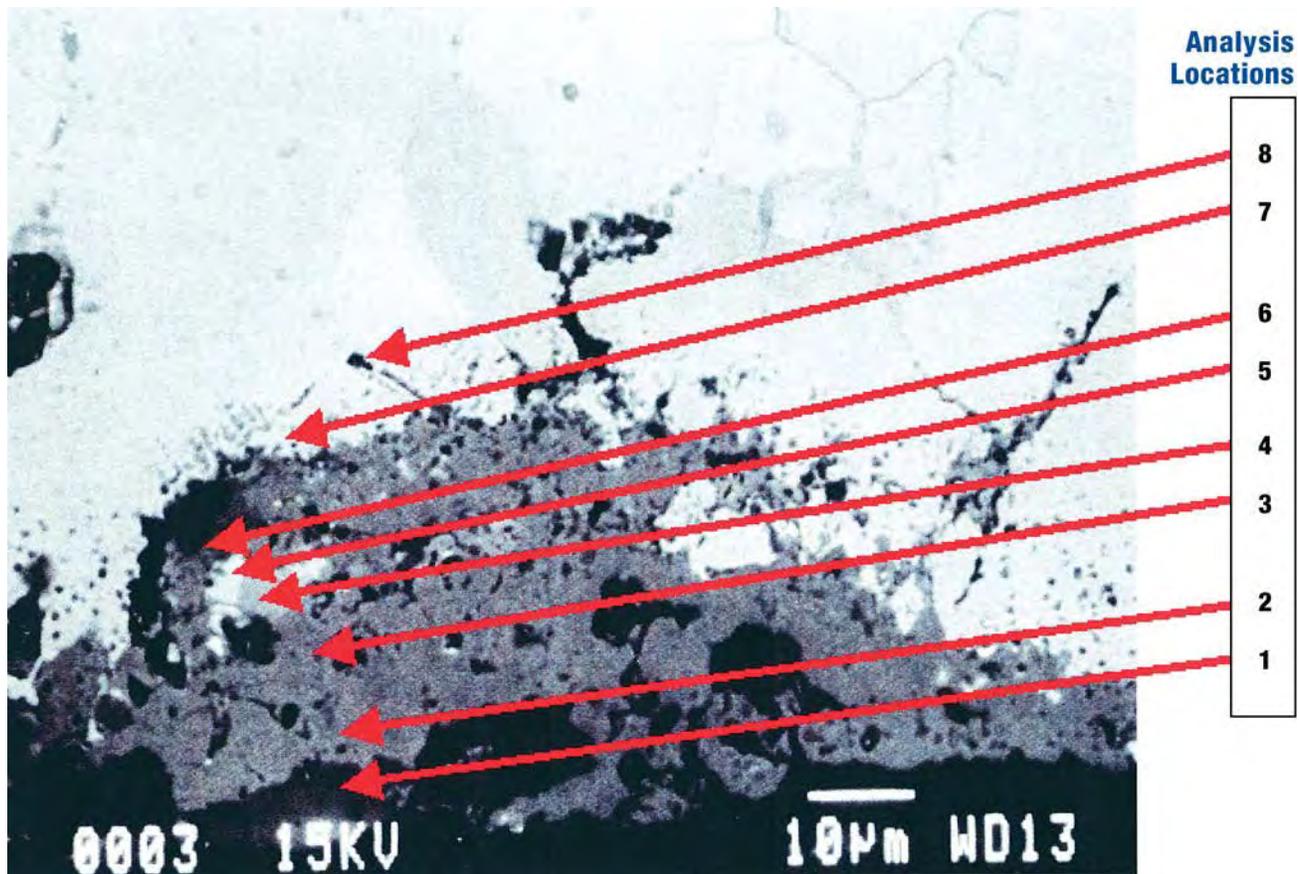
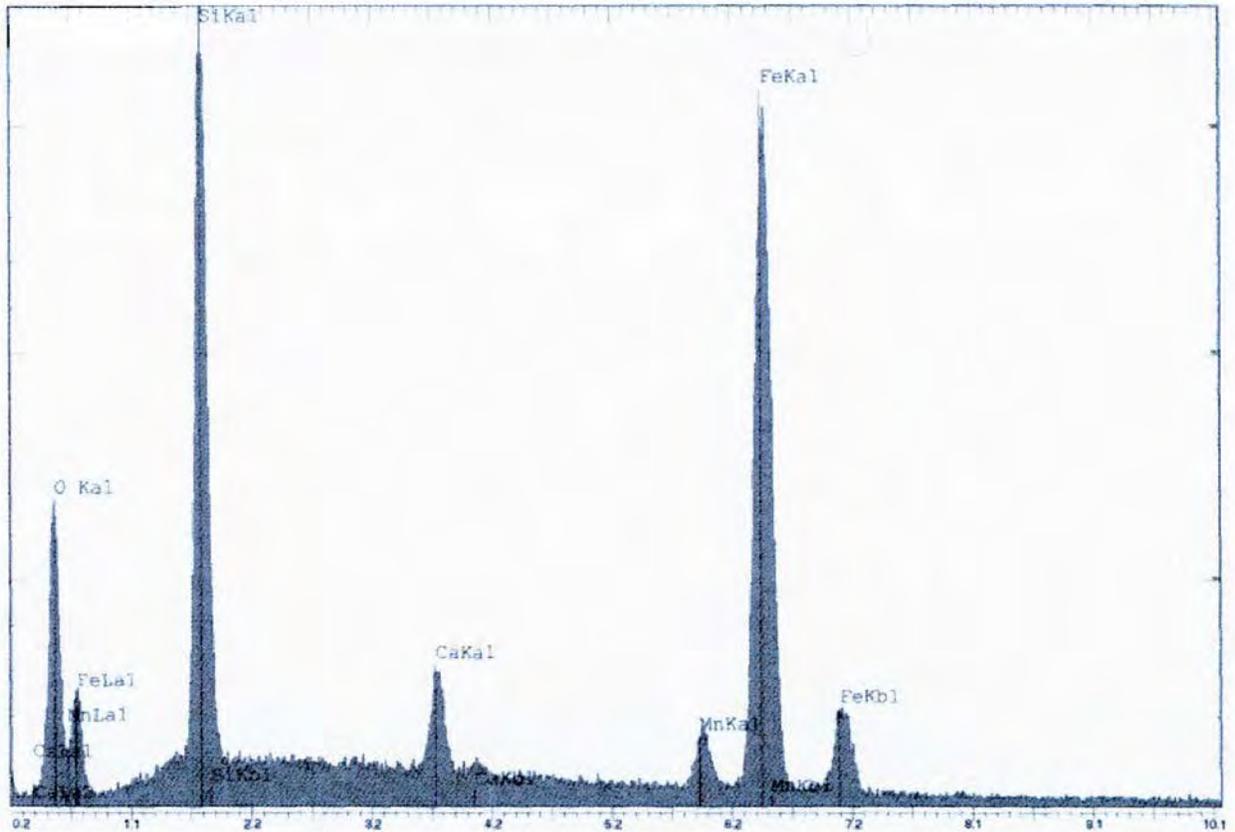
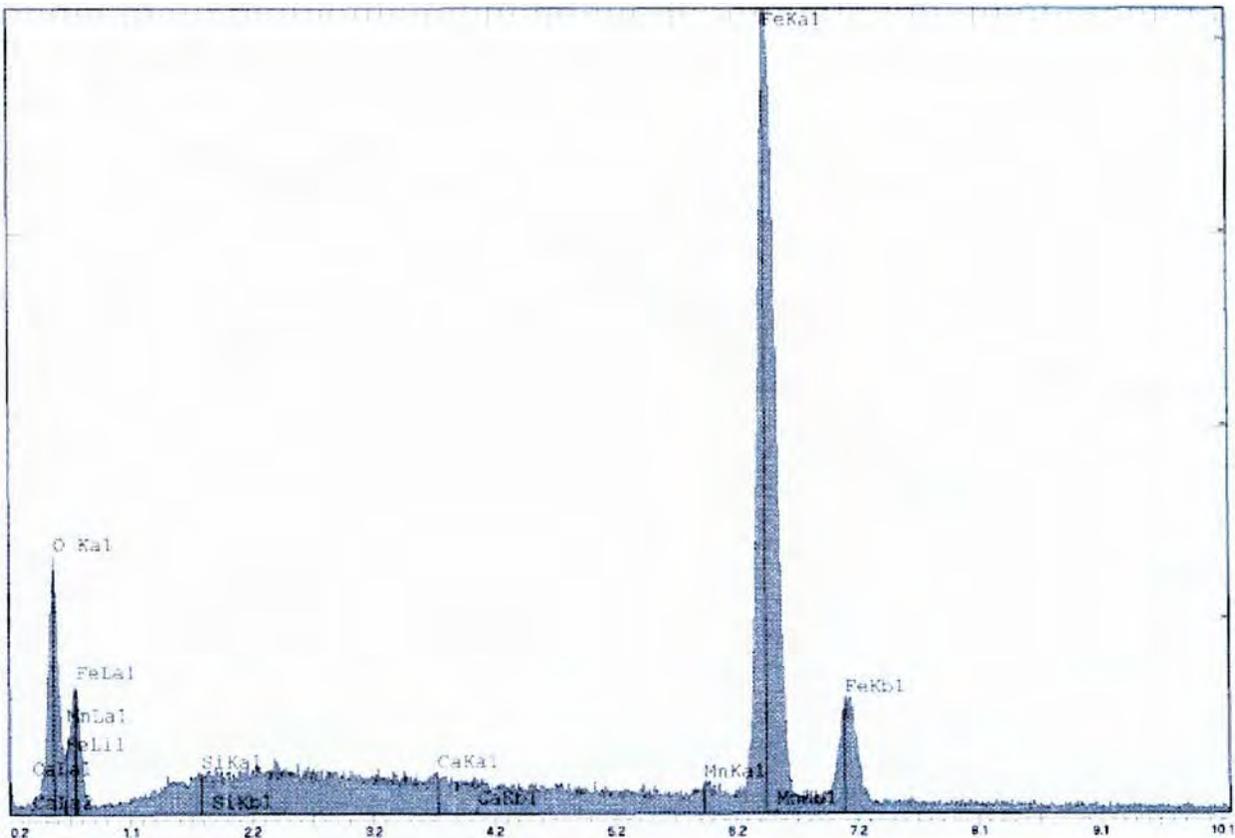
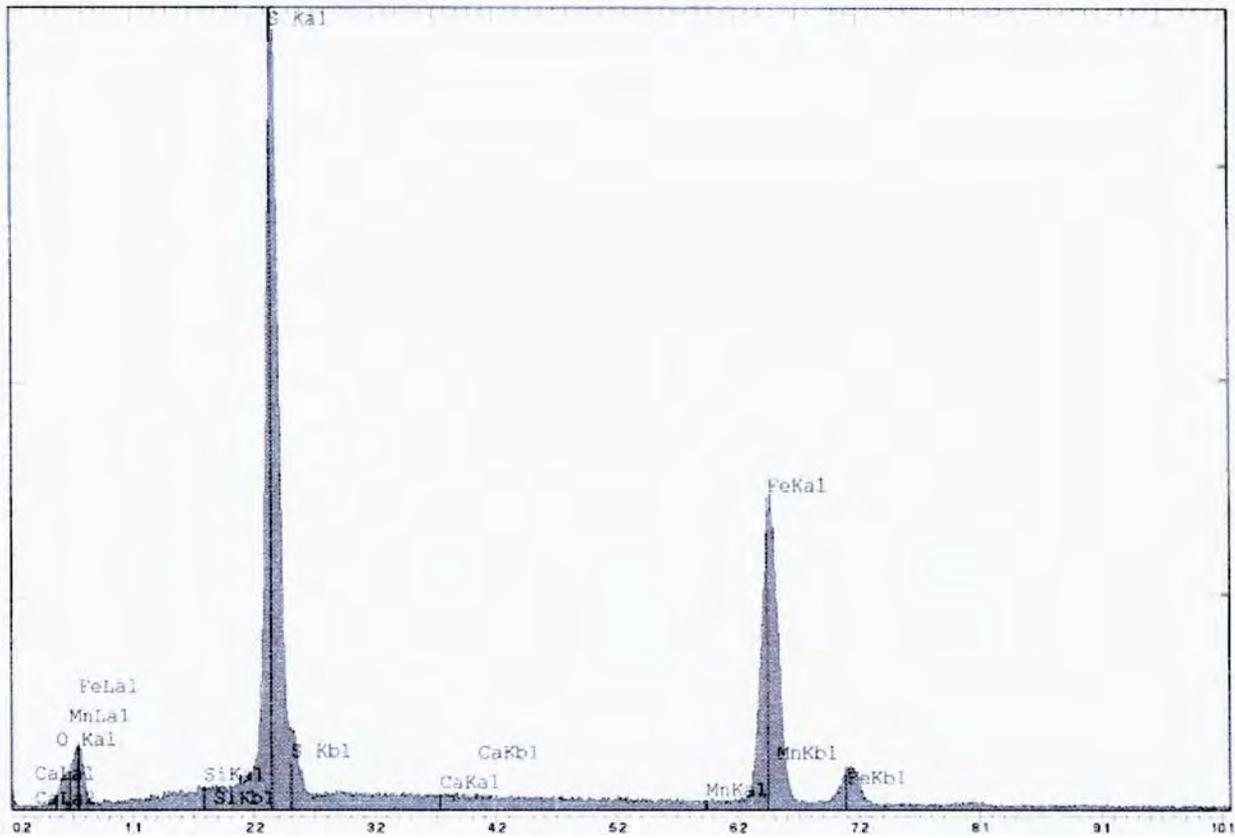
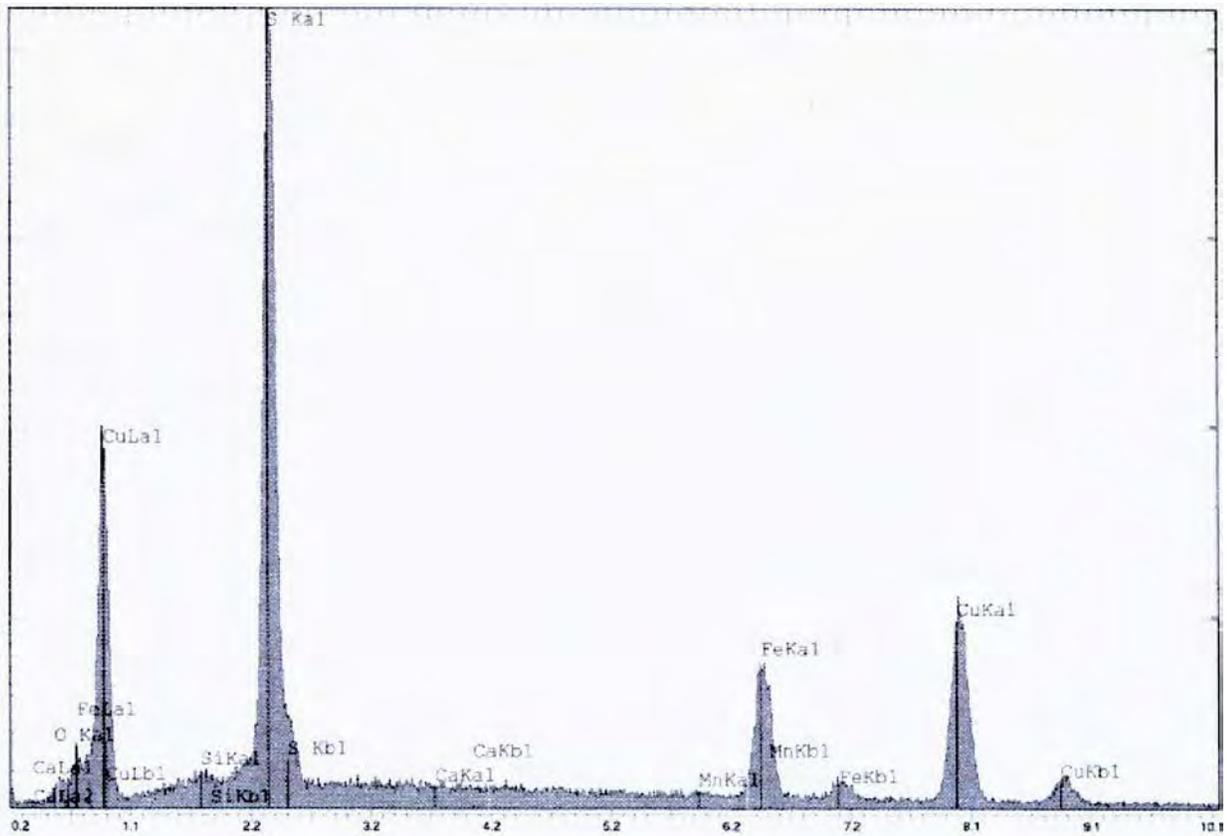
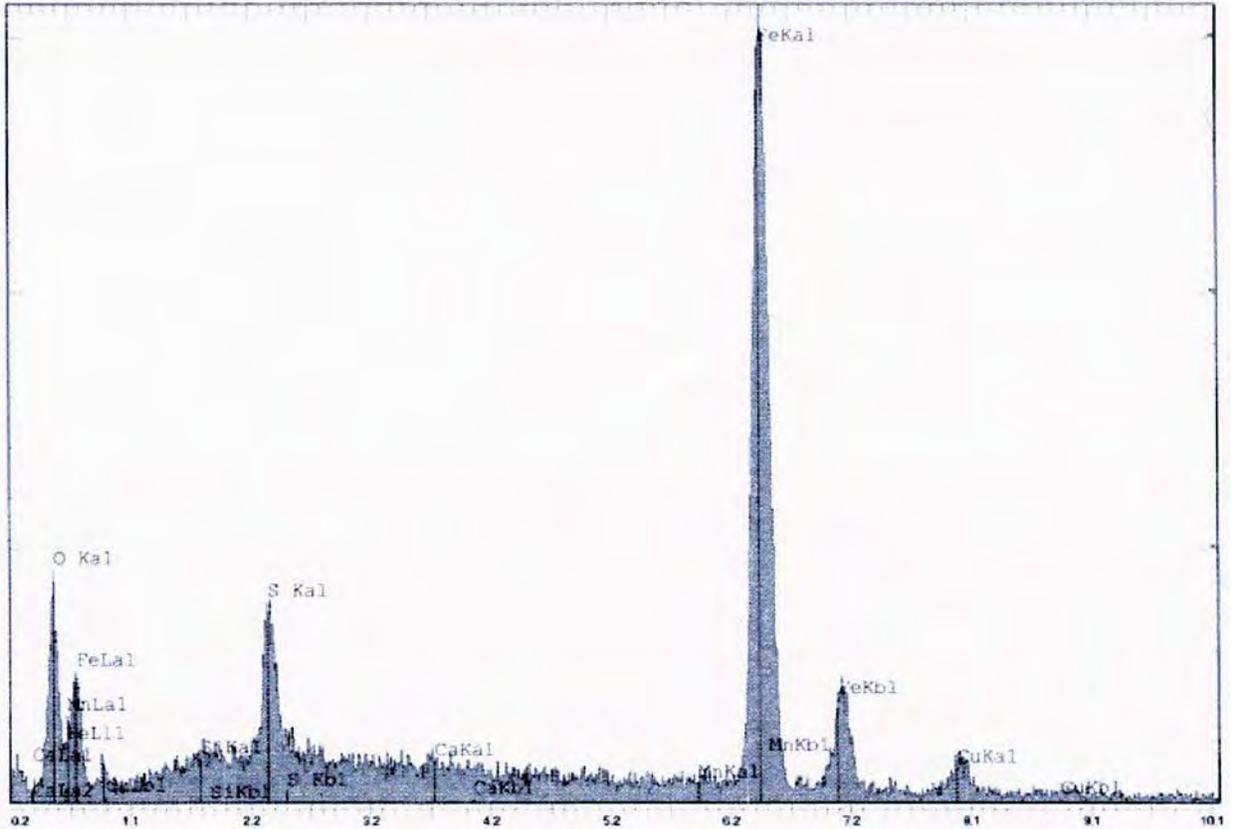
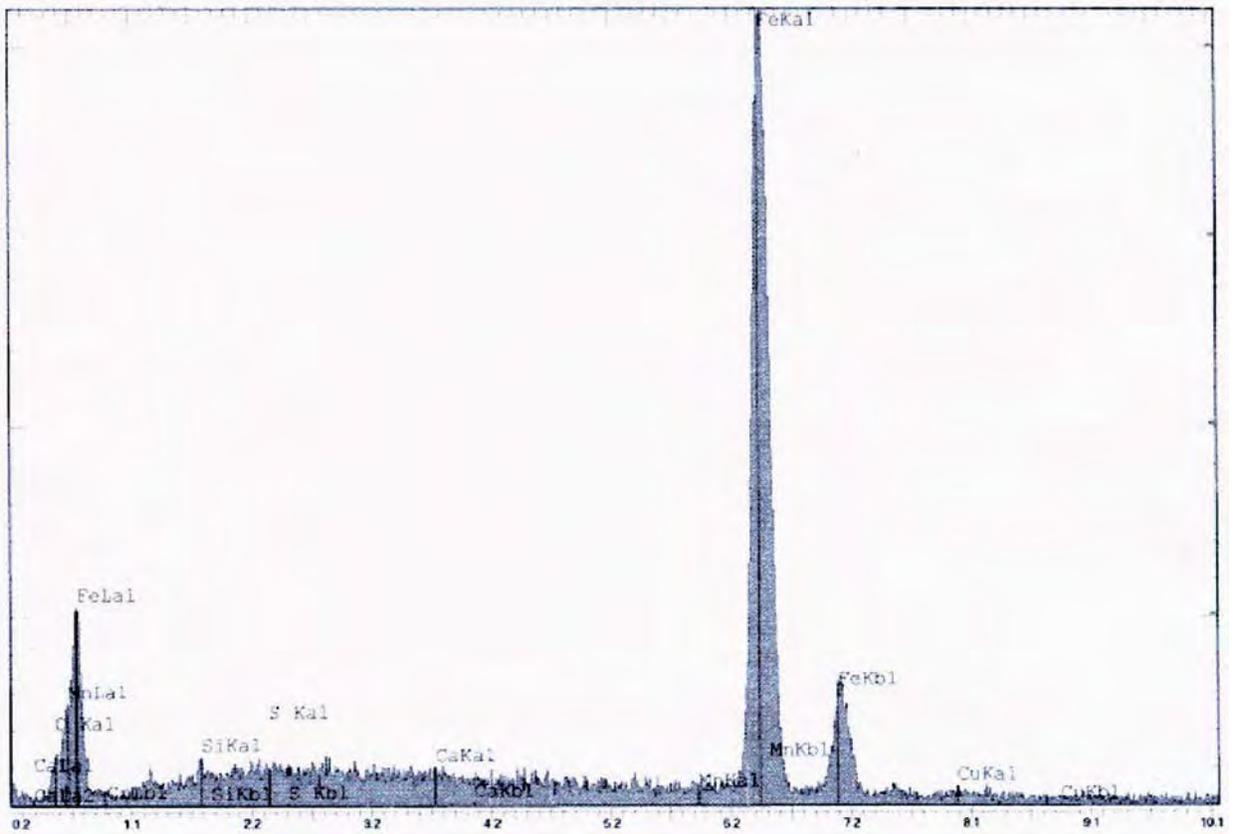
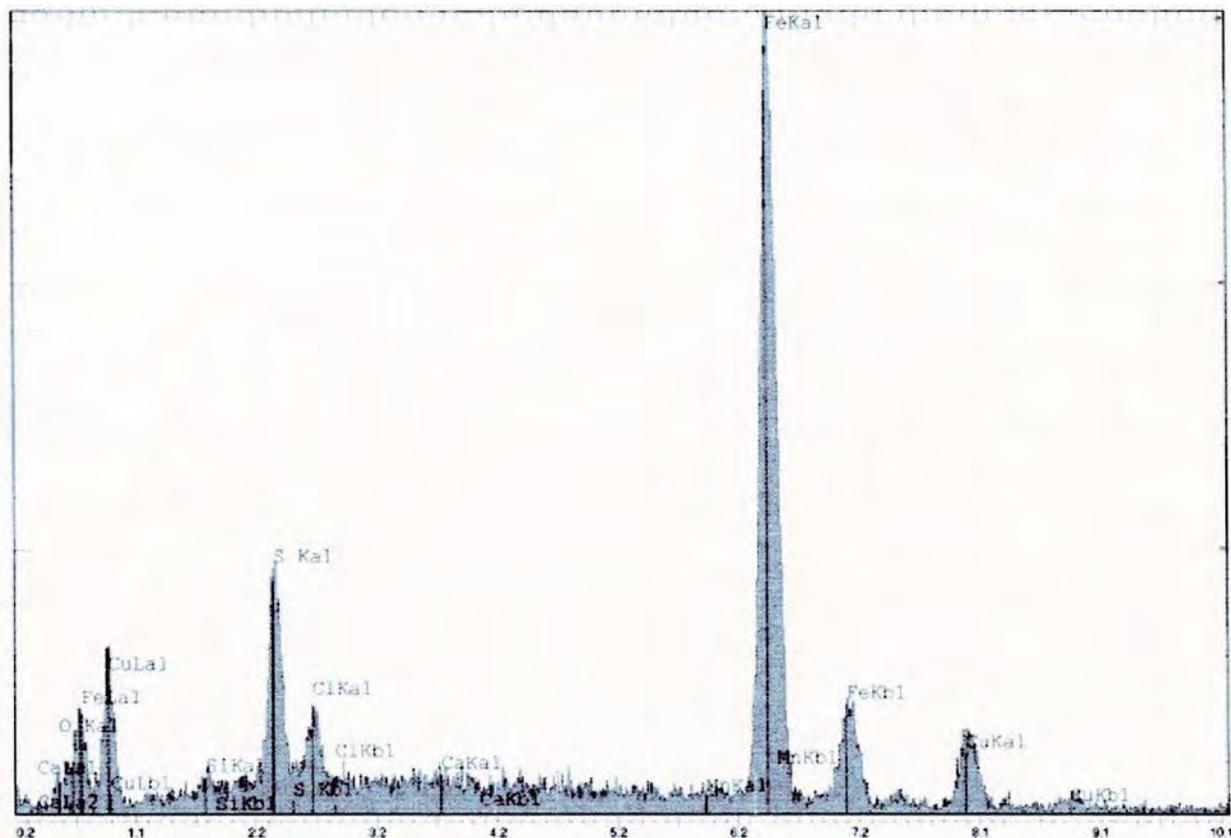
Figure C-13 Regions where chemical analysis was performed.

Figure C-13 shows the region where a qualitative chemical analysis of the eroded region was performed. The comparison of the EDX spectra from the specific regions identified in Figure C-13 shows concentration of copper and sulfur in the grain boundaries in addition to iron sulfide formation adjacent to iron oxide in the oxidized surface layer. Sulfide formation within the steel microstructure increases in concentration as the oxidized region is approached from the steel side. This is clearly shown in Figure C-14.

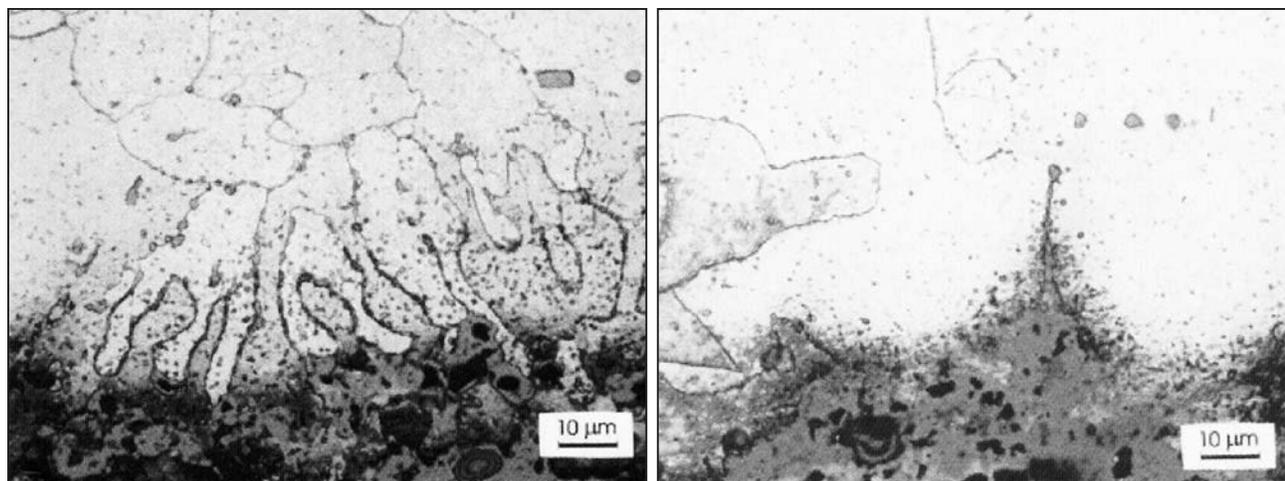
The larger sulfides further into the steel are the more stable manganese sulfides that were formed when the steel was made. The smaller sulfides that have formed as a result of the fire do not contain significant amounts of manganese, but rather are primarily sulfides containing iron and copper. These sulfides have a lower melting temperature range than manganese sulfide. It is much more difficult to tell if melting has occurred in the grain boundary regions in this steel as was observed in the A36 steel from WTC 7. It is possible and likely, however, that even if grain boundary melting did not occur, substantial penetration by a solid state diffusion mechanism would have occurred as evidenced by the high concentration of sulfides in the grain interiors near the oxide layer. Temperatures in this region of the steel were likely to be in the range of 700–800 °C (1,290–1,470 °F).

Figure C-14 Gradient of sulfides into the steel from the oxide-metal interface.

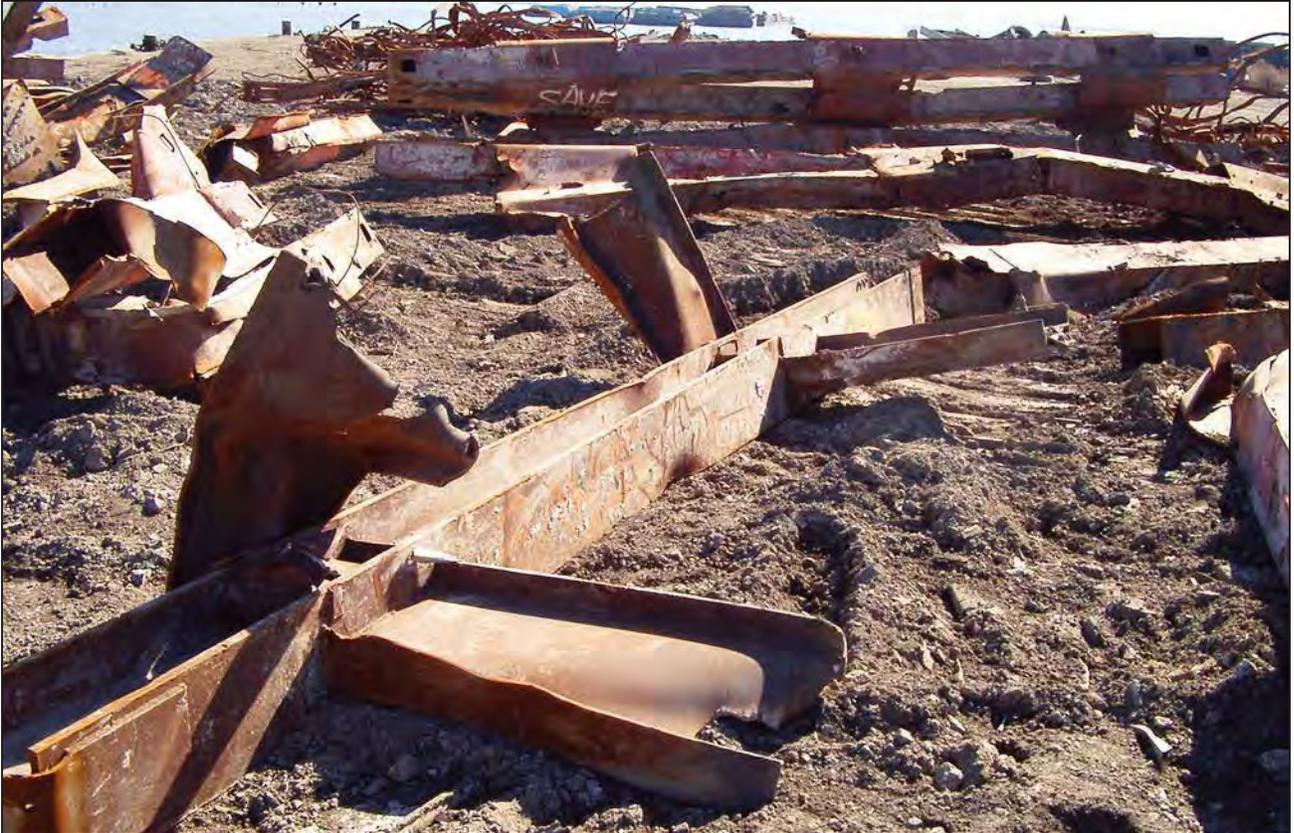
Figure D-14 WTC 7 W14 column tree with beams attached to two floors.

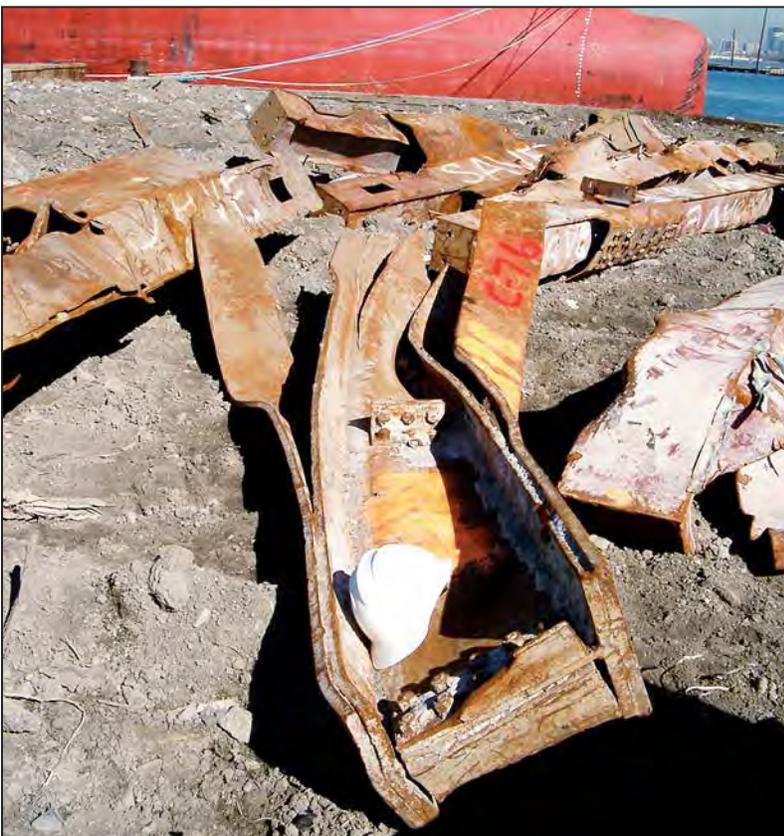
Figure D-15  
Built-up member with failure along stitch  
welding.

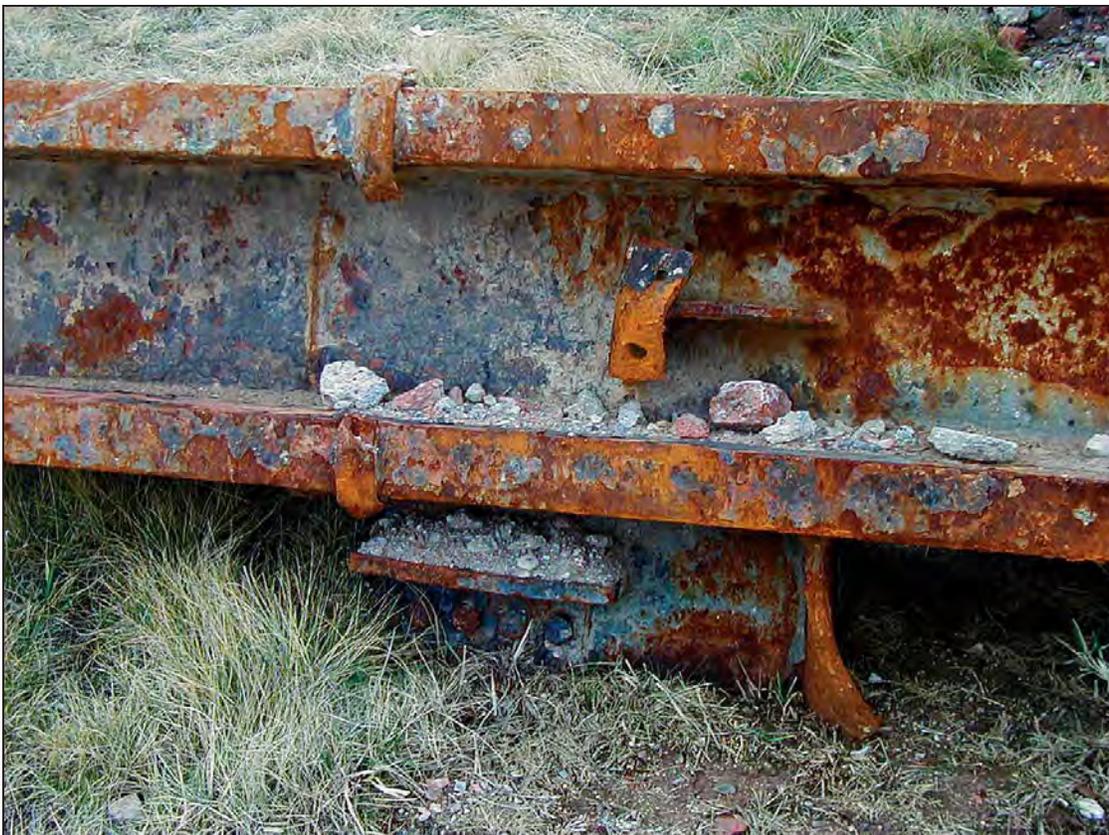
Figure D-17 Seat connection in fire-damaged W14 column from WTC 7.

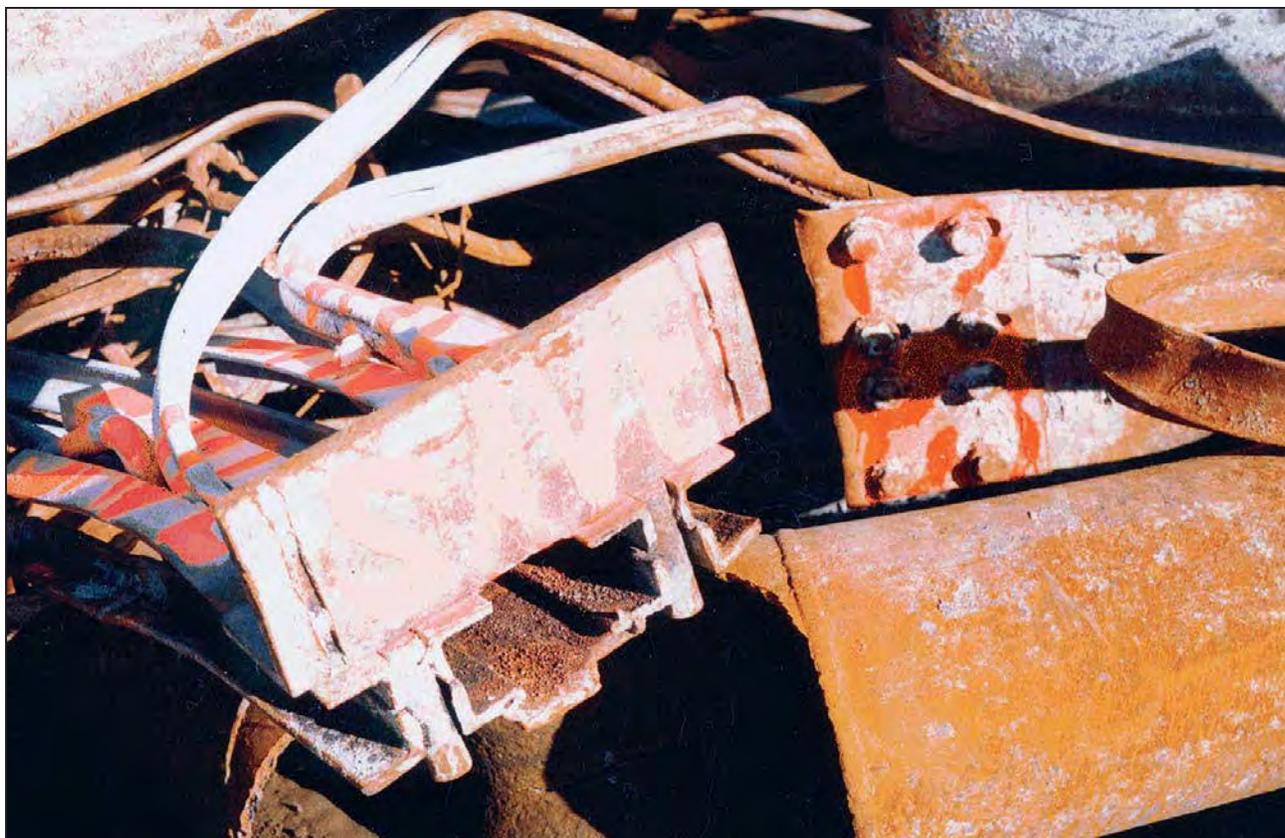
Figure D-18 WTC 1 or WTC 2 floor-truss section with seat connection fractured along welds.
